CITROEN C4 Picasso: 1GKN203

Limited Technical Inspection

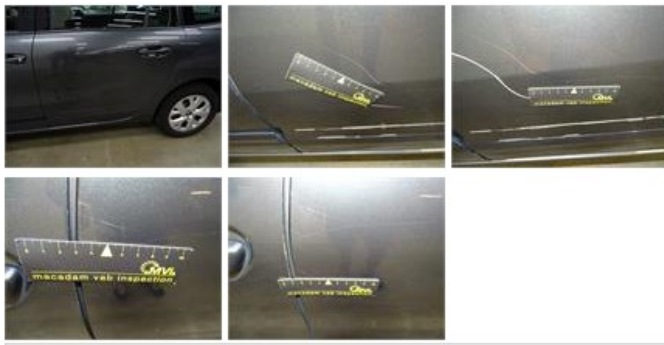
Total cost ex VAT	2150,82
Door moulding Lower R R, Scratch(es), Acceptable	0,00
<i>No pictures to display</i>	
Door R L, Scratch(es), LI - Repair and paint (complete)	318,35

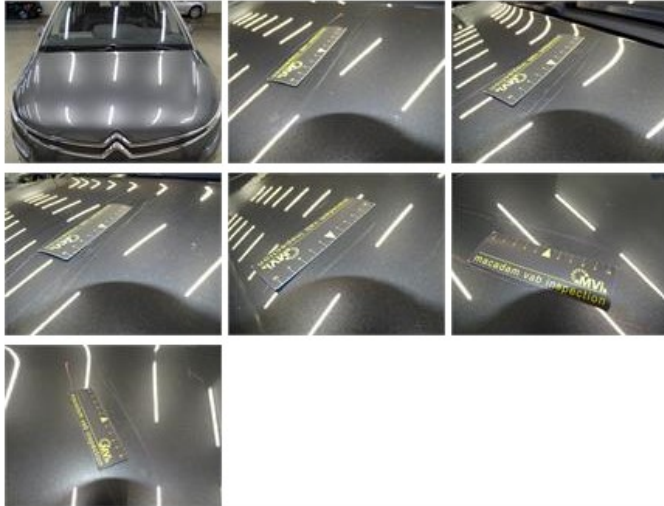
Bonnet, Scratch(es), LI - Repair and paint (complete)

290,08

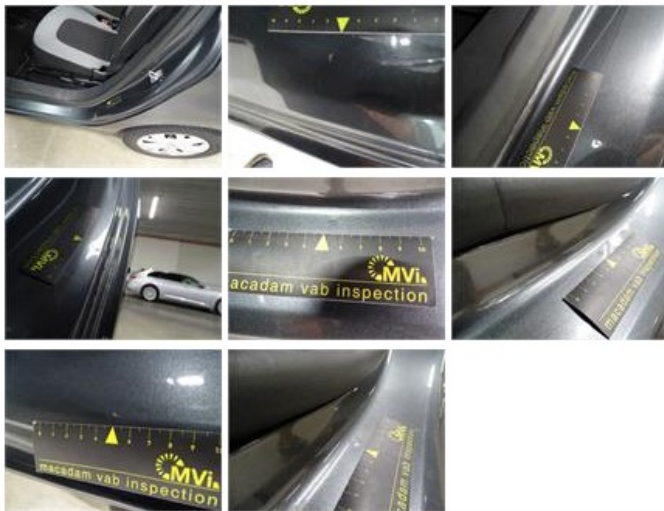
Rocker panel inner R L, Dent(s), LI - Repair and paint (complete)

115,56

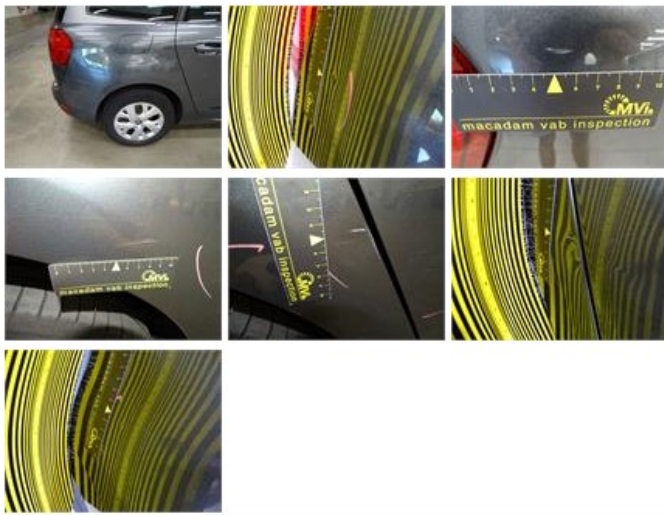
Wing R R, Dent(s) and scratch(es), LI - Repair and paint (complete)

308,20

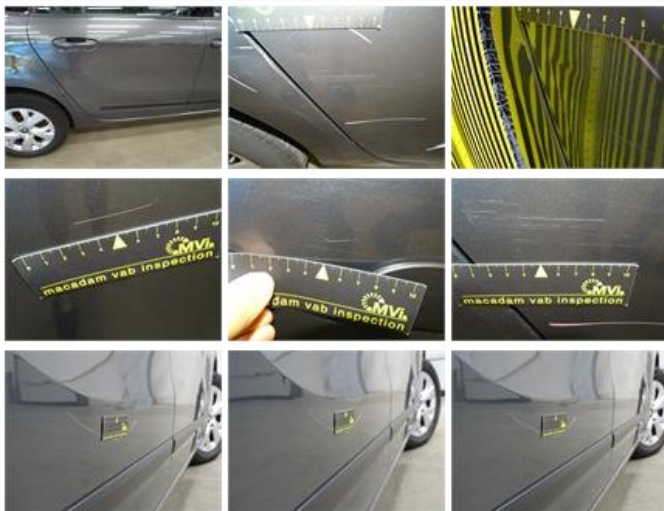
Door R R, Dent(s) and scratch(es), LI - Repair and paint (complete) 318,35

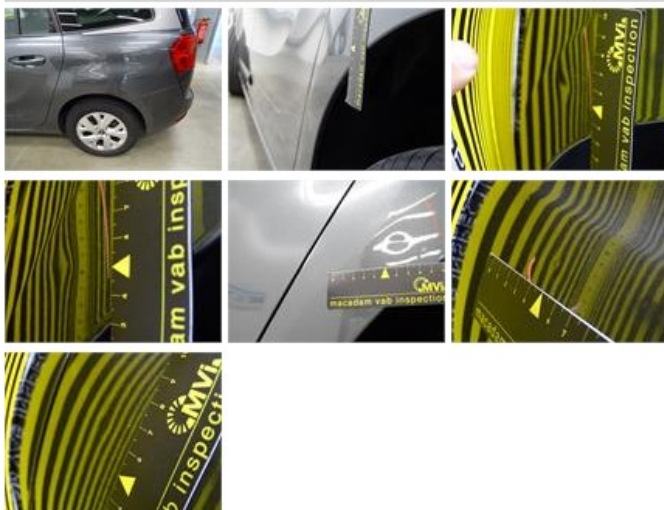
Wing R L, Dent(s), PDR - Paintless dent repair 82,80

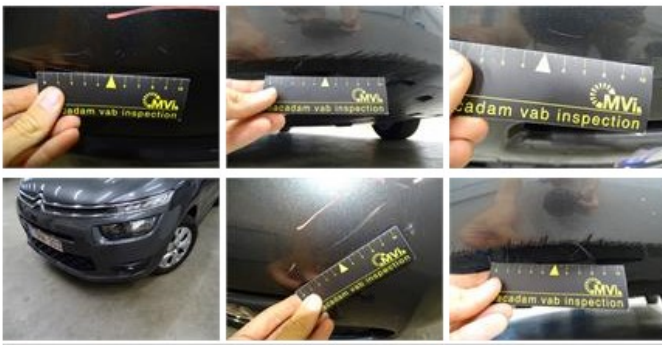
Bumper F, Scratch(es), LI - Repair and paint (complete) 211,80

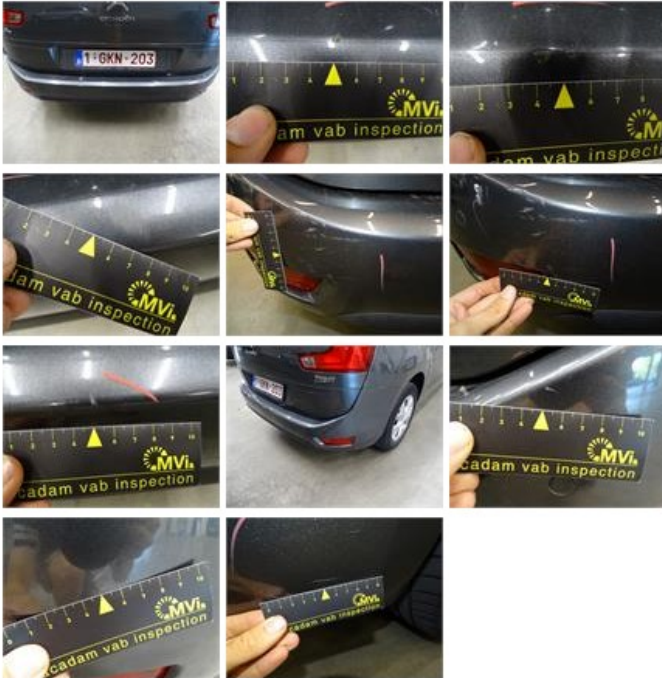
Bumper R, Scratch(es), LI - Repair and paint (complete) 211,80
