MERCEDES CLA: 1SCB684

Limited Technical Inspection

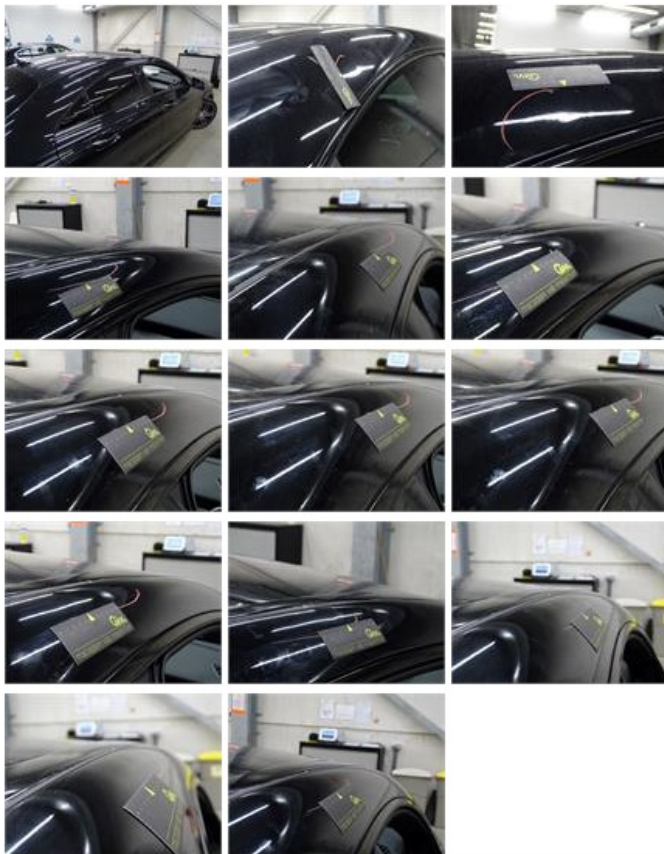
Total cost ex VAT	1235,04
Roof pillar R, Dent(s), LI - Repair and paint (complete)	220,18

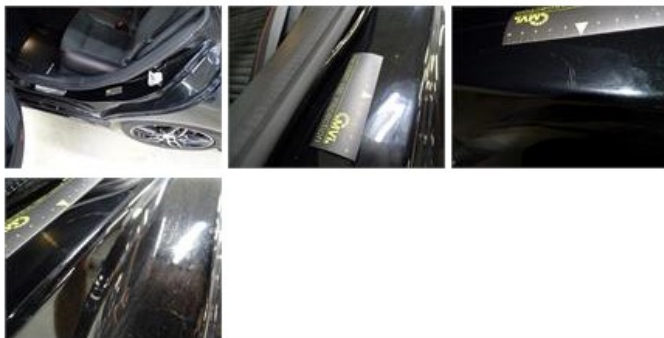
Rocker panel inner R L, Dent(s), LI - Repair and paint (complete)

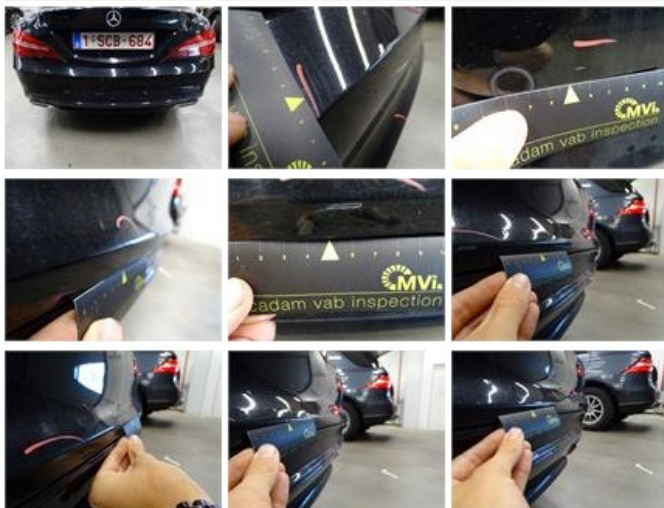
Bumper R, Dent(s) and scratch(es), LI - Repair and paint (complete)

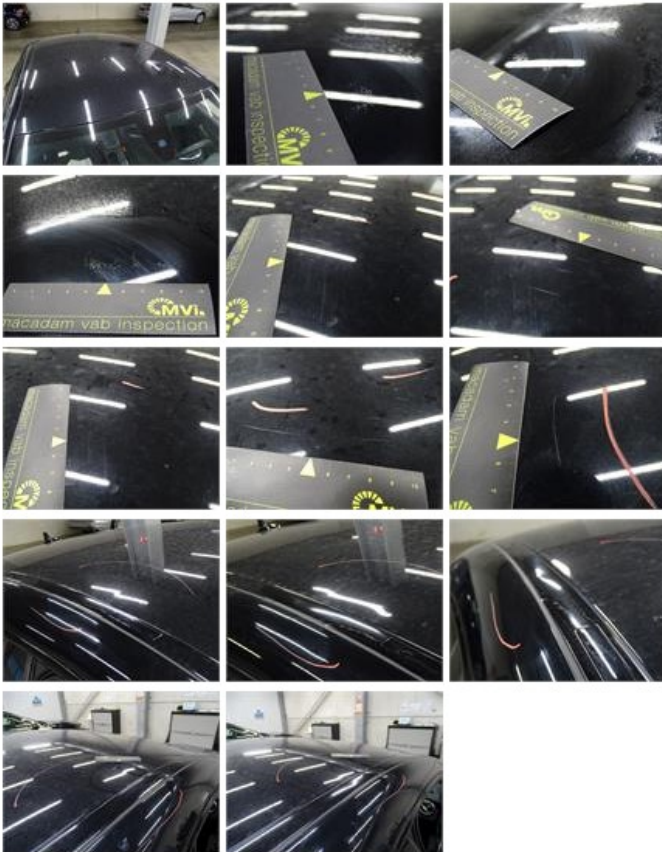
Roof, Chemical polution, LI - Repair and paint (complete)

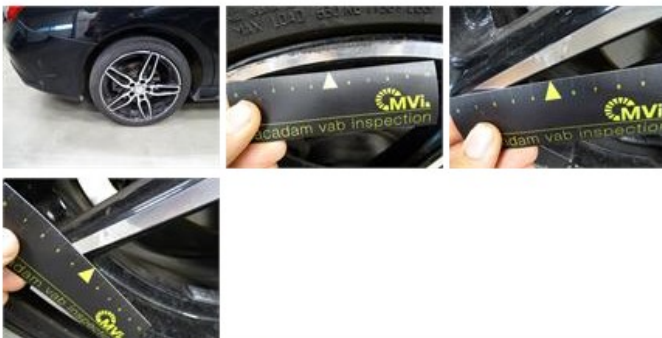
Alloy rim R R polished, Scratch(es), LI - Repair and paint (complete)
