CITROEN C4 Picasso: 1HSZ756

Limited Technical Inspection

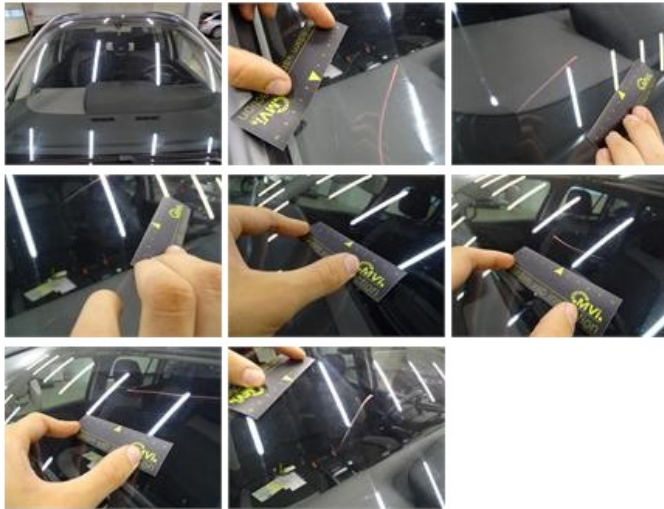
Windscreen, Scratch(es), Acceptable

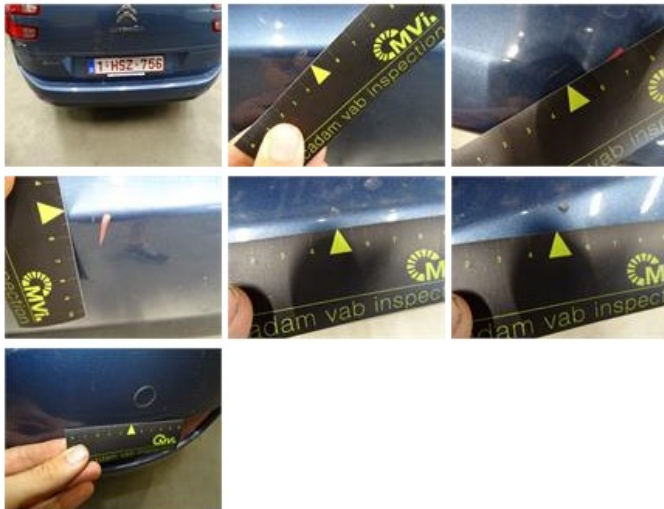
Bumper R, Scratch(es), LI - Repair and paint (complete)

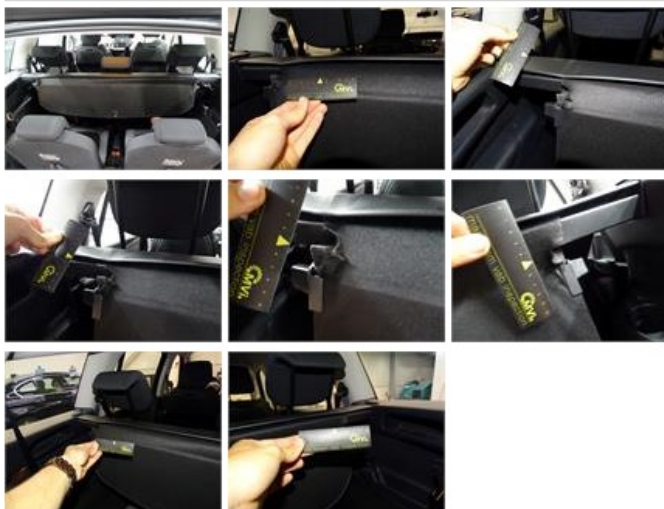
Luggage space cover, Damaged, E - Replace

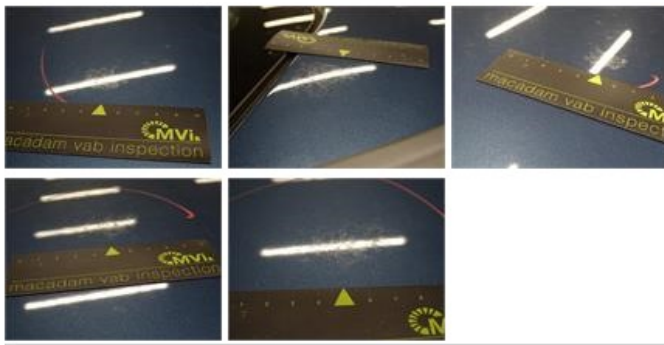
Roof, Chemical pollution, LI - Repair and paint (complete)

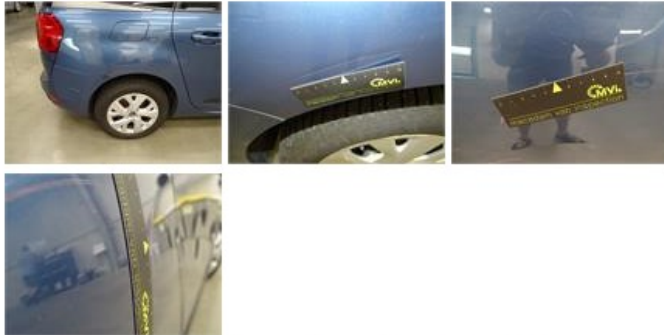
Wing R R, Dent(s) and scratch(es), LI - Repair and paint (complete)

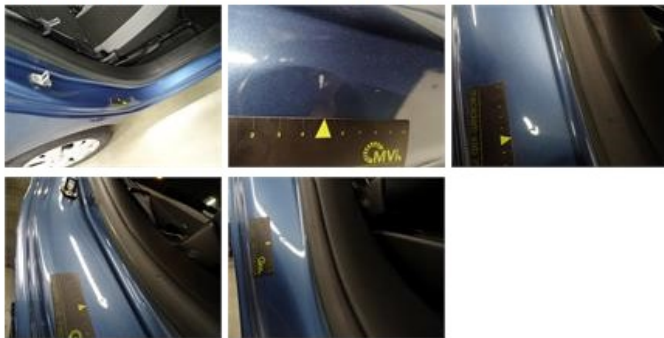
Rocker panel inner R R, Dent(s), LI - Repair and paint (complete)

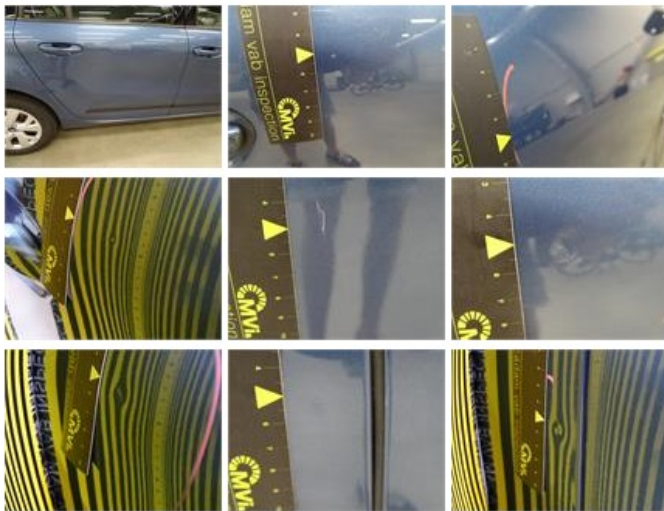
Door R R, Dent(s) and scratch(es), LI - Repair and paint (complete)

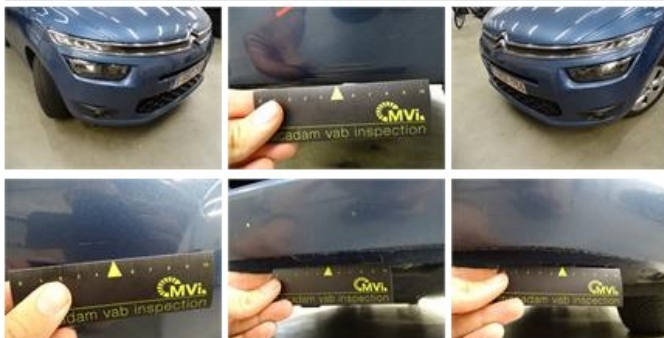
Bumper F, Scratch(es), LI - Repair and paint (complete)
