Lexus NX300H: 1 SSF201

Limited Technical Inspection

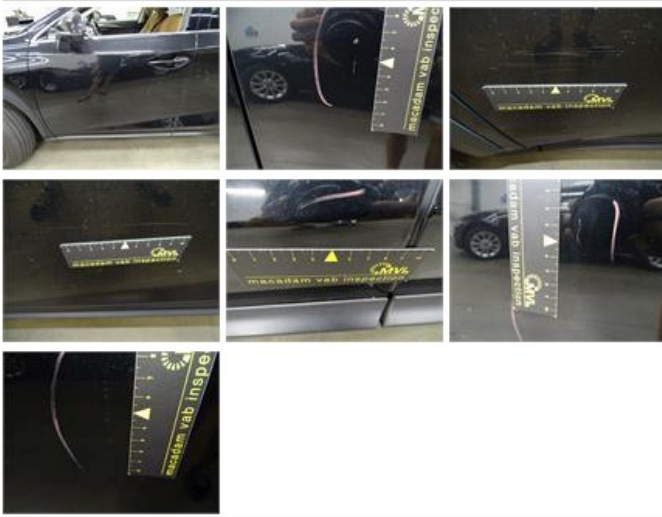
Door F L, Scratch(es), LI - Repair and paint (complete) 382,02

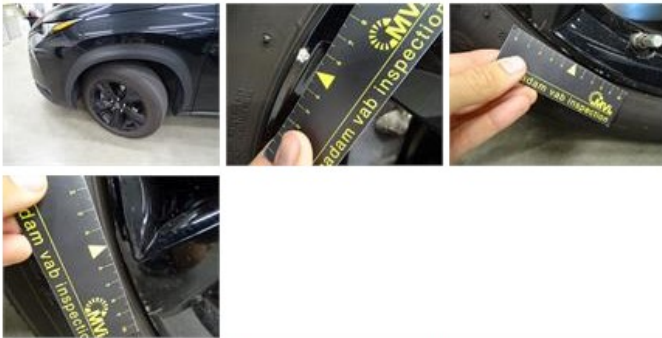
Alloy rim F L, Scratch(es), LI - Repair and paint (complete) 95,00

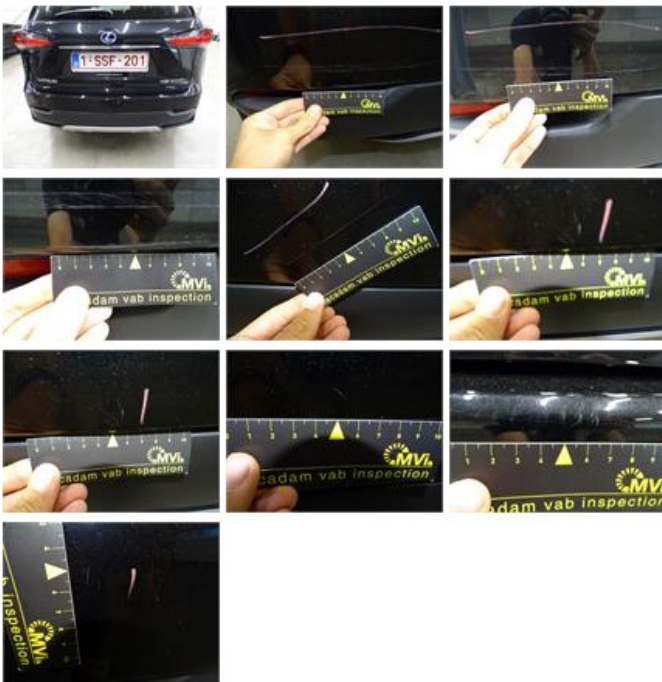
Bumper R, Scratch(es), LI - Repair and paint (complete) 254,16

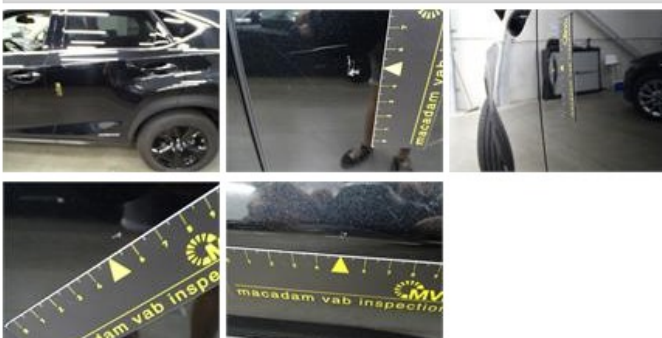
Door R L, Dent(s) and scratch(es), LI - Repair and paint (complete) 382,02

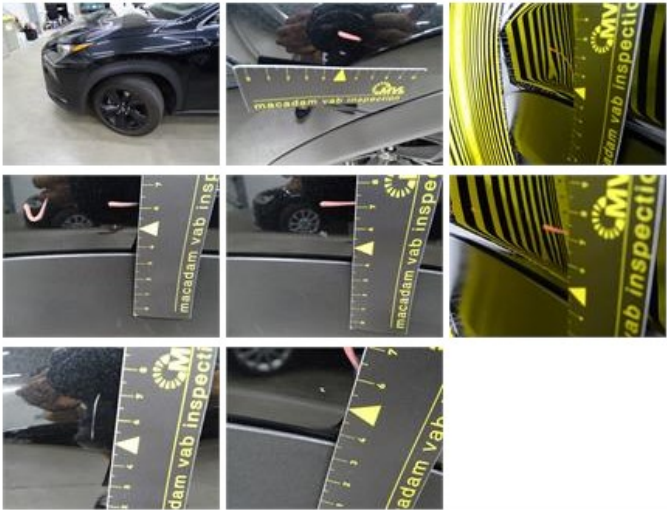
Rearview mirror housing R, Scratch(es), Acceptable	0,00
<i>No pictures to display</i>	
Wing F L, Dent(s) and scratch(es), LI - Repair and paint (complete)	264,21
