**SKODA OCTAVIA COMBI: 1KBT327**

**Limited Technical Inspection**

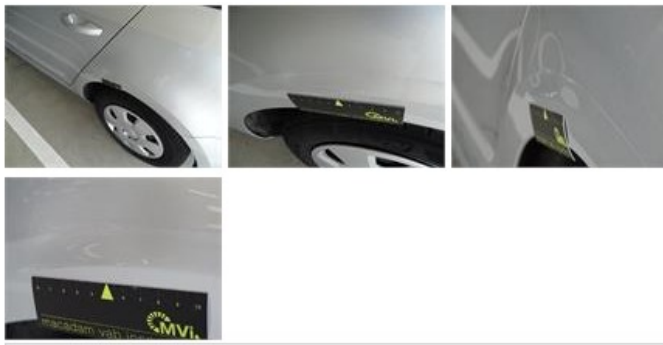
Total cost ex VAT	<b>920,72</b>
Wing R R, Dent(s), Acceptable	<b>0,00</b>
<i>No pictures to display</i>	
Wing R L, Dent(s) and scratch(es), LI - Repair and paint (complete)	<b>308,20</b>

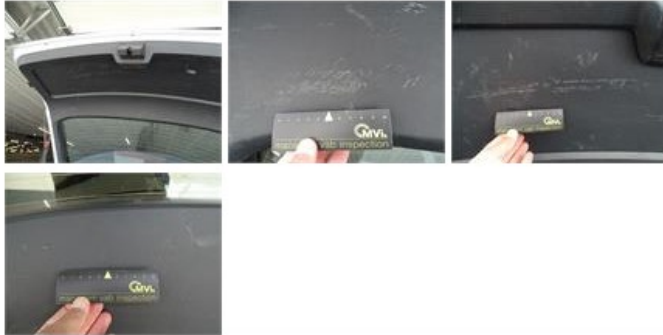
Trunk lid covering R, Scratch(es), Smart repair 110,64

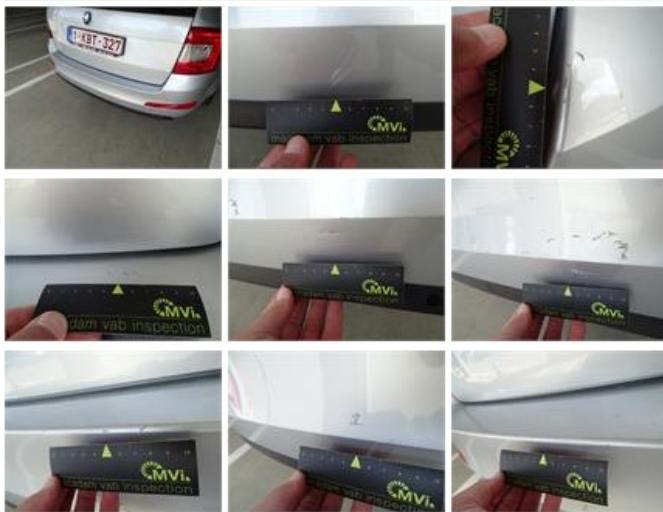
Bumper R, Scratch(es), LI - Repair and paint (complete) 211,80
