SMART FORFOUR: LJ4560

Limited Technical Inspection

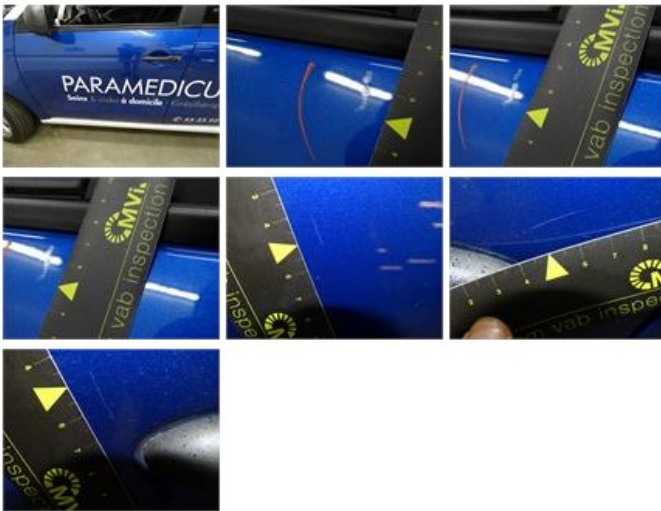
Door F L, Chemical pollution, LI - Repair and paint (complete)

254,68

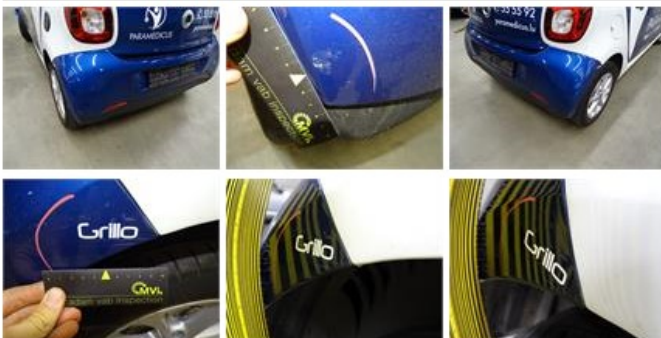
Bumper R, Dent(s) and scratch(es), LI - Repair and paint (complete)

169,44

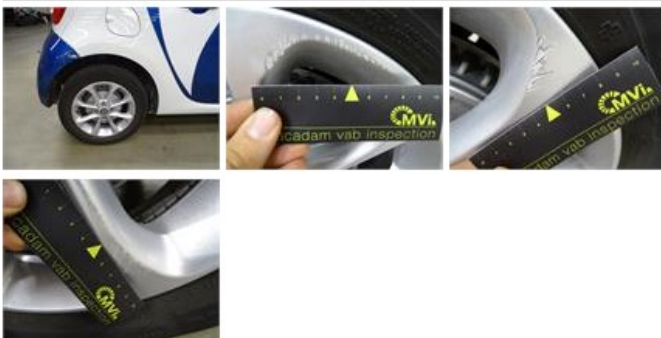
Alloy rim R R, Scratch(es), LI - Repair and paint (complete)

95,00
