OPEL Insignia: 1HGV228

Limited Technical Inspection

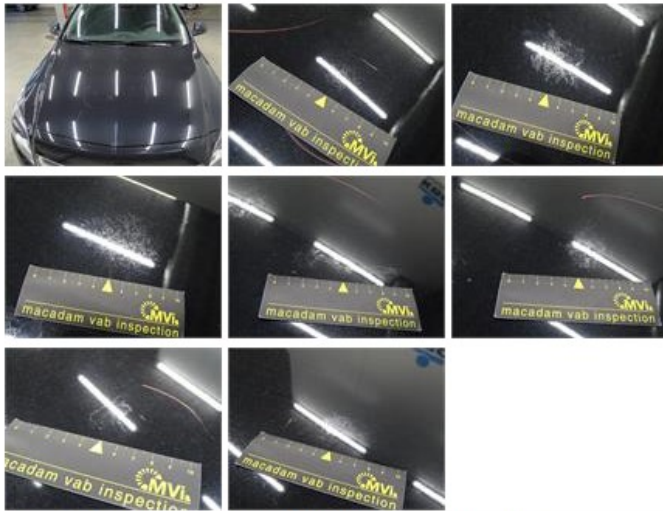
Bonnet, Chemical polution, LI - Repair and paint (complete)

290,08

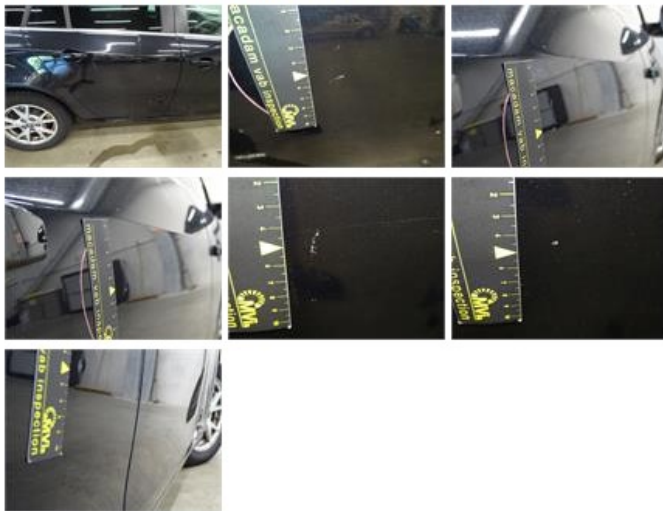
Door R R, Dent(s) and scratch(es), LI - Repair and paint (complete)

318,35

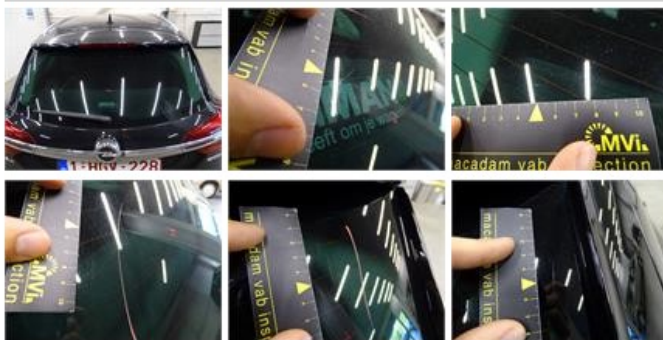
Rear window, Scratch(es), Acceptable

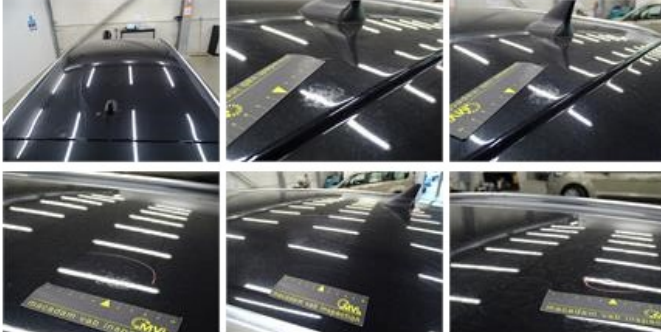
Roof, Chemical polution, LI - Repair and paint (complete)

481,50

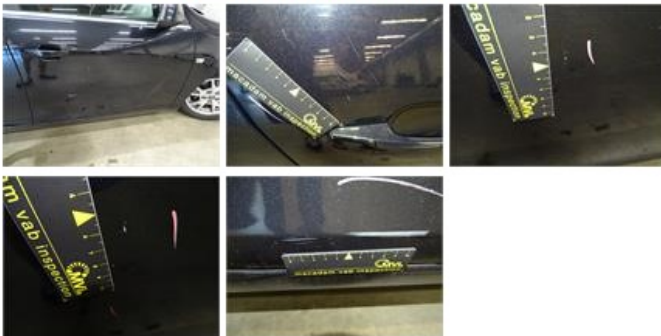
Door F R, Scratch(es), LI - Repair and paint (complete)

318,35

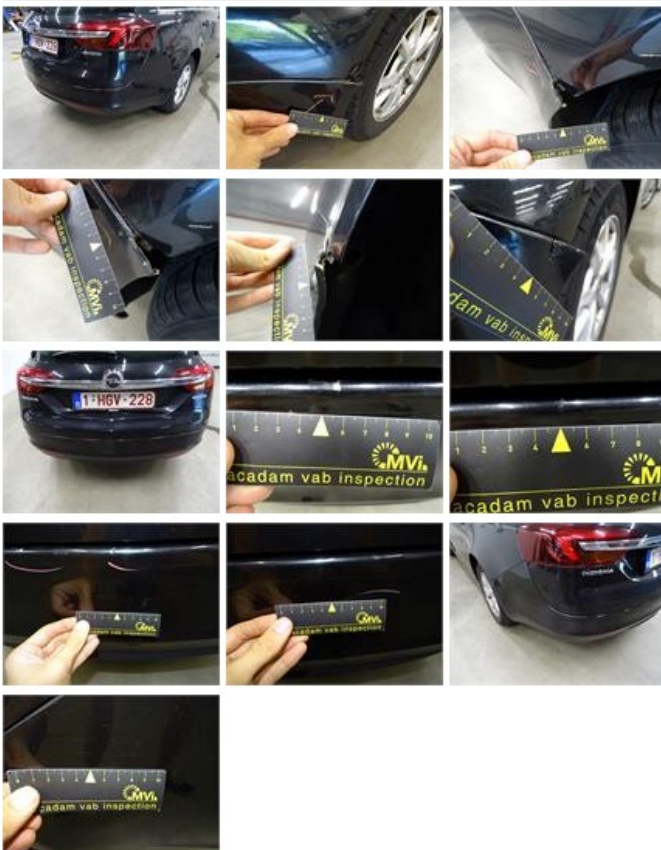
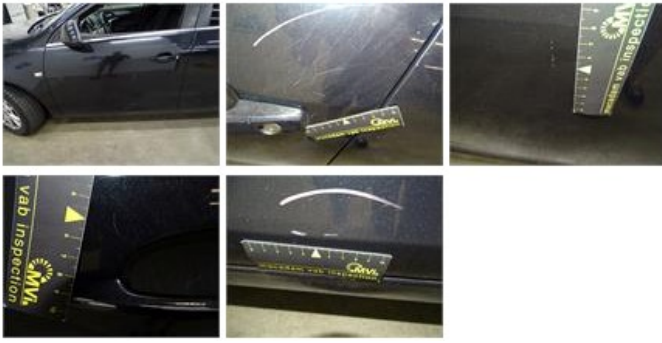
Bumper R, Deformed / Strained, Le - Replace and paint

651,00
