MERCEDES B: 1JSU875

Limited Technical Inspection

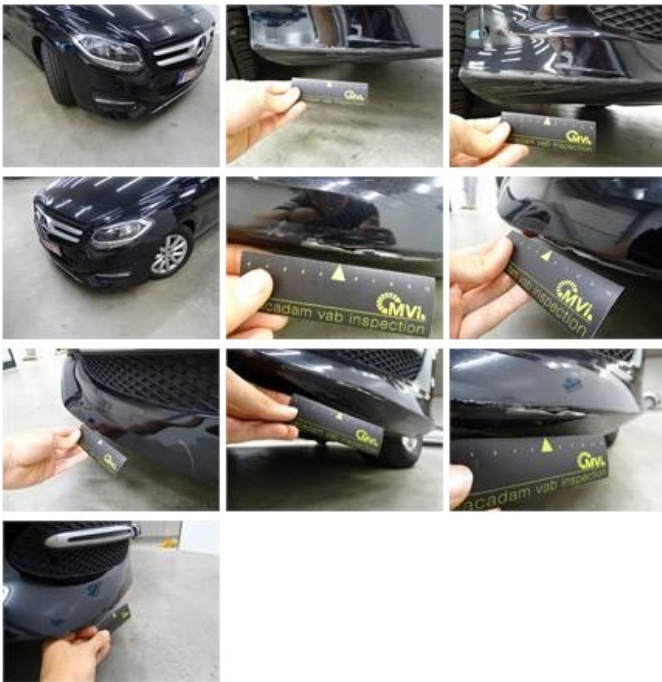
Bumper F, Broken, Le - Replace and paint

735,00

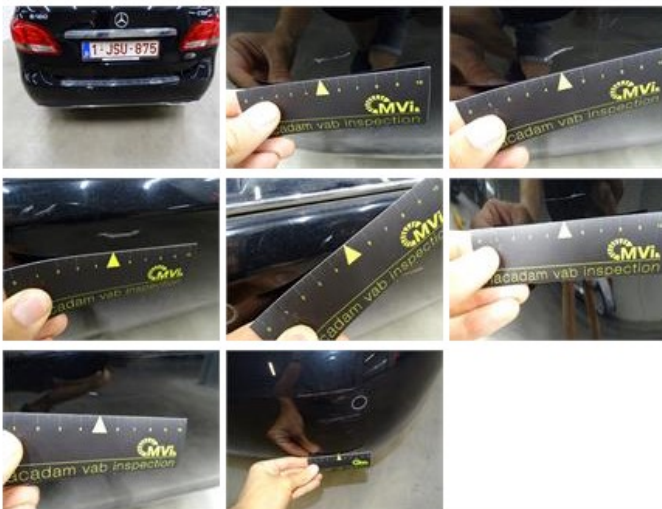
Bumper R, Scratch(es), LI - Repair and paint (complete)

211,80

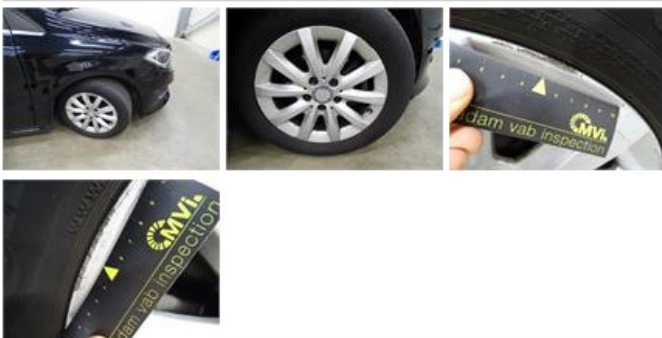
Alloy rim F R, Scratch(es), LI - Repair and paint (complete)

95,00

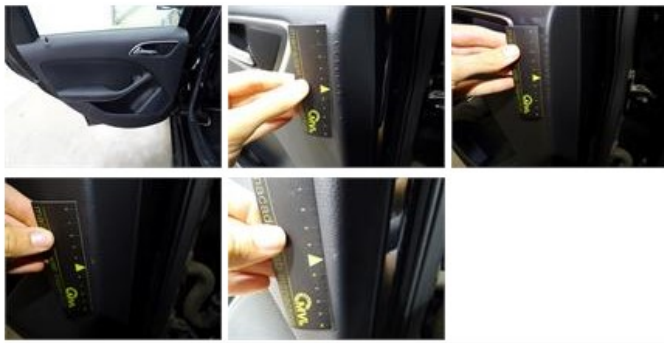
Door panel R L, Tear, E - Replace

114,00

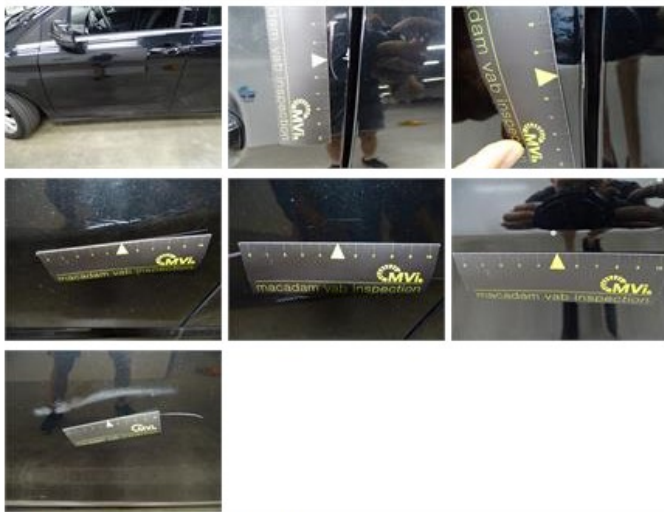
Door F L, Scratch(es), LI - Repair and paint (complete) 318,35
