MERCEDES GLA: KQ6153			
Vinnumber:	<b>WDC1569081J406167</b>	Versionname:	<b>GLA 200 d</b>
First Registrationdate:	<b>7/07/2017</b>	Fiscalpower:	
Expertise Mileage:	<b>54809</b>	Power Kw:	<b>100</b>
Bodytype:	<b>SUV</b>	Body color:	<b>Dark Blue</b>
Gearbox:	<b>MAN 6 VIT</b>	Paint type:	<b>Metalic</b>
Transmission:	<b>Front</b>	Rims summer:	<b>Aluminium</b>
Fueltype:	<b>Diesel</b>	Oil level:	<b>OK</b>
Battery functioning:	<b>Yes</b>	Parking lot:	<b>3701</b>
Number of doors:	<b>5</b>		
Number of seats:	<b>5</b>		
Number head rests:	<b>5</b>		
Rims summer:	<b>Aluminium</b>		
Category:	<b>Passenger Car</b>		
Oil level:	<b>OK</b>

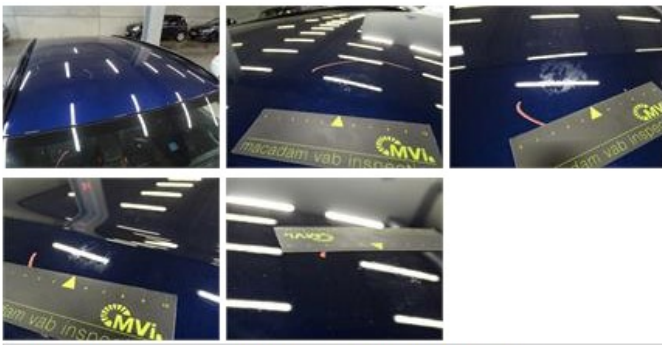
Assistance equipment			
Repair kit	<b>Yes</b>	Compressor	<b>Yes</b>
Number of charging cables (normal)	<b>0</b>		
Number of charging cables (rapid charge)	<b>0</b>		
Total cost ex VAT			<b>2132,77</b>
Roof, Chemical polution, LI - Repair and paint (complete)			<b>577,80</b>

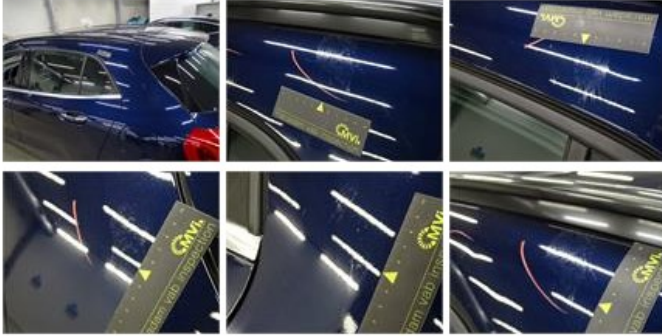
Roof pillar L, Chemical polution, LI - Repair and paint (complete)

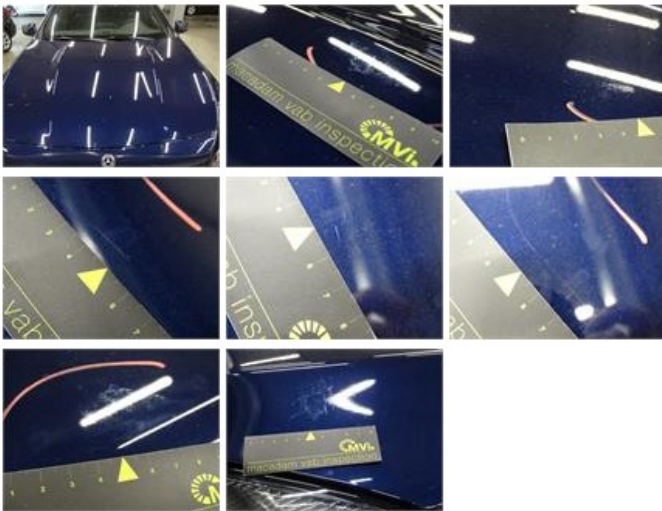
Bonnet, Chemical polution, LI - Repair and paint (complete)

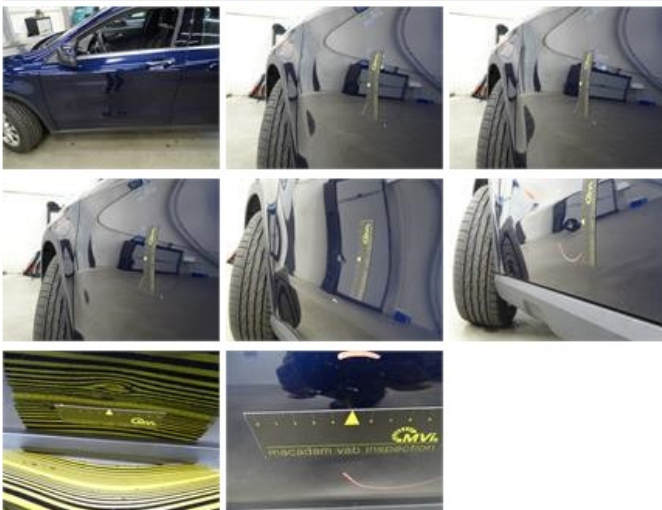
Door F L, Dent(s) and scratch(es), LI - Repair and paint (complete)

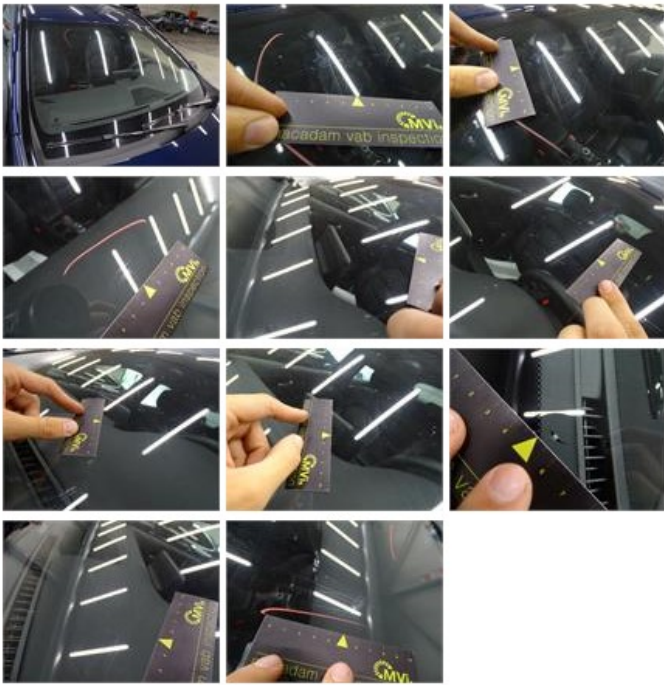
Windscreen, Scratch(es), E - Replace
