**VOLVO V60: 1KPU423**

**Limited Technical Inspection**

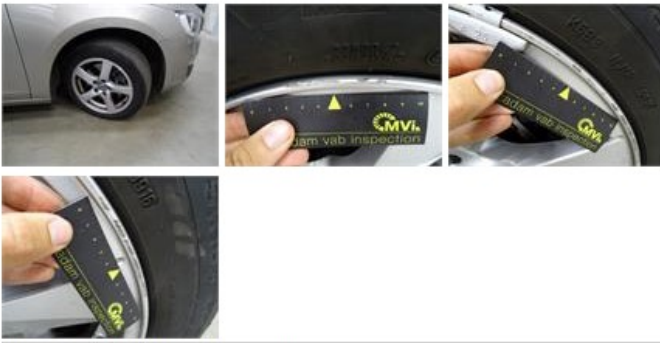
Alloy rim F R, Scratch(es), LI - Repair and paint (complete) 95,00

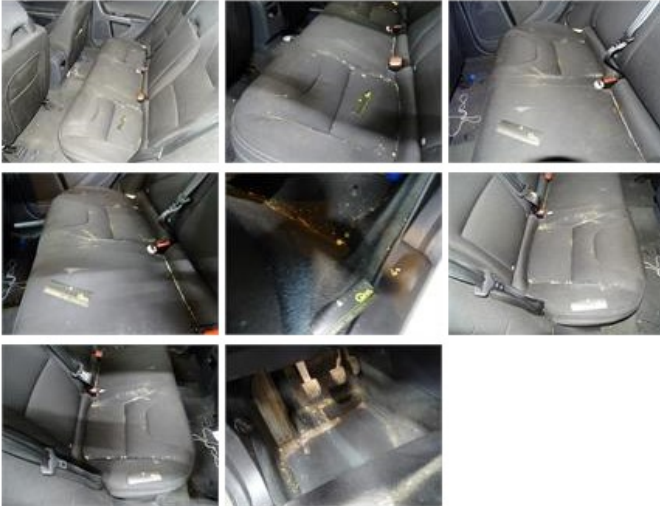
Interior, Dirty, Cleaning 50,00

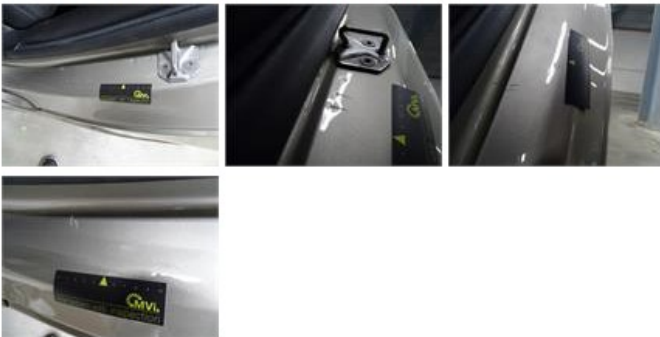
Rocker panel inner R L, Dent(s), LI - Repair and paint (complete) 115,56

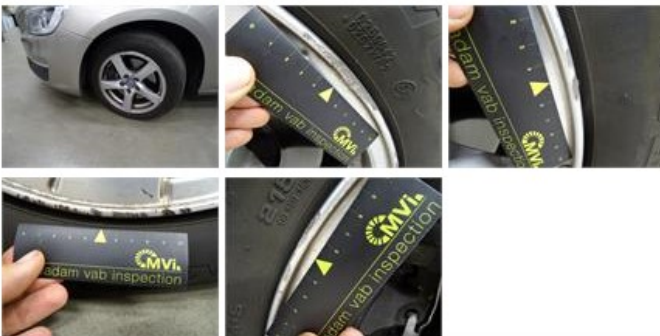
Alloy rim F L, Scratch(es), LI - Repair and paint (complete) 95,00
