VOLVO V60: 1JLV335

Limited Technical Inspection

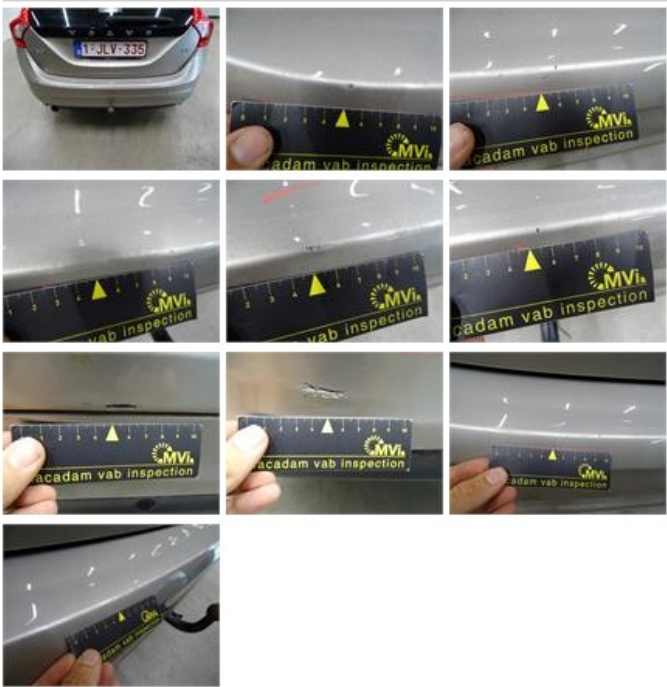
Door R R, Dent(s) and scratch(es), Acceptable	0,00
<i>No pictures to display</i>	
Bumper R, Scratch(es), LI - Repair and paint (complete)	211,80
