VOLKSWAGEN TOURAN: 1LDN479

Limited Technical Inspection

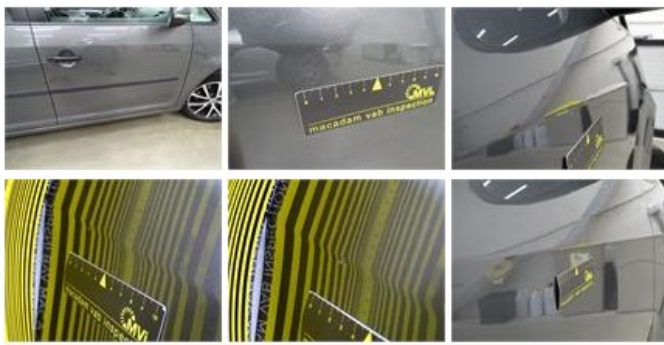
Total cost ex VAT	1652,15
Door F R, Dent(s) and scratch(es), LI - Repair and paint (complete)	318,35

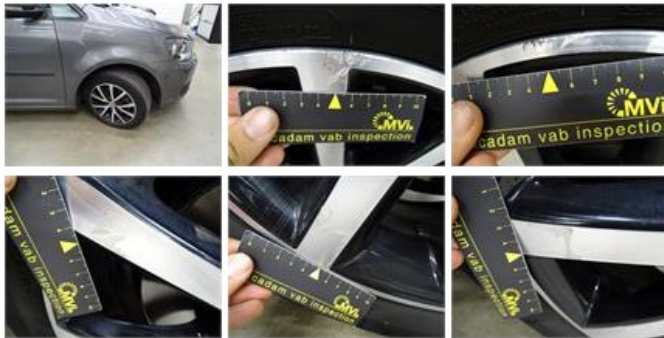
Alloy rim F R polished, Scratch(es), LI - Repair and paint (complete)

95,00

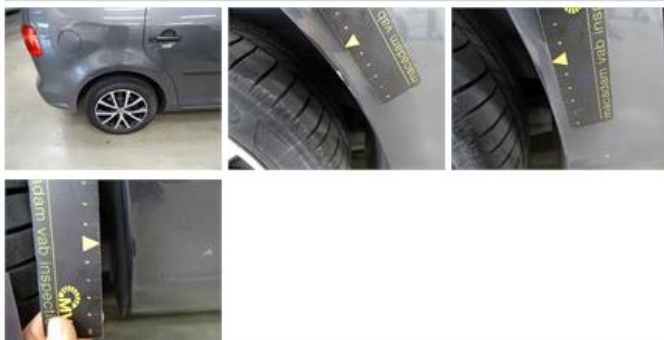
Wing R R, Bad repair, Acceptable

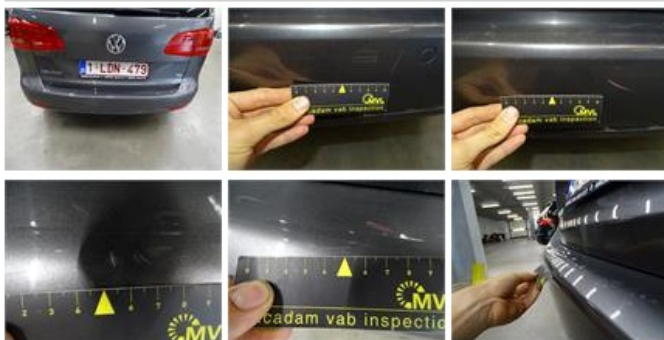
Bumper R, Scratch(es), LI - Repair and paint (complete)

211,80

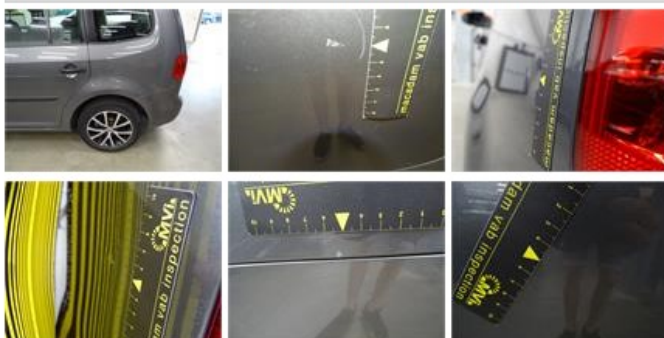
Wing R L, Dent(s) and scratch(es), LI - Repair and paint (complete)

308,20

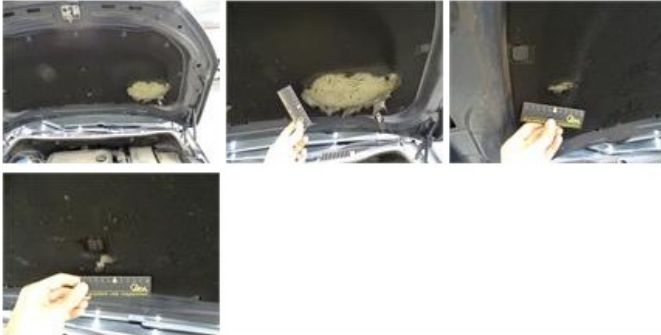
Protection plate M, Deformed / Strained, E - Replace 74,00

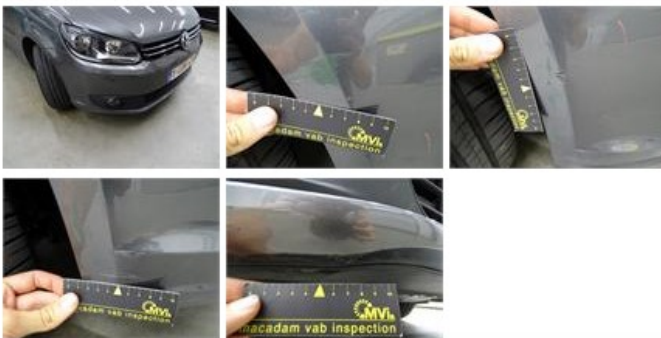
Bumper F, Scratch(es), LI - Repair and paint (complete) 211,80
