**SKODA OCTAVIA COMBI: 1KTP298**

**Limited Technical Inspection**

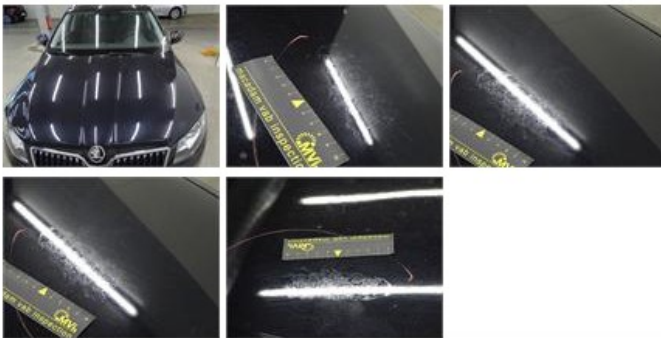
Bonnet, Chemical polution, LI - Repair and paint (complete) 290,08

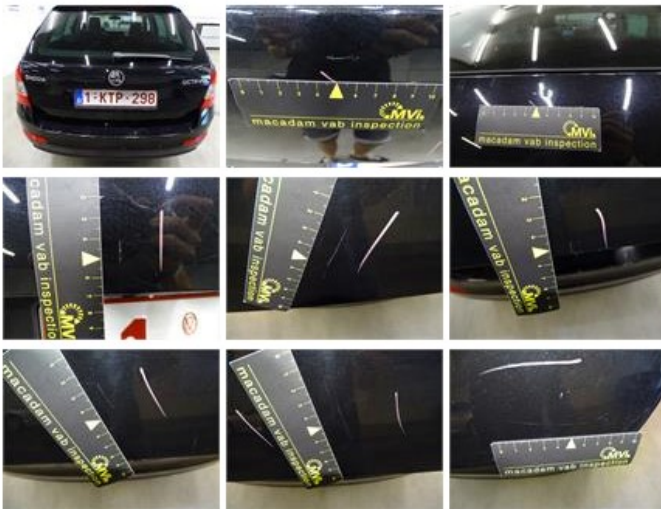
Tailgate, Dent(s) and scratch(es), LI - Repair and paint (complete) 301,68

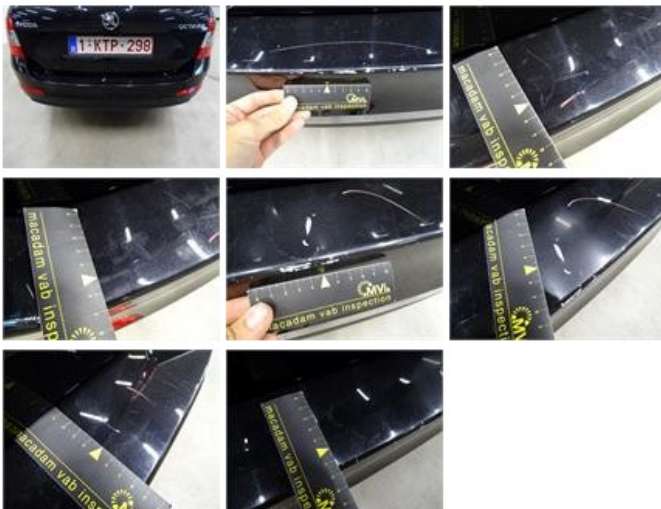
Bumper R, Scratch(es), LI - Repair and paint (complete) 211,80

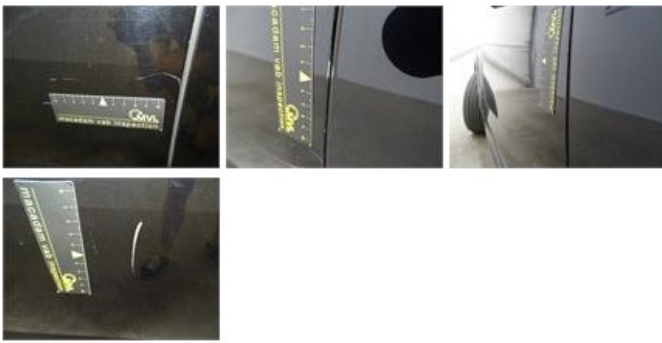
Door F L, Dent(s) and scratch(es), LI - Repair and paint (complete) 318,35

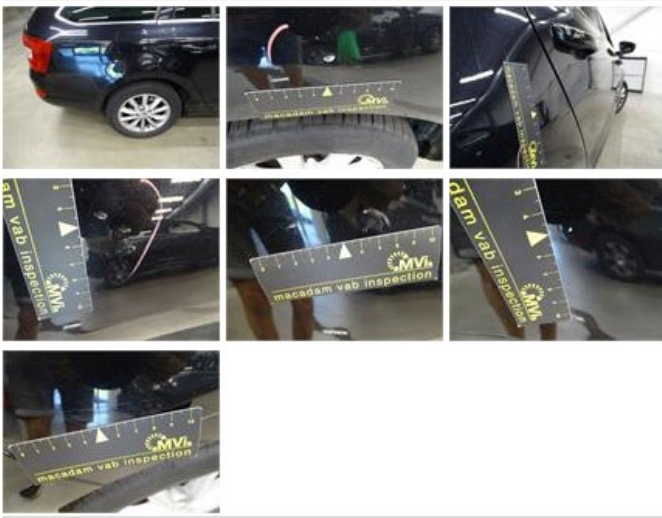
Wing R R, Dent(s) and scratch(es), LI - Repair and paint (complete) 308,20

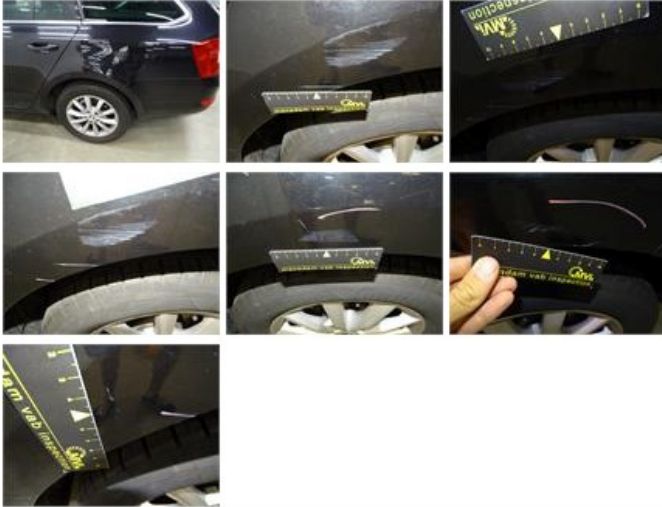
Wing R L, Scratch(es), LI - Repair and paint (complete) 308,20

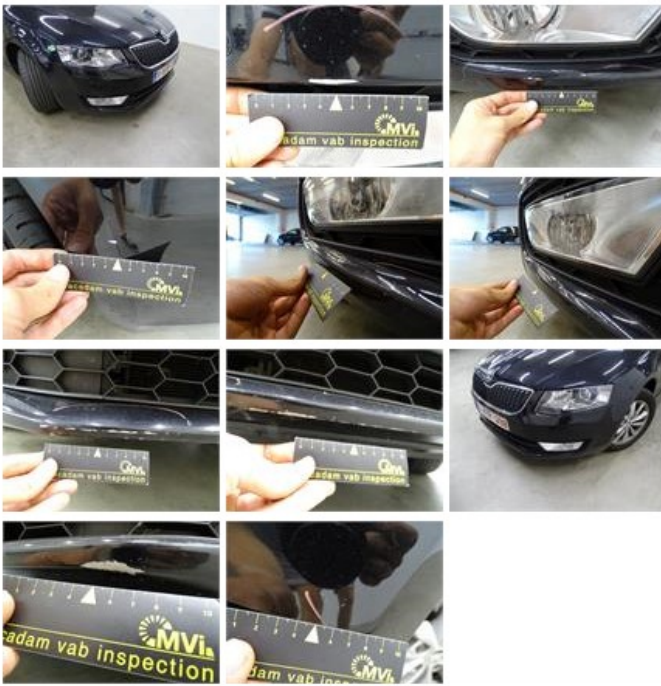
Bumper F, Dent(s) and scratch(es), LI - Repair and paint (complete)

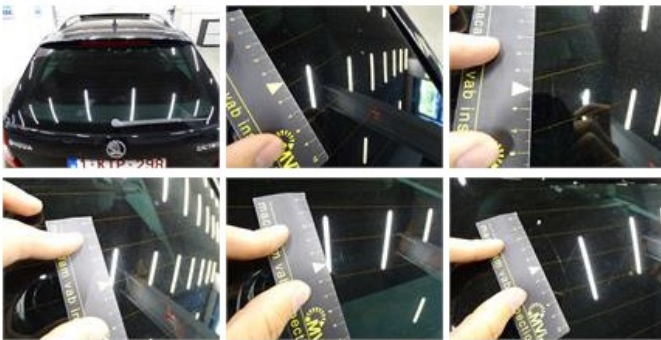
Rear window, Scratch(es), Acceptable

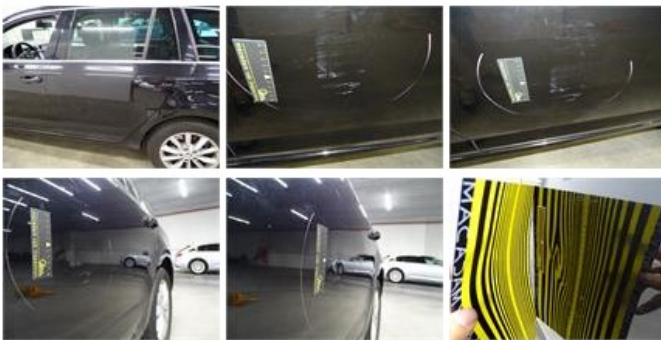
Door R L, Dent(s) and scratch(es), LI - Repair and paint (complete)

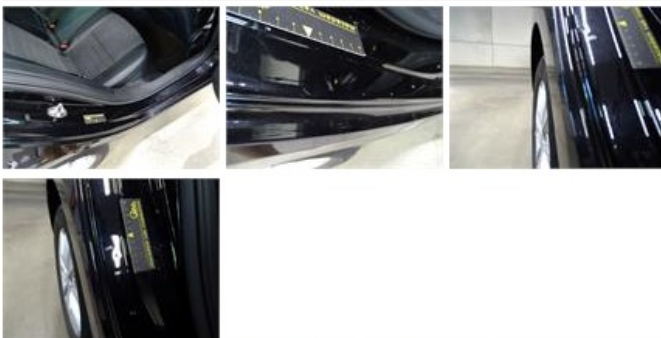
Rocker panel inner R R, Dent(s), LI - Repair and paint (complete)
