SKODA OCTAVIA COMBI: 1JGR869

| Vinnnumber: | TMBJG7NEXF0124766 | Versionname: | 1.6 CRTDI 77KW GREENTEC AMBITION |

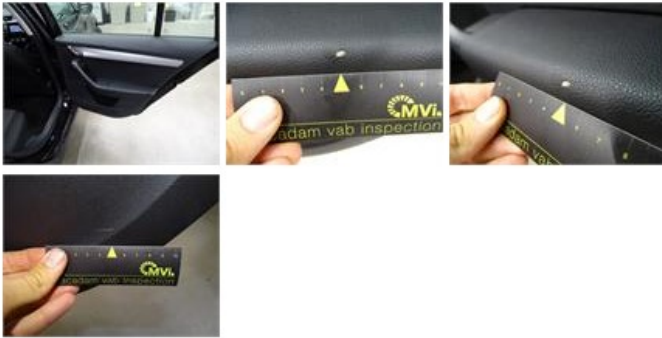
Door panel R R, Tear, Smart repair

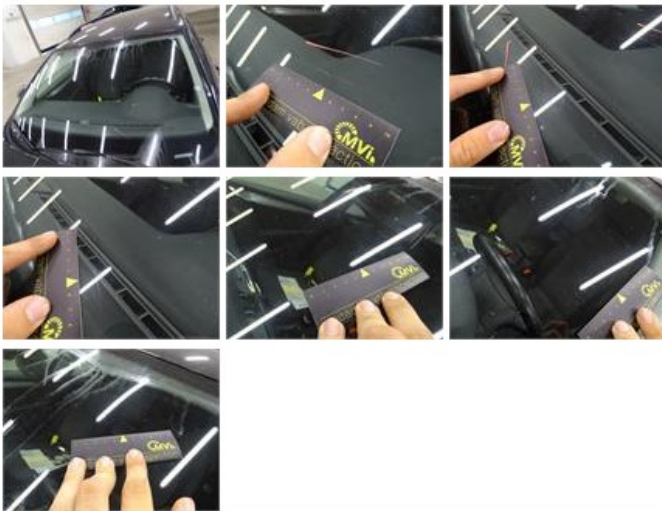
Windscreen, Scratch(es), Acceptable

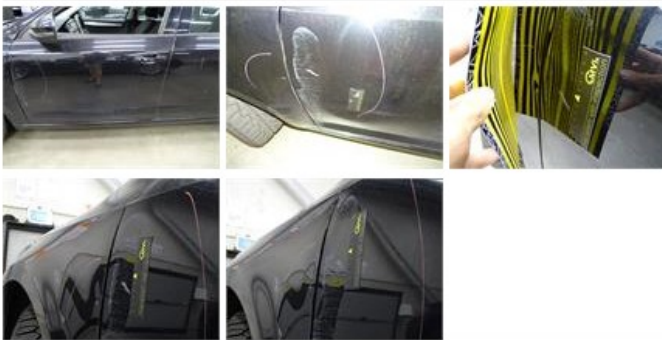
Door F L, Dent(s) and scratch(es), LI - Repair and paint (complete)

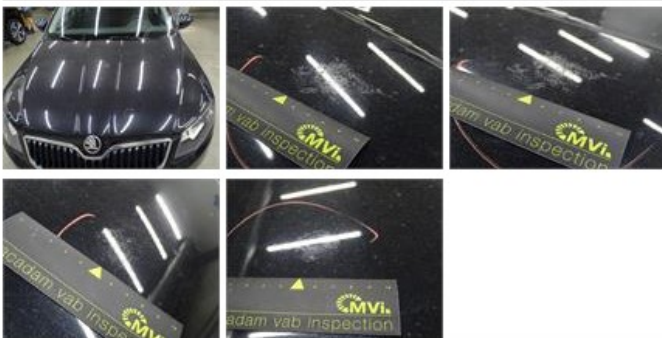
Bonnet, Chemical pollution, LI - Repair and paint (complete)

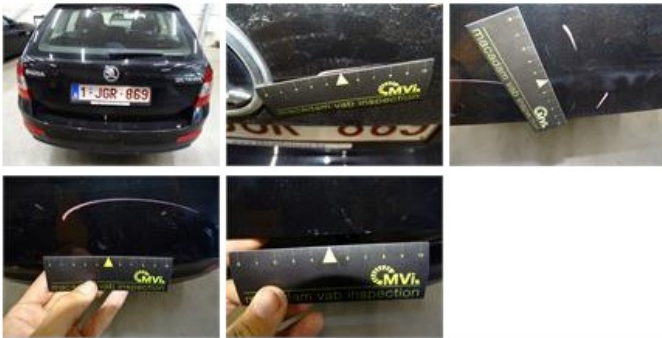
Tailgate, Scratch(es), LI - Repair and paint (complete) 301,68

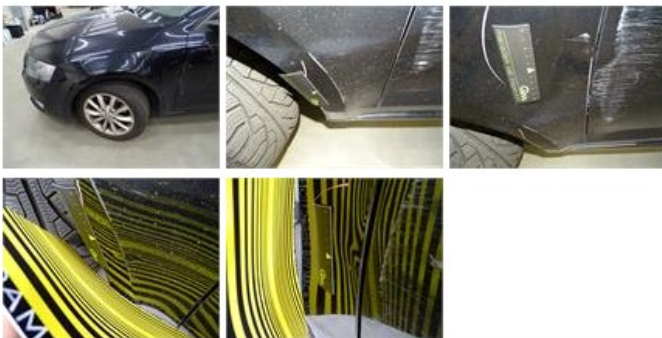
Wing F L, Dent(s) and scratch(es), LI - Repair and paint (complete) 268,18

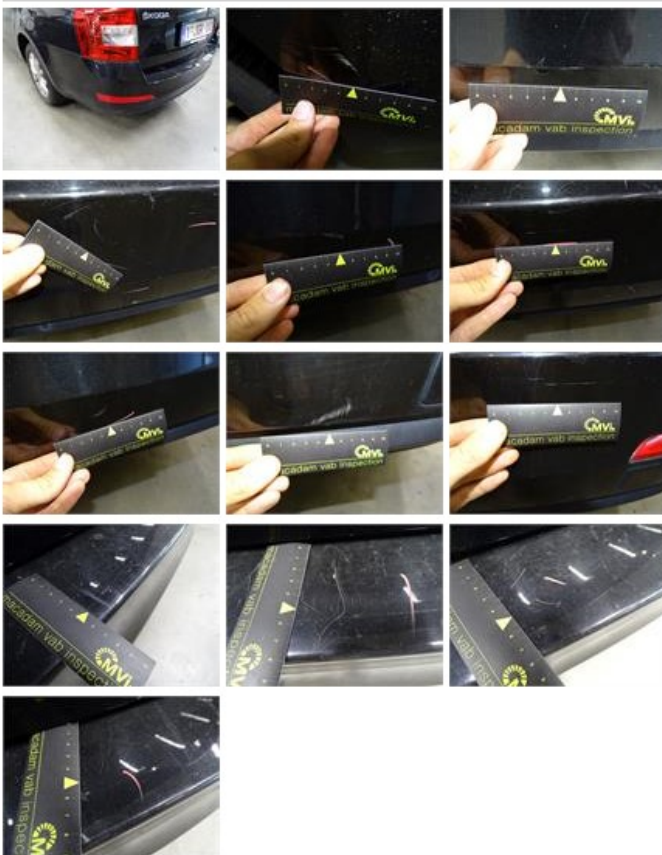
Bumper R, Scratch(es), LI - Repair and paint (complete) 211,80

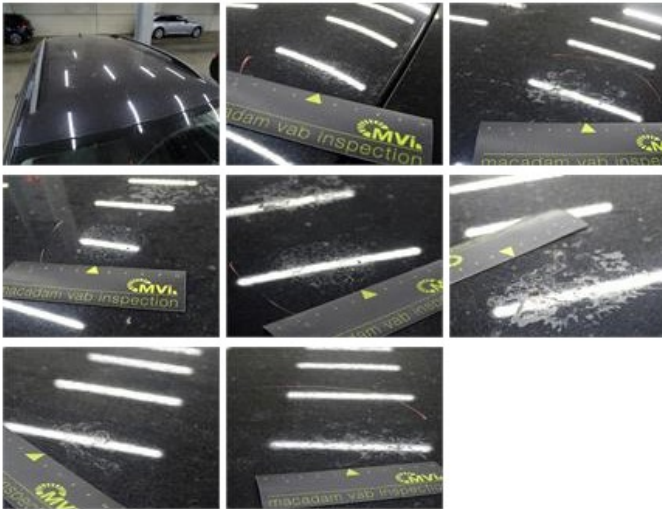
Roof, Chemical polution, LI - Repair and paint (complete)

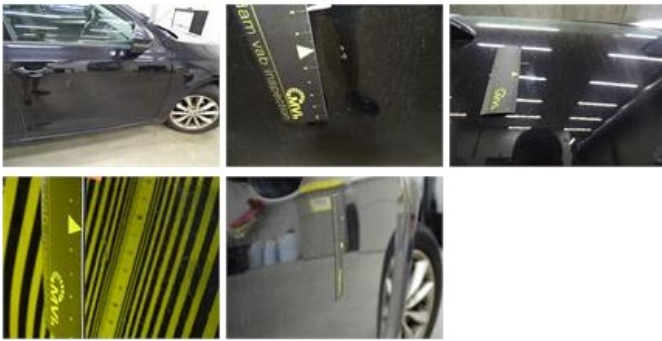
Door F R, Dent(s) and scratch(es), LI - Repair and paint (complete)

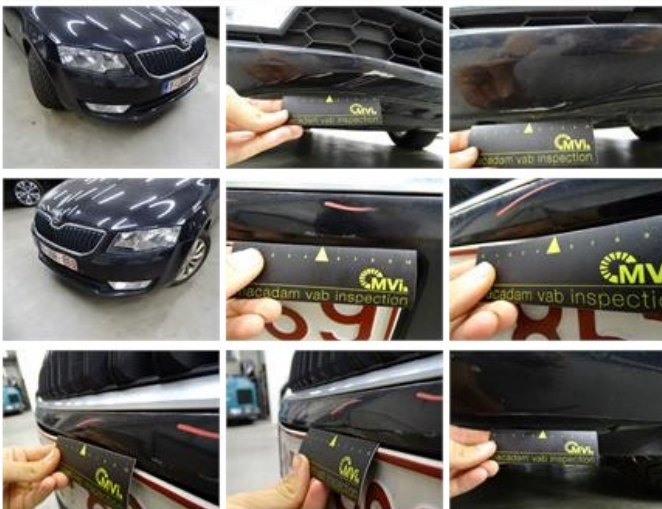
Bumper F, Dent(s) and scratch(es), LI - Repair and paint (complete)
