**VOLVO V60: 1JTK242**

**Limited Technical Inspection**

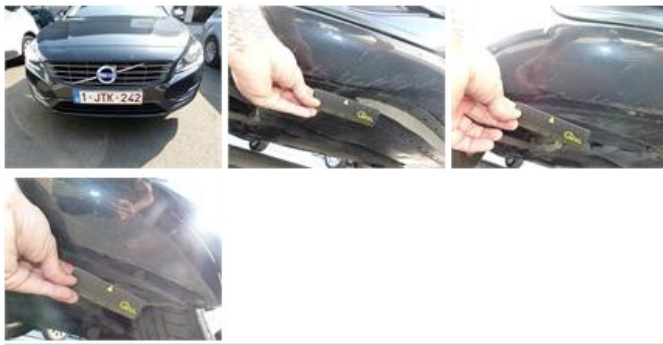
Total cost ex VAT	<b>1029,35</b>
Bumper F, Scratch(es), LI - Repair and paint (complete)	<b>211,80</b>

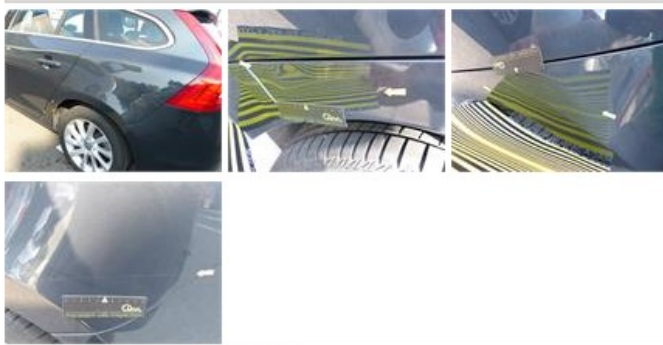
Door R R, Chemical pollution, P - Check	0,00
<i>No pictures to display</i>	
Wing R L, Dent(s) and scratch(es), LI - Repair and paint (complete)	356,20
