BMW 3: 1HGK247			
Vinnumber:	WBA3K11010F833389	Versionname:	3 TOURING 318d 136PK
First Registrationdate:	15/07/2014	Fiscalpower:	
Expertise Mileage:	143724	Power Kw:	100
Bodytype:	Break	Body color:	Grey
Gearbox:	MAN 6 VIT	Paint type:	Metalic
Transmission:		Rims summer:	Aluminium
Fueltype:	Diesel	Oil level:	OK
Battery functioning:	Yes	Parking lot:	1128
Number of doors:	5		
Number of seats:	5		
Number head rests:	5		
Rims summer:	Aluminium		
Category:	Passenger Car		
Oil level:	OK		
Registration Certificate Car (BE):	Yes

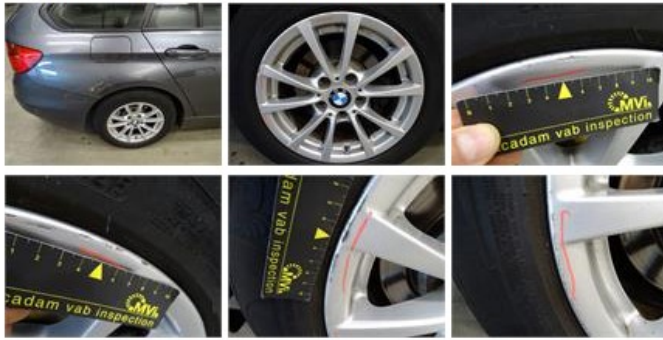
Alloy rim R R, Scratch(es), LI - Repair and paint (complete)

95,00

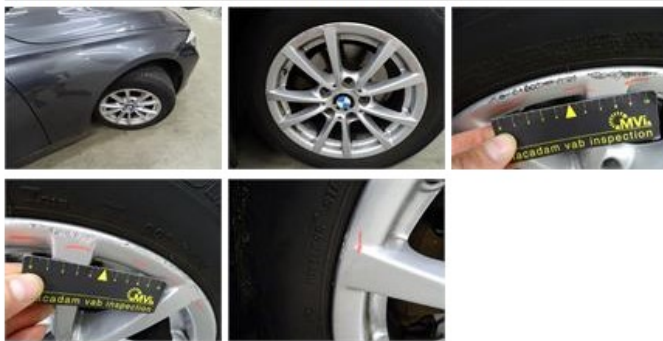
Alloy rim F R, Scratch(es), LI - Repair and paint (complete)

95,00

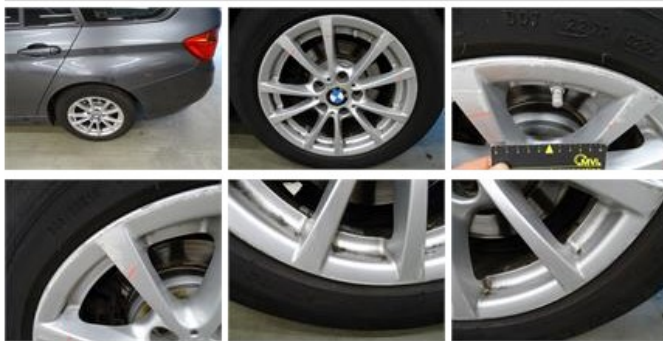
Alloy rim R L, Scratch(es), LI - Repair and paint (complete)

95,00

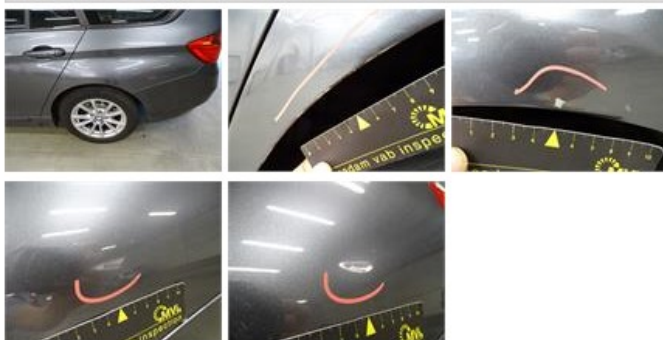
Wing R L, Dent(s) and scratch(es), LI - Repair and paint (complete)

308,20

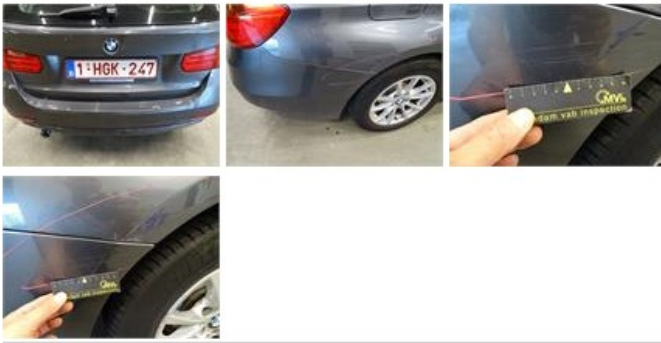
Bumper R, Scratch(es), LI - Repair and paint (complete) 0,00
