BMW 5 BERLINE: 1KSC934

Limited Technical Inspection

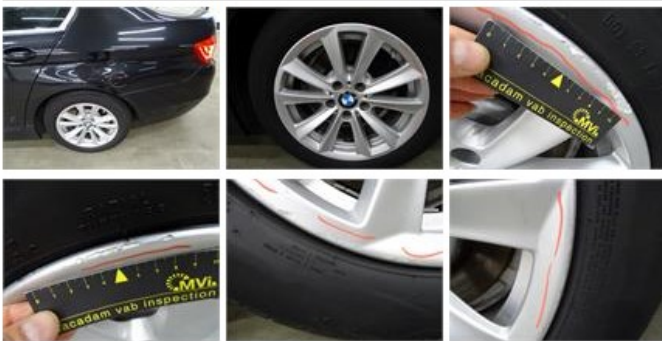
Alloy rim R L, Scratch(es), LI - Repair and paint (complete) 95,00

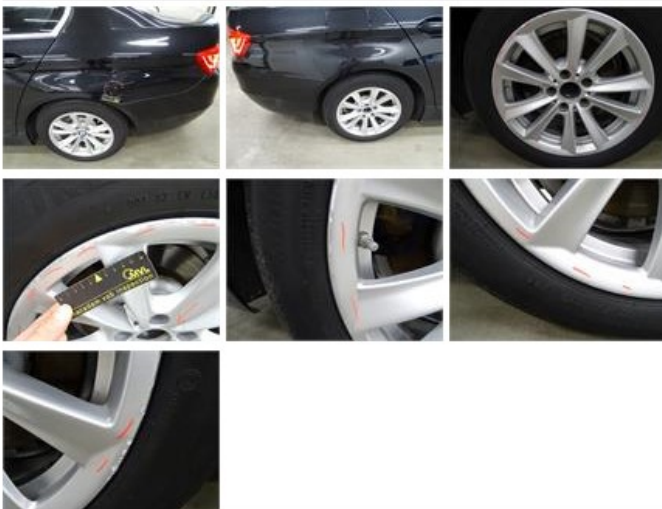
Alloy rim R R, Scratch(es), LI - Repair and paint (complete) 95,00

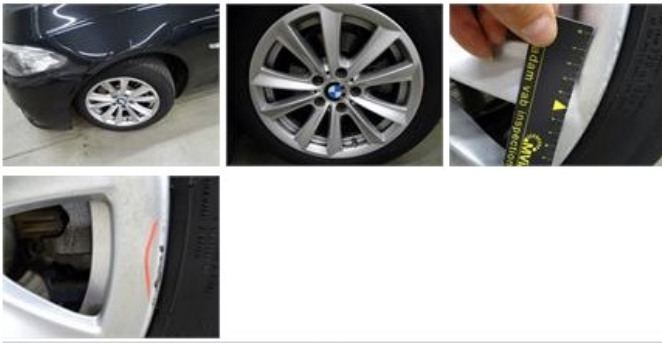
Alloy rim F L, Scratch(es), LI - Repair and paint (complete) 95,00
