**BMW SERIE 3 GRAN TURISMO: 1JVB747**

**Limited Technical Inspection**

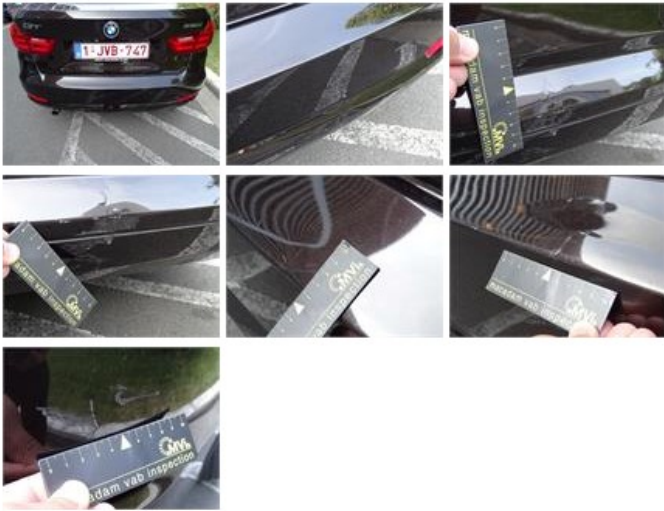
Tailgate, Scratch(es), Acceptable	0,00
No pictures to display	
Bumper R, Dent(s) and scratch(es), LI - Repair and paint (complete)	307,80

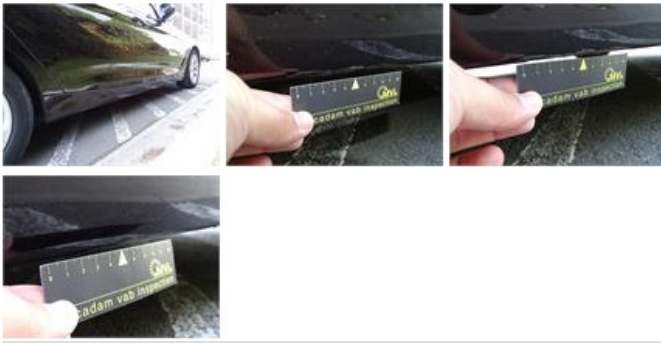
Sill trim R, Scratch(es), It - Spot repair

115,56

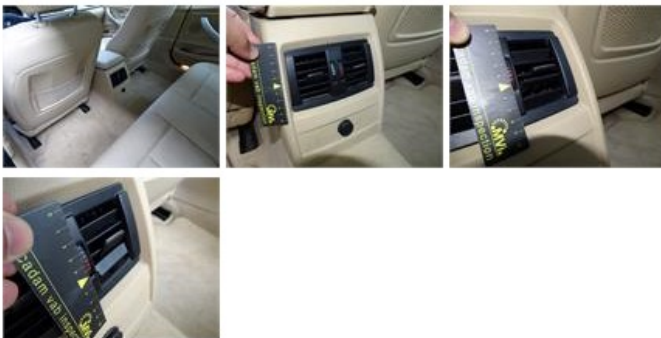
Air vent R M, Broken, E - Replace

156,00
