**VOLVO XC60: 1KCG283**

**Limited Technical Inspection**

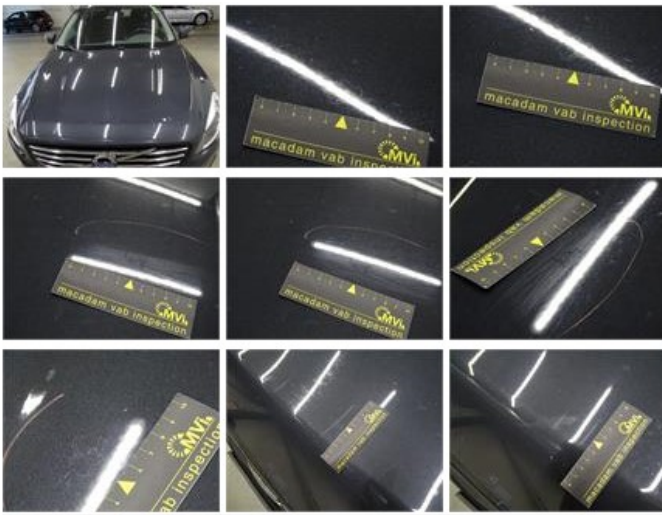
Total cost ex VAT	<b>2257,51</b>
Bonnet, Chemical polution, LI - Repair and paint (complete)	<b>348,09</b>

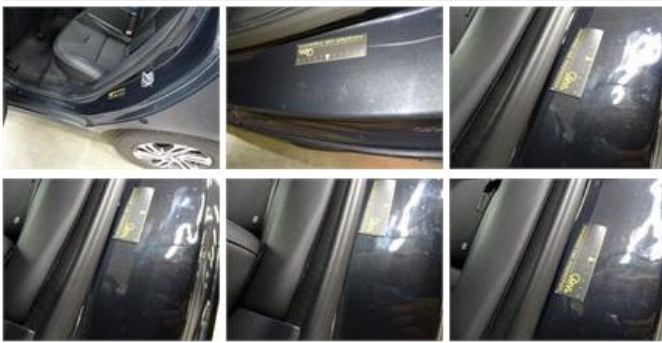
Rocker panel inner R L, Dent(s), LI - Repair and paint (complete) 115,56

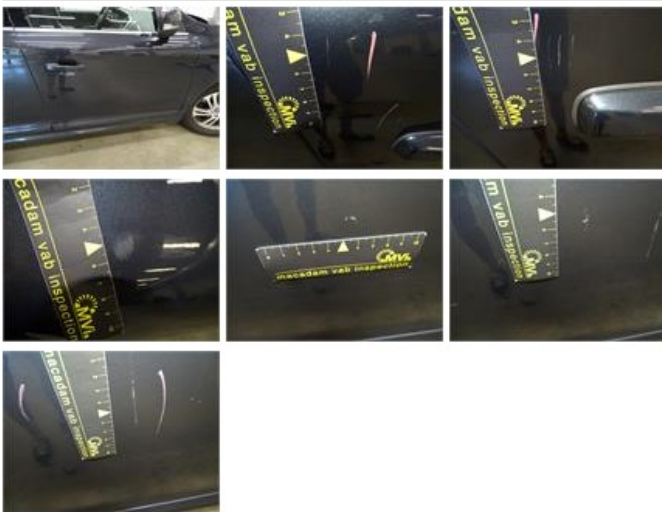
Door F R, Scratch(es), LI - Repair and paint (complete) 382,02

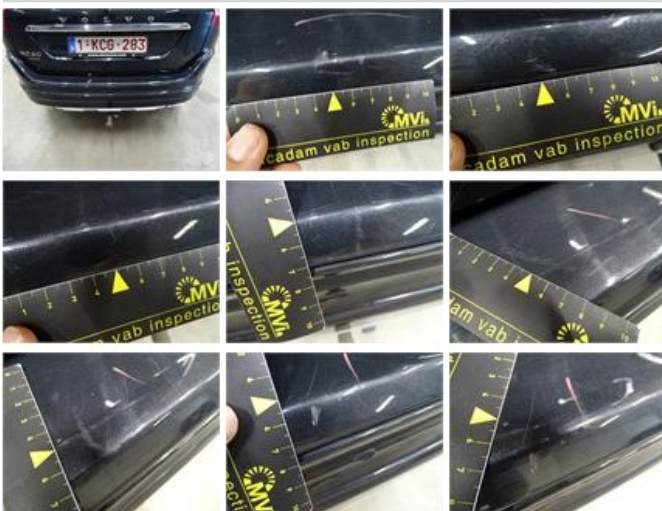
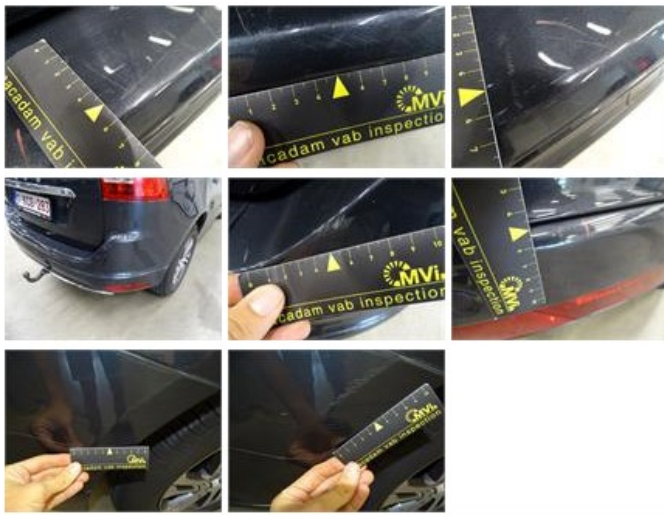
Bumper R, Scratch(es), LI - Repair and paint (complete) 254,16

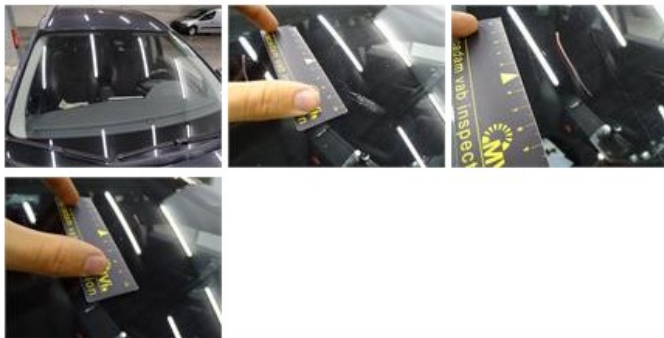
Windscreen, Scratch(es), Acceptable

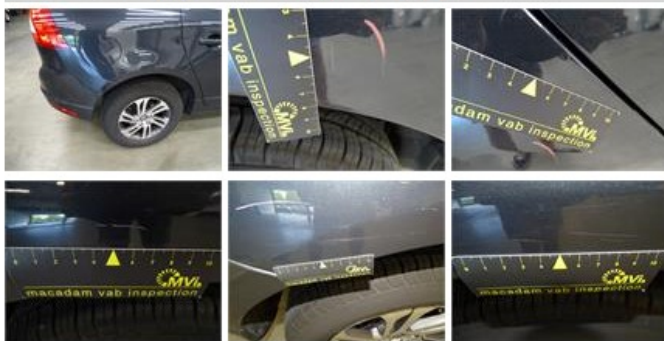
Wing R R, Scratch(es), LI - Repair and paint (complete)

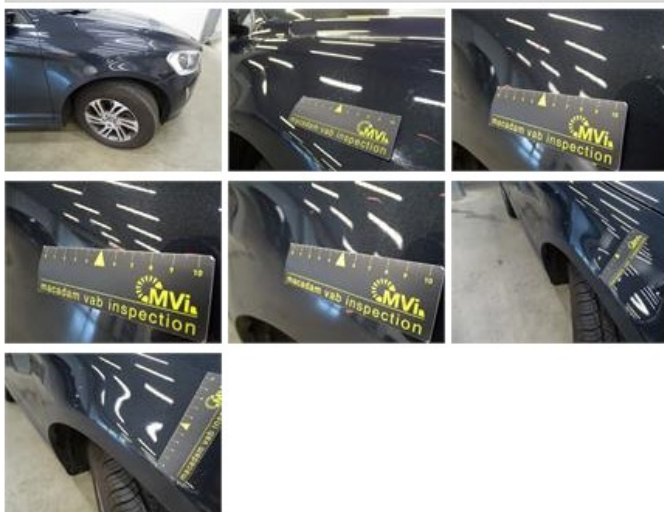
Wing F R, Bad repair, Acceptable

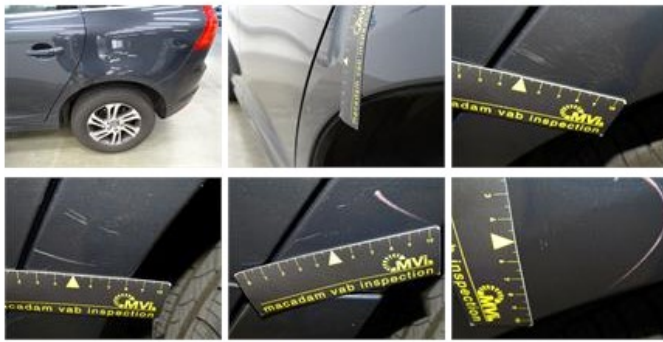
Wing R L, Dent(s) and scratch(es), LI - Repair and paint (complete)

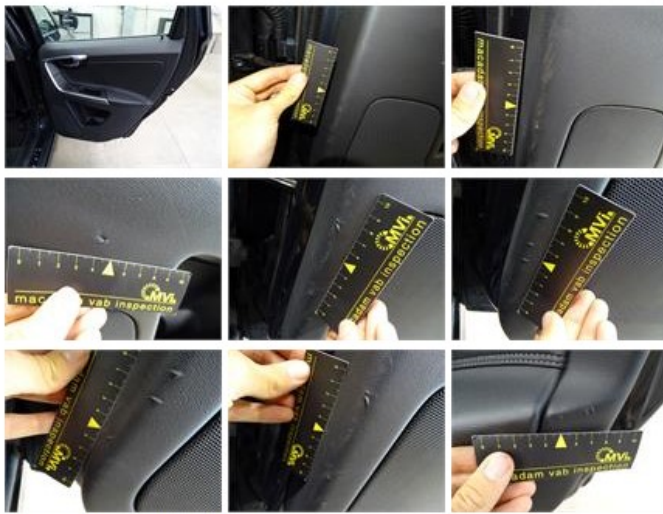
Door panel R R, Tear, E - Replace

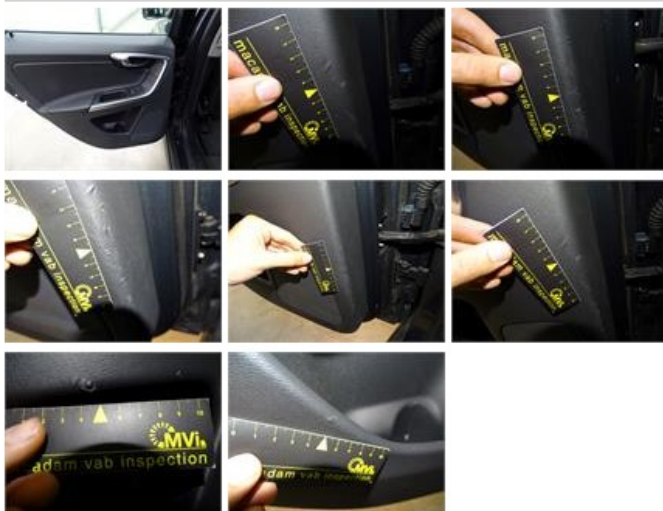
Door panel R L, Tear, E - Replace
