**FORD Transit 300S: XNC709**

**Limited Technical Inspection**

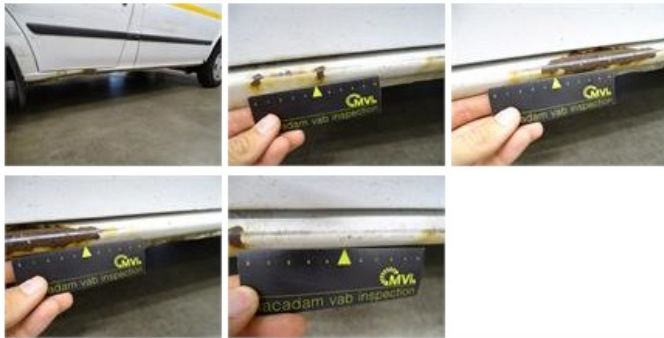
Sill outer L, Scratch(es), LI - Repair and paint (complete) 232,88

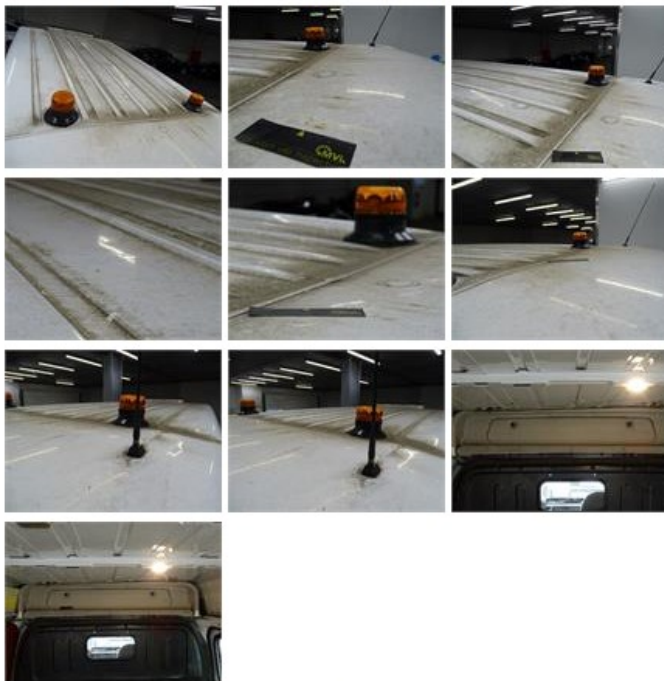
Roof, Dent(s) and scratch(es), LI - Repair and paint (complete) 433,13

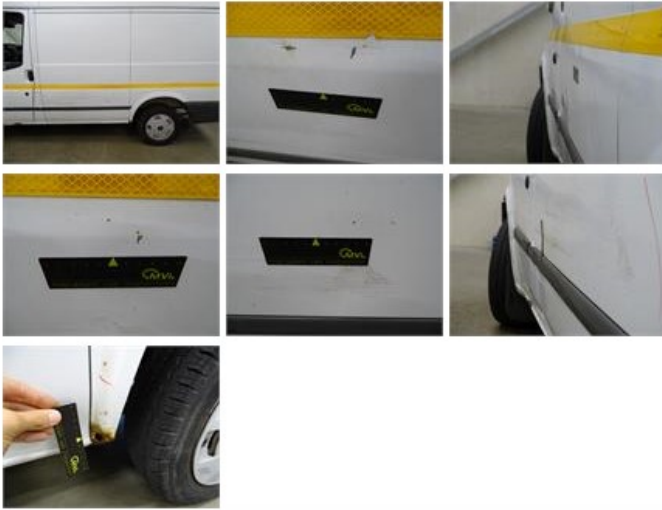
Wing R L, Dent(s) and scratch(es), LI - Repair and paint (complete)

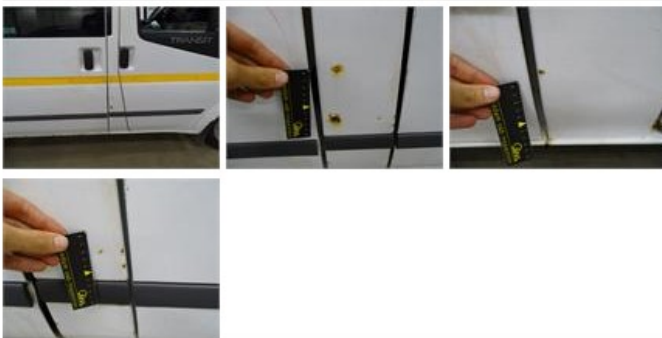
Central pillar R, Rust, LI - Repair and paint (complete)

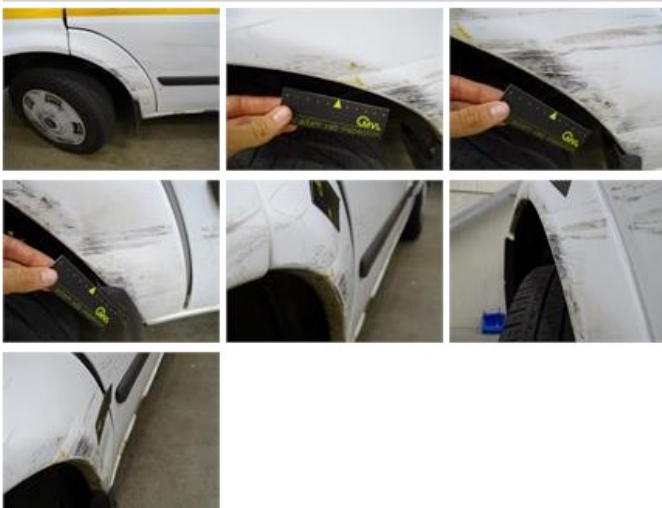
Wing moulding F L, Dent(s) and scratch(es), Le - Replace and paint

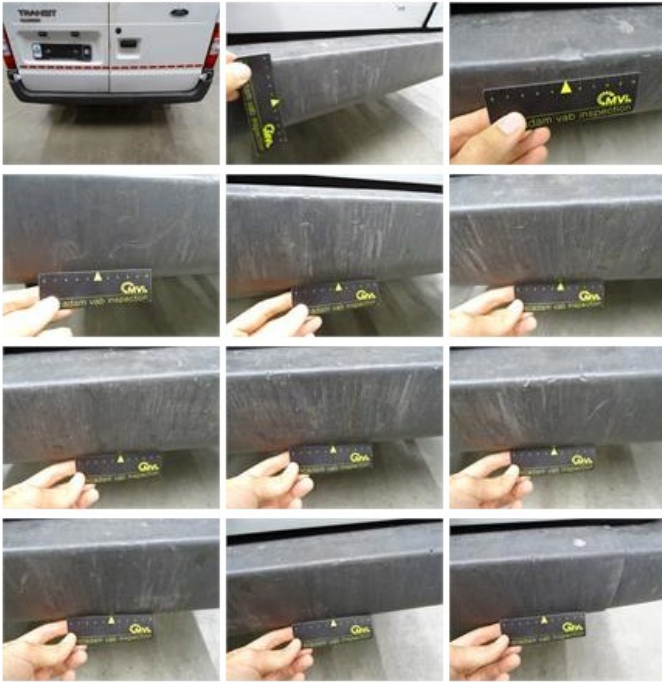
Bumper R, Scratch(es), Smart repair 110,64

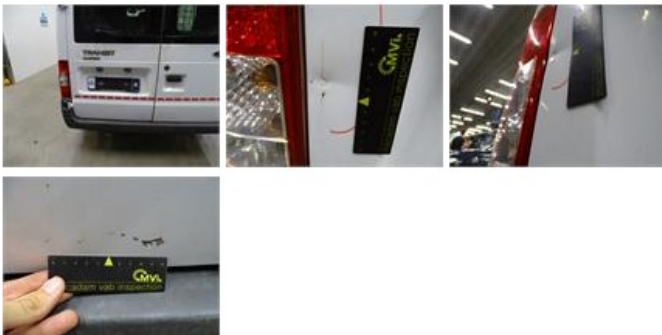
Trunk door R L, Dent(s) and scratch(es), It - Spot repair 115,56

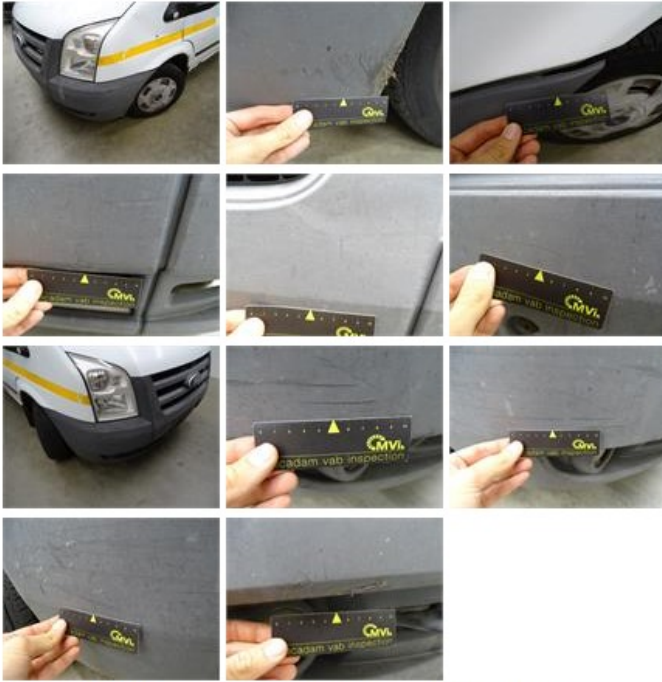
Bumper F, Scratch(es), Smart repair

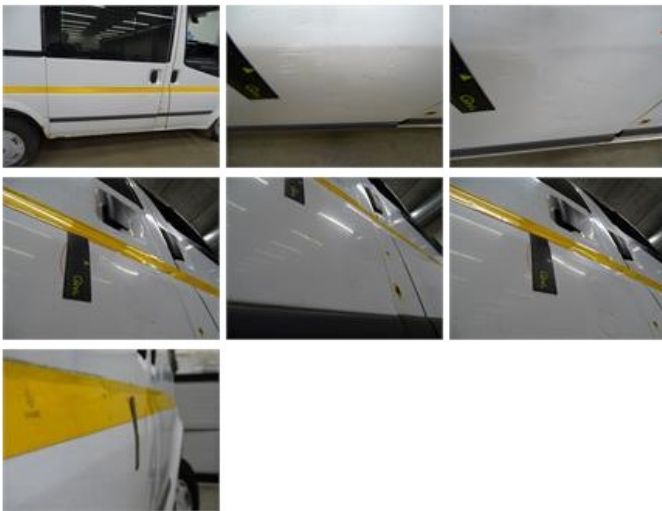
Door R R, Dent(s) and scratch(es), LI - Repair and paint (complete)
