MERCEDES A: 1L BG299

Limited Technical Inspection

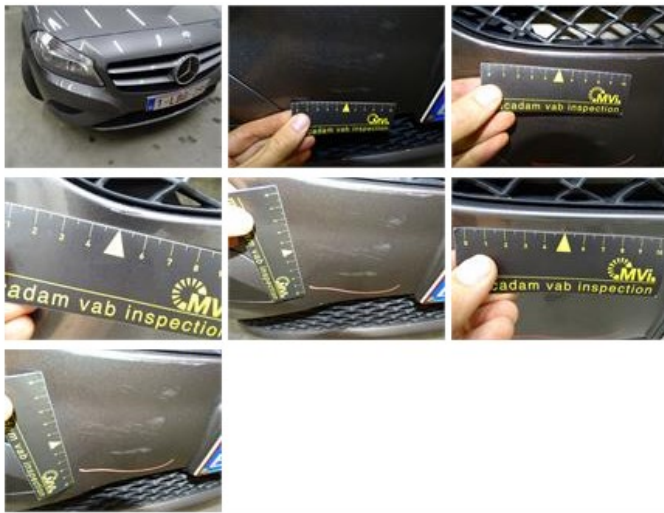
Total cost ex VAT	2207,70
Wheel cover F R, Scratch(es), Acceptable	0,00
<i>No pictures to display</i>	
Bumper F, Scratch(es), LI - Repair and paint (complete)	211,80

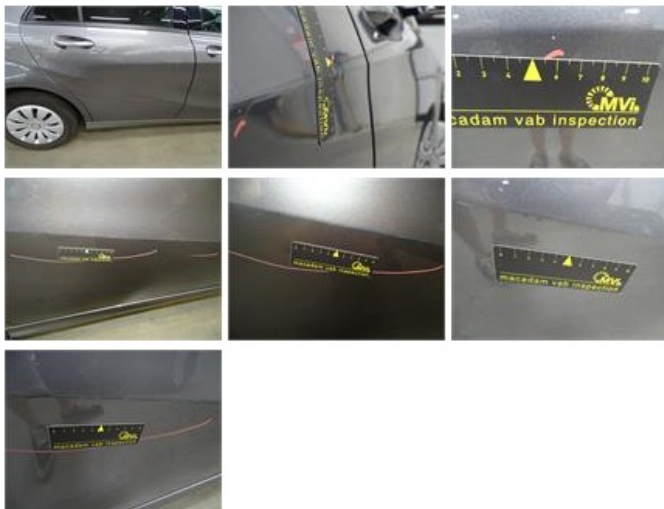
Door R R, Dent(s) and scratch(es), LI - Repair and paint (complete) 318,35

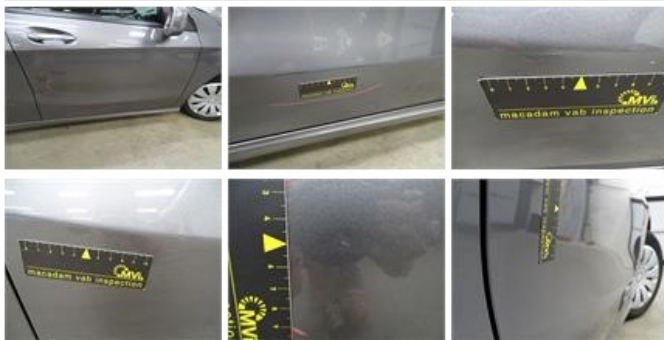
Door F R, Dent(s) and scratch(es), LI - Repair and paint (complete) 318,35

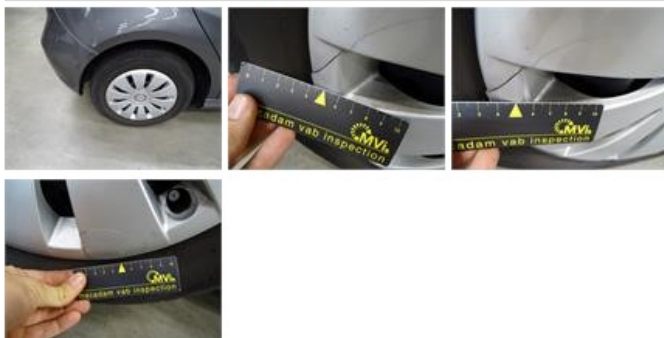
Wheel cover R R, Broken, E - Replace 30,00

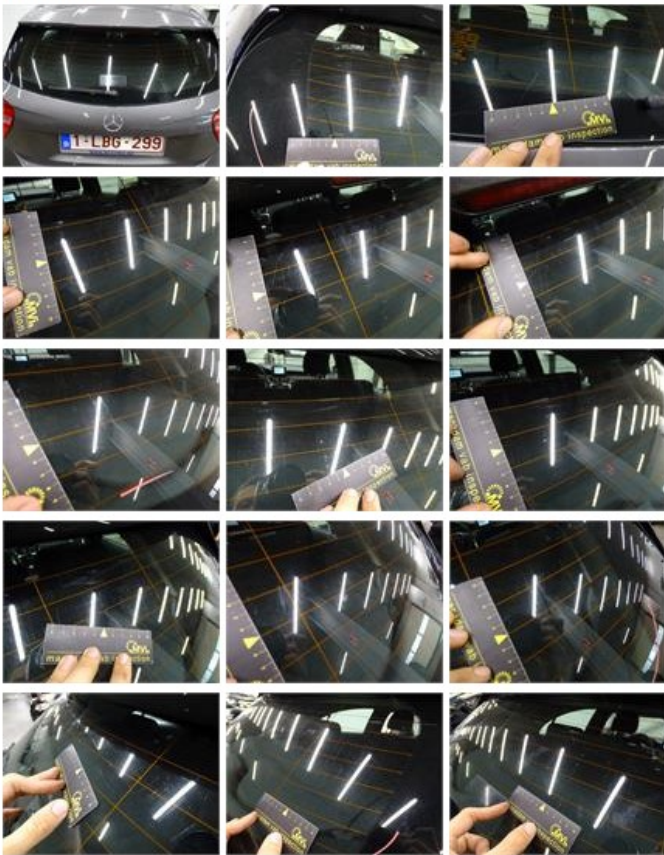
Rear window, Scratch(es), E - Replace 370,00

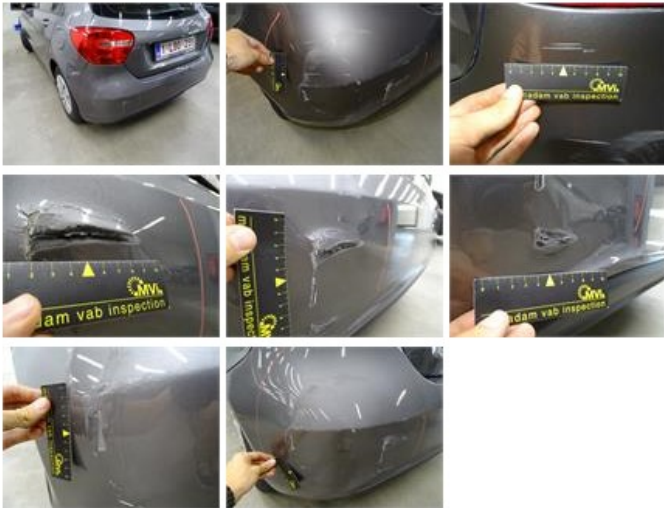
Bumper R, Deformed / Strained, Le - Replace and paint 651,00
