MERCEDEZ VITO: YIC872

Limited Technical Inspection

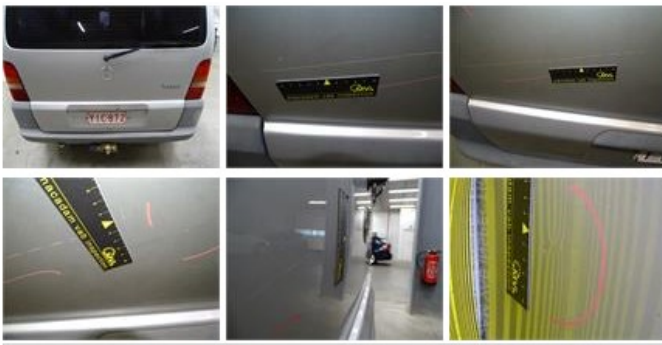
Total cost ex VAT	2689,10
Roof, Dent(s), Acceptable	0,00
<i>No pictures to display</i>	
Tailgate, Dent(s) and scratch(es), LI - Repair and paint (complete)	362,02

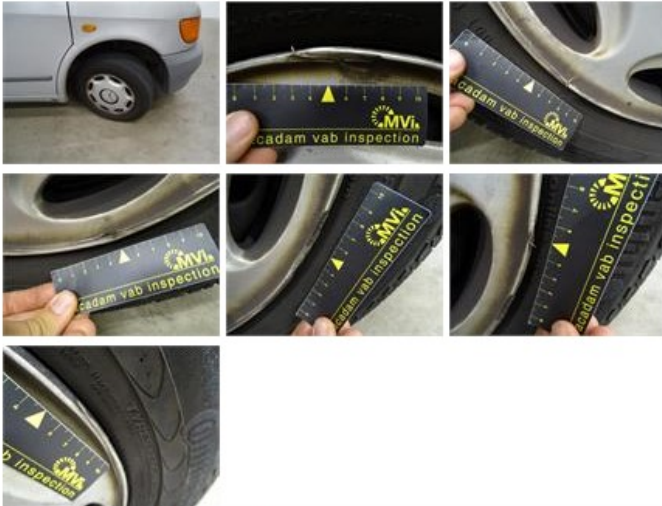
Wheel cover F R, Scratch(es), E - Replace 22,50

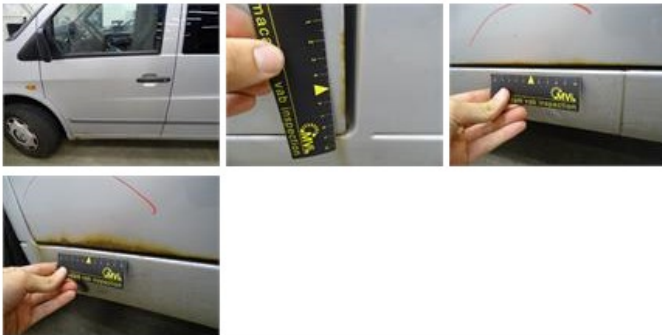
Door F L, Rust, LI - Repair and paint (complete) 238,76

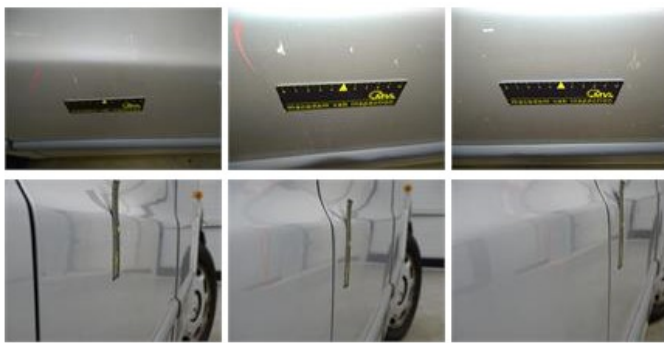
Door R R, Dent(s) and scratch(es), LI - Repair and paint (complete) 238,76

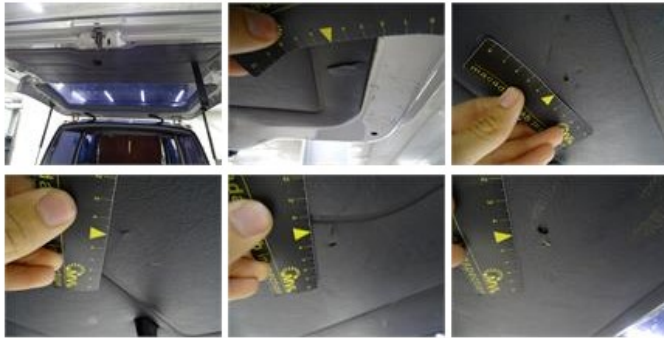
Internal Boot Lining L, Tear, Acceptable	0,00
No pictures to display	
Switch window control F R, Missing, Repair/replace (lump sum)	0,00
No pictures to display	
Wing F L, Rust, Acceptable	0,00
No pictures to display	
Trunk lid covering R, Tear, Smart repair	110,64

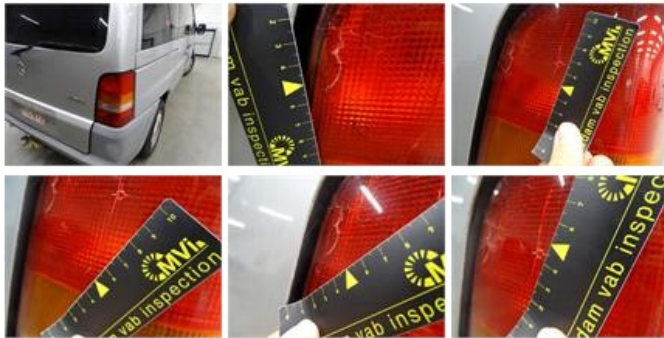
Wing F R, Scratch(es), Acceptable	0,00
No pictures to display	
Bumper F, Scratch(es), Acceptable	0,00
No pictures to display	
Bonnet, Dent(s), Acceptable	0,00
No pictures to display	
Rearlight R , Crack, E - Replace	91,50

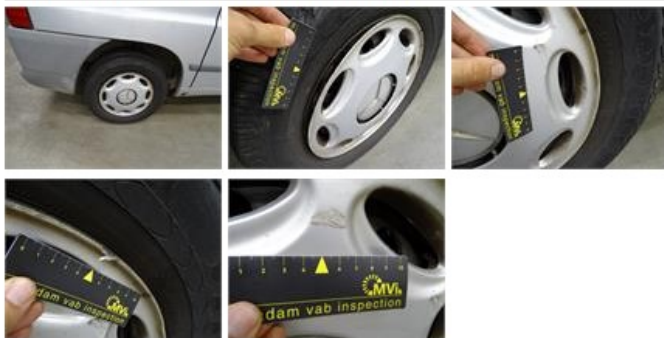
Wheel cover R R, Deformed / Strained, E - Replace	22,50
---	-------

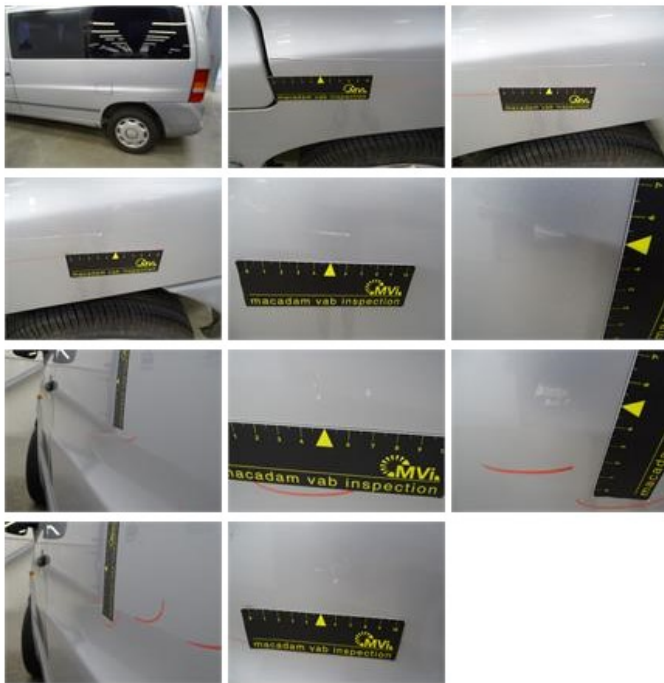
Wing R L, Dent(s) and scratch(es), LI - Repair and paint (complete)	231,15
---	--------

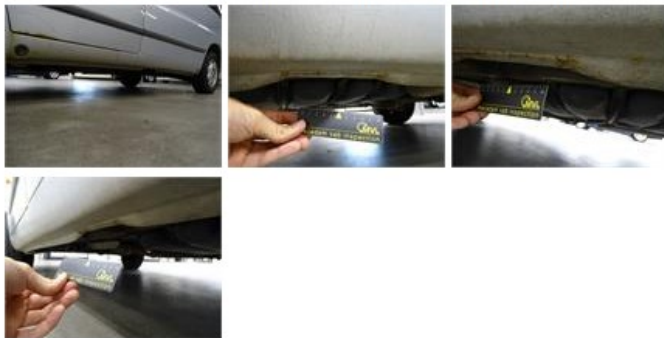
Sill outer L, Dent(s) and scratch(es), LI - Repair and paint (complete) 232,88

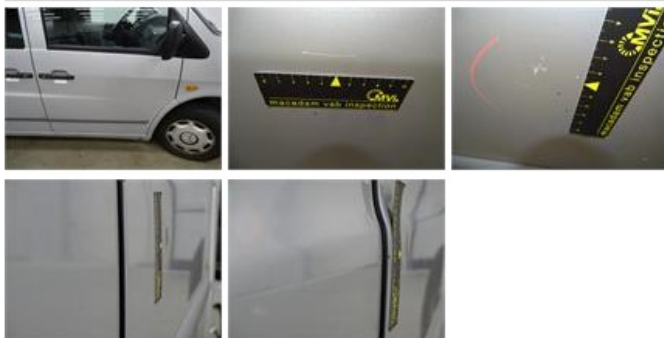
Door F R, Dent(s) and scratch(es), LI - Repair and paint (complete) 238,76

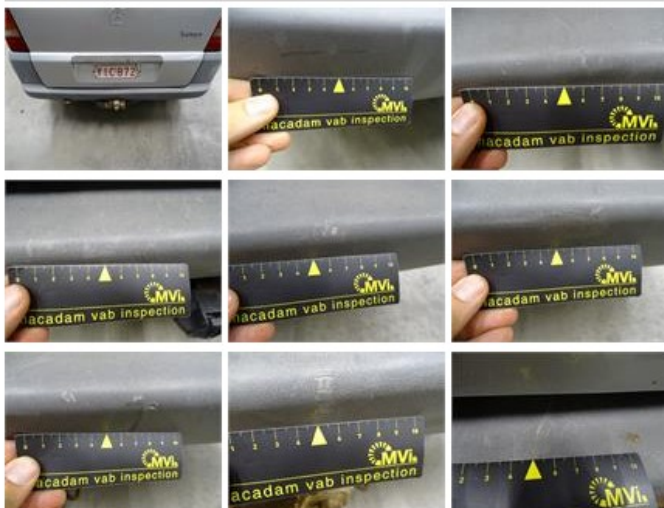
Bumper R, Scratch(es), Smart repair 110,64

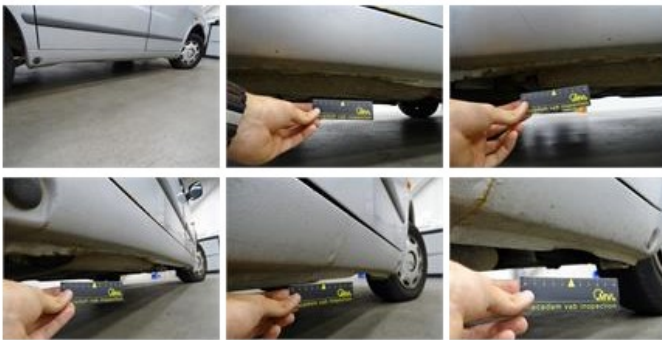
Sill outer R, Dent(s) and scratch(es), LI - Repair and paint (complete) 232,88

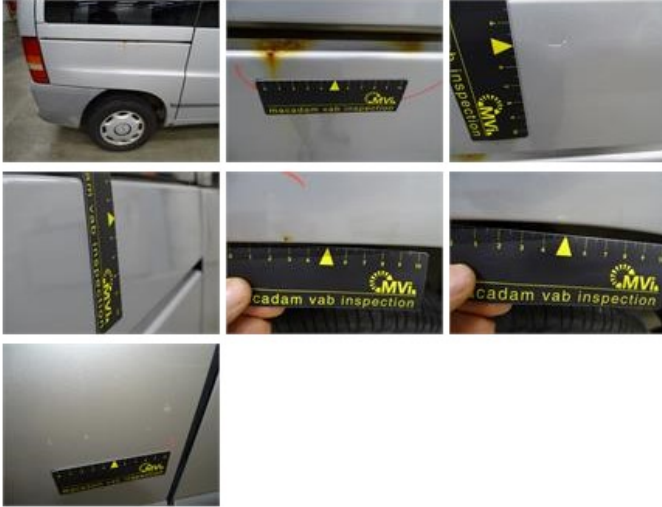
Wing R R, Dent(s) and scratch(es), LI - Repair and paint (complete) 231,15
