OPEL Zafira: 1HXP347

Vinnumber:	W0LPE9E33F2007737	Versionname:	ZAFIRA TOURER ecoFL.Cosmo S/S 136PK
First Registrationdate:	22/10/2014	Fiscalpower:	
Expertise Mileage:	131436	Power Kw:	100
Bodytype:	MPV	Body color:	Brown
Gearbox:	MAN 6 VIT	Paint type:	Metalic
Transmission:	Front	Rims summer:	Aluminium
Fueltype:	Diesel	Oil level:	OK
Battery functioning:	Yes	Parking lot:	2510
Number of doors:	5		
Number of seats:	7		
Number head rests:	7		
Rims summer:	Aluminium		
Category:	Passenger Car		
Oil level:	OK		
Registration Certificate Car (BE):	Yes

Limited Technical Inspection

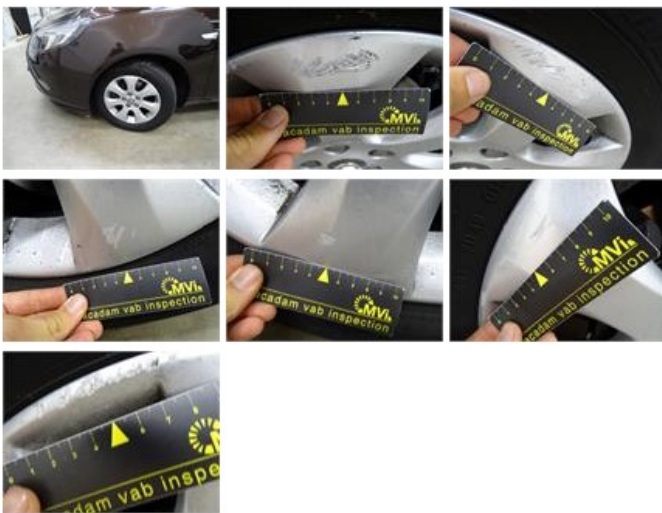
Total cost ex VAT	2603,54
Alloy rim F L, Scratch(es), LI - Repair and paint (complete)	95,00

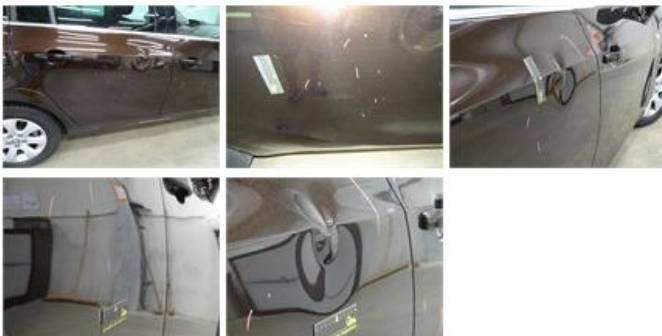
Door R R, Dent(s) and scratch(es), LI - Repair and paint (complete) 462,35

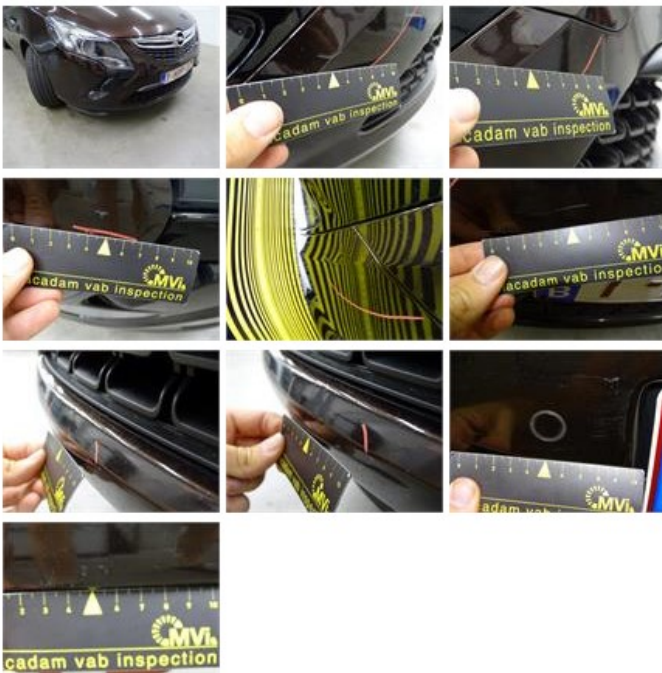
Bumper F, Scratch(es), LI - Repair and paint (complete) 211,80

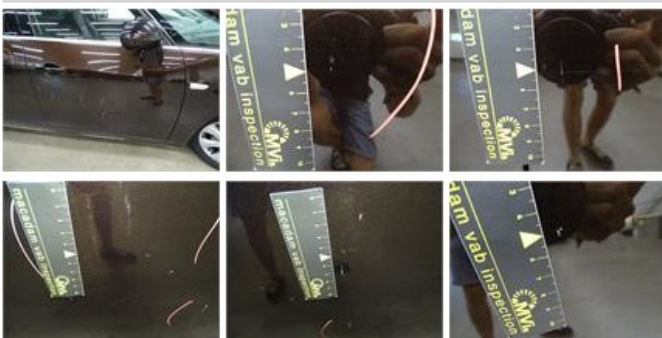
Door F R, Scratch(es), LI - Repair and paint (complete) 0,00

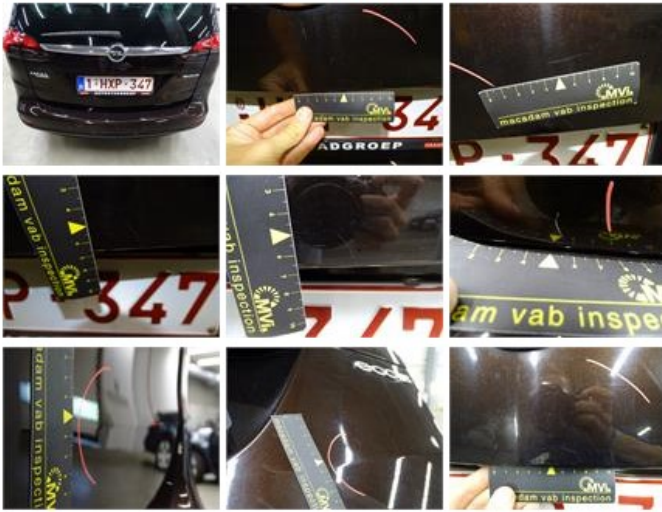
Tailgate, Dent(s) and scratch(es), LI - Repair and paint (complete)

301,68

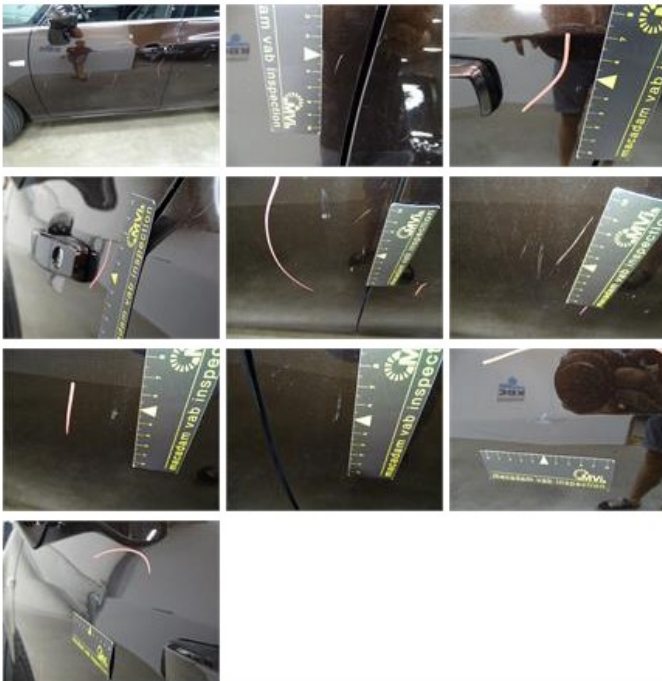
Door F L, Dent(s) and scratch(es), LI - Repair and paint (complete)

318,35

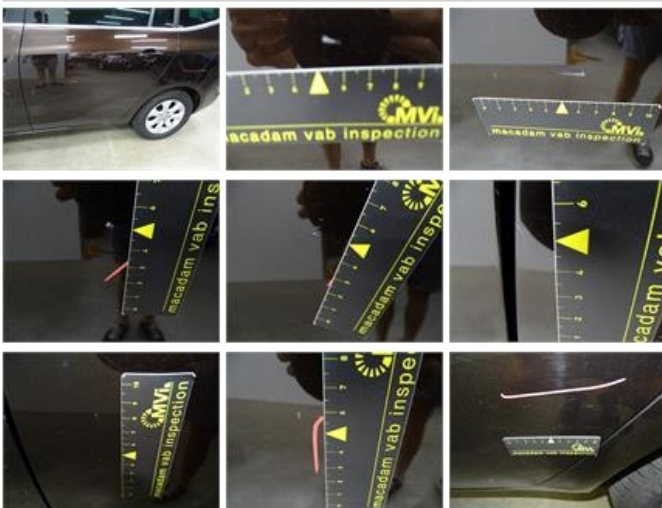
Door R L, Scratch(es), LI - Repair and paint (complete)

0,00

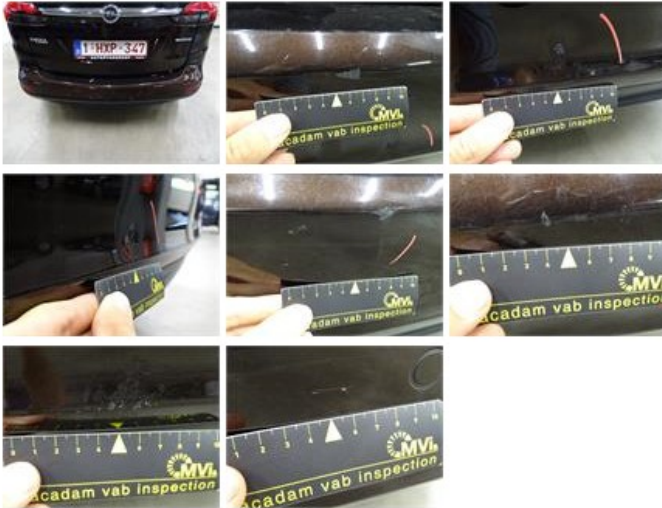
Bumper R, Dent(s) and scratch(es), LI - Repair and paint (complete)

211,80
