BMW 5 BERLINE: 1JXD348

Limited Technical Inspection

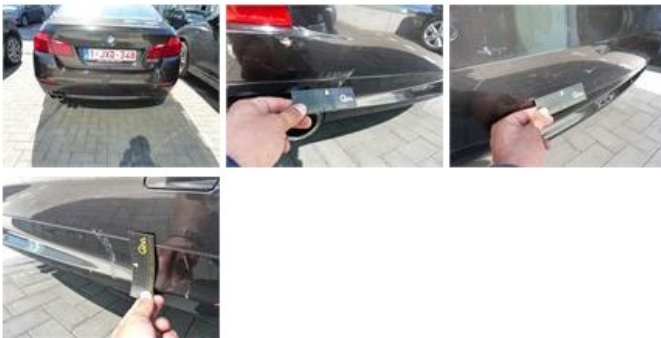
Bumper R, Dent(s) and scratch(es), LI - Repair and paint (complete)

254,16

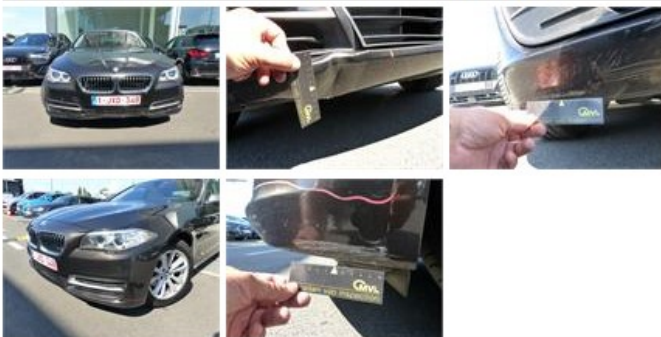
Bumper F, Dent(s) and scratch(es), LI - Repair and paint (complete)

302,16
