BMW 1 HATCH: 1NLD778

Limited Technical Inspection

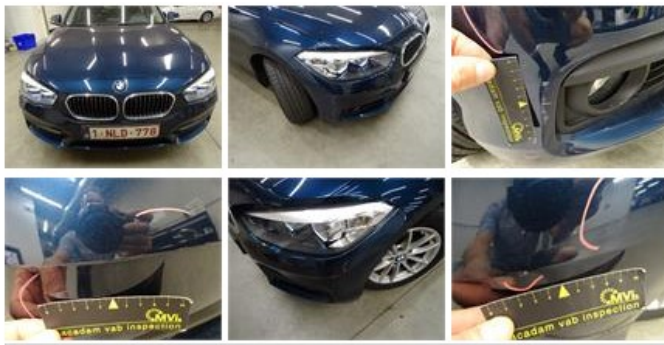
Total cost ex VAT	1318,45
Wing F R, Scratch(es), 67 - Polish	0,00
<i>No pictures to display</i>	
Bonnet, Stone chip(s), Acceptable	0,00
<i>No pictures to display</i>	
Bumper F, Scratch(es), LI - Repair and paint (complete)	211,80

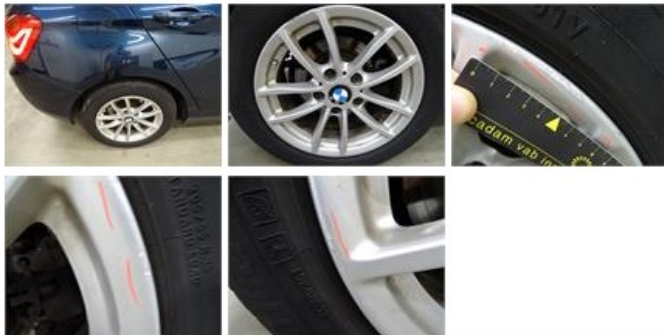
Alloy rim R R, Scratch(es), LI - Repair and paint (complete)

95,00

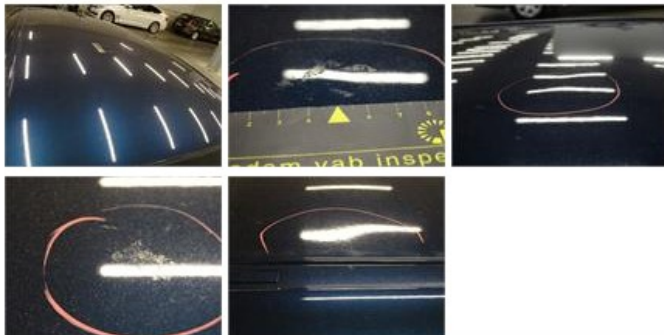
Roof, Chemical polution, LI - Repair and paint (complete)

481,50
