SEAT LEON ST: 1SAP804

Limited Technical Inspection

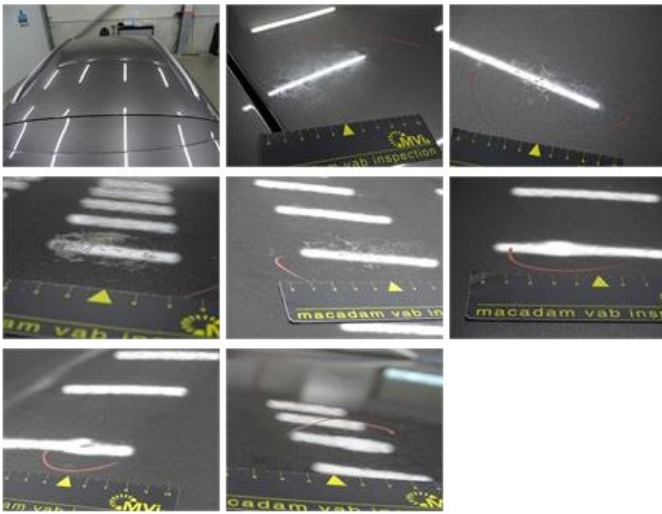
Roof, Chemical polution, LI - Repair and paint (complete)

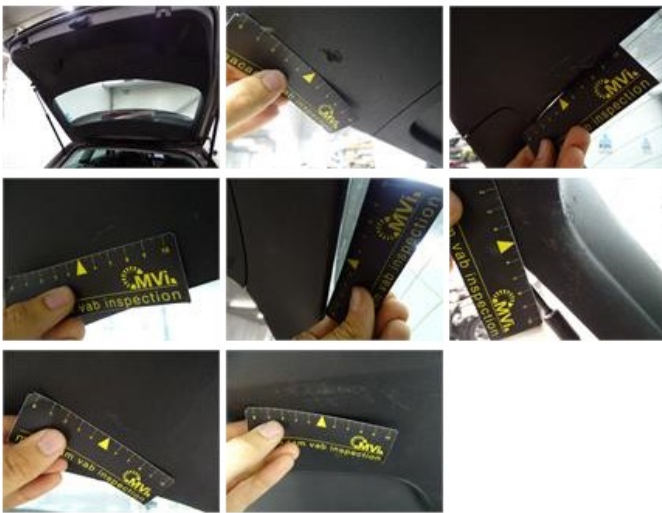
Trunk lid covering R, Scratch(es), Smart repair

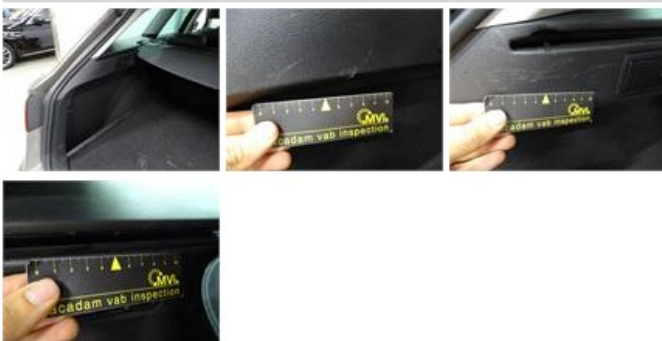
Internal Boot Lining L, Scratch(es), Smart repair

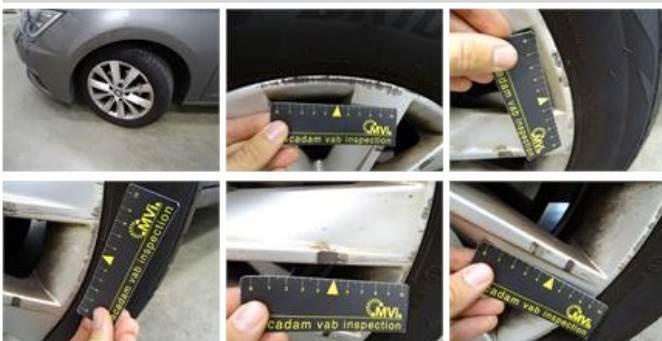
Alloy rim F L, Scratch(es), LI - Repair and paint (complete)

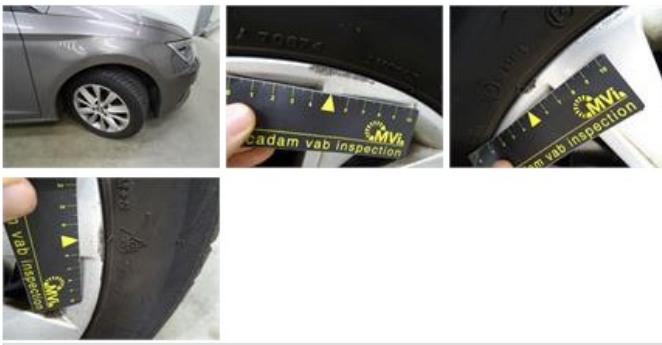
Alloy rim F R, Scratch(es), LI - Repair and paint (complete)

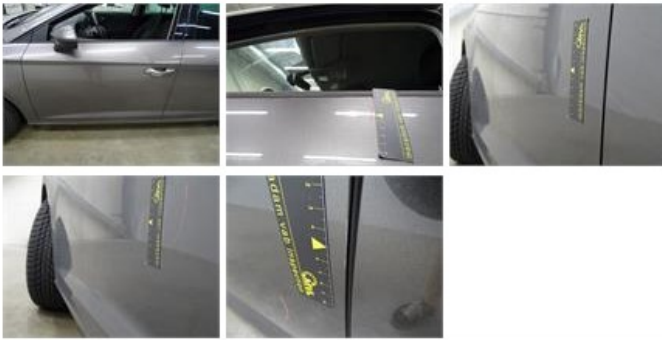
Door F L, Dent(s), LI - Repair and paint (complete) 318,35

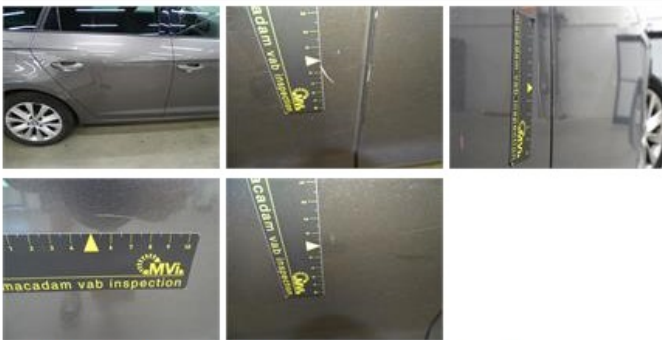
Door R R, Dent(s) and scratch(es), LI - Repair and paint (complete) 318,35

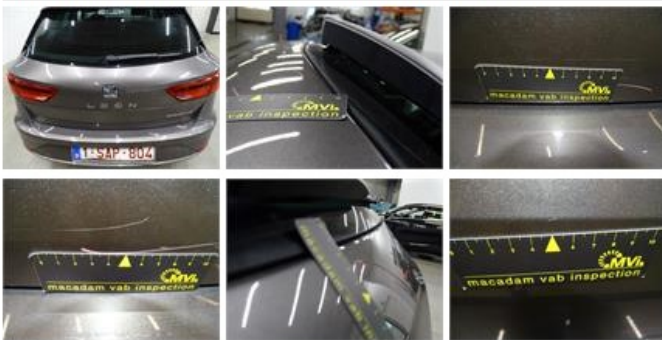
Tailgate, Dent(s) and scratch(es), LI - Repair and paint (complete) 301,68

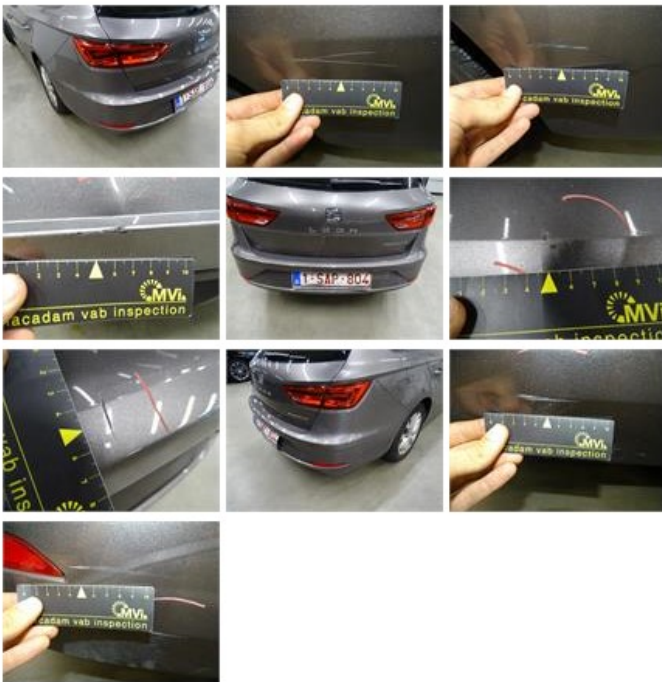
Bumper R, Scratch(es), LI - Repair and paint (complete)

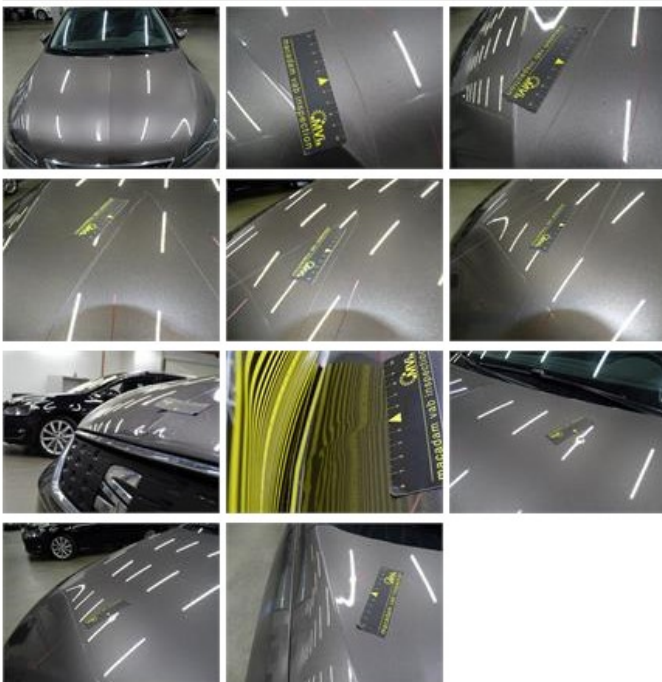
Bonnet, Dent(s) and scratch(es), LI - Repair and paint (complete)

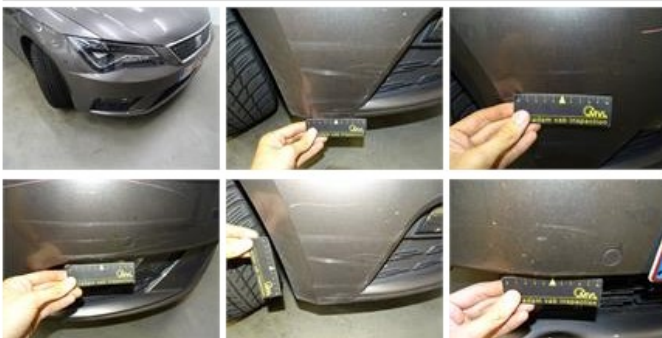
Bumper F, Scratch(es), LI - Repair and paint (complete)

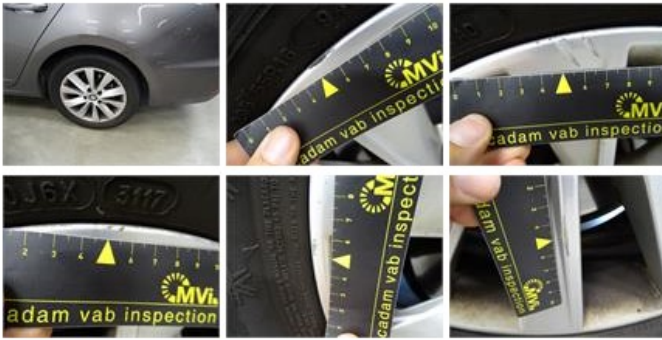
Alloy rim R L, Scratch(es), LI - Repair and paint (complete) 95,00
