VOLKSWAGEN GOLF VII: 1KVC238

Limited Technical Inspection

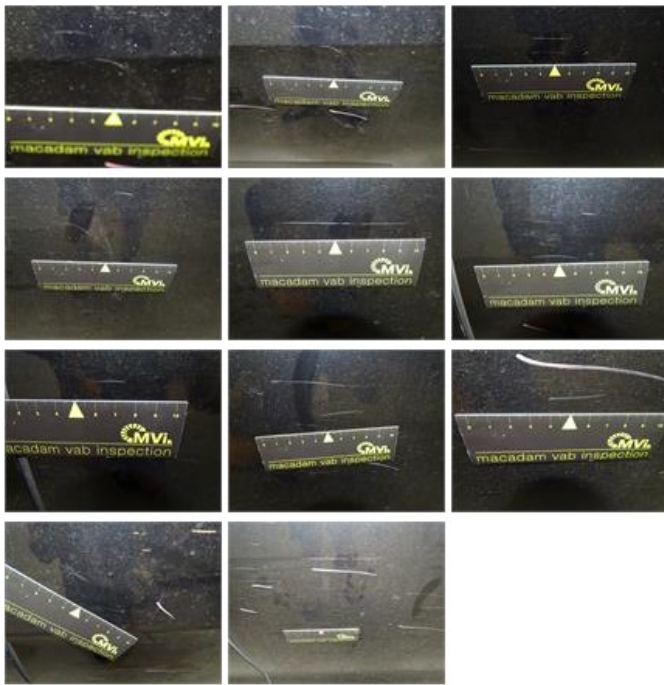
Door R L, Dent(s) and scratch(es), LI - Repair and paint (complete) 318,35

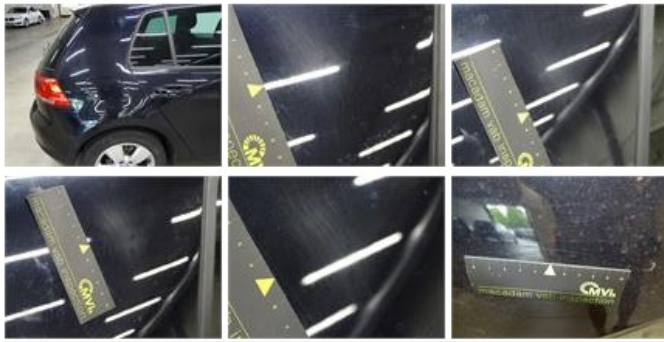
Wing R R, Scratch(es), LI - Repair and paint (complete)

308,20

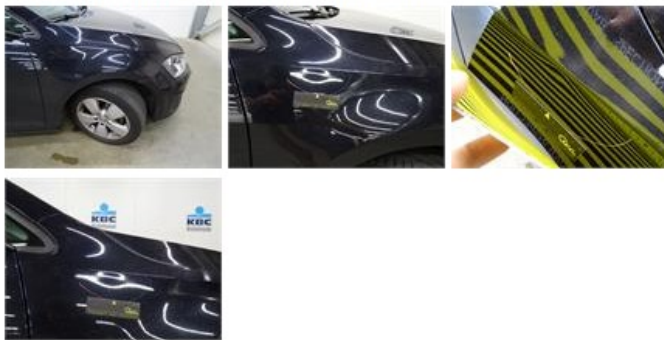
Wing F R, Dent(s), LI - Repair and paint (complete)

220,18

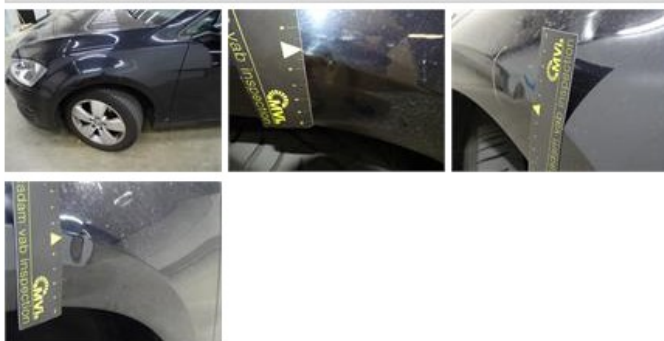
Wing F L, Dent(s) and scratch(es), LI - Repair and paint (complete)

220,18

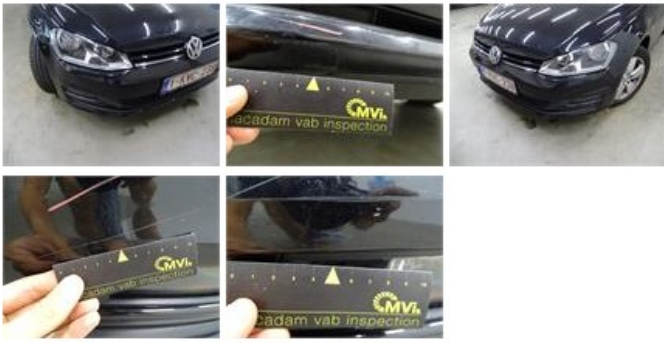
Bumper F, Scratch(es), LI - Repair and paint (complete)

211,80
