SKODA Fabia: 1HHA108

Limited Technical Inspection

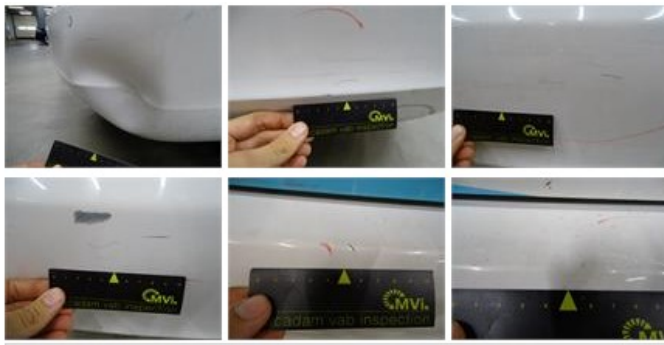
Total cost ex VAT	2129,86
Bumper R, Deformed / Strained, Le - Replace and paint	535,20

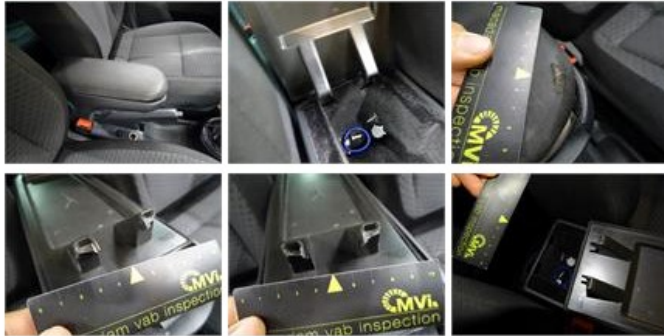
Armrest F Mid, Damaged, Smart repair 64,32

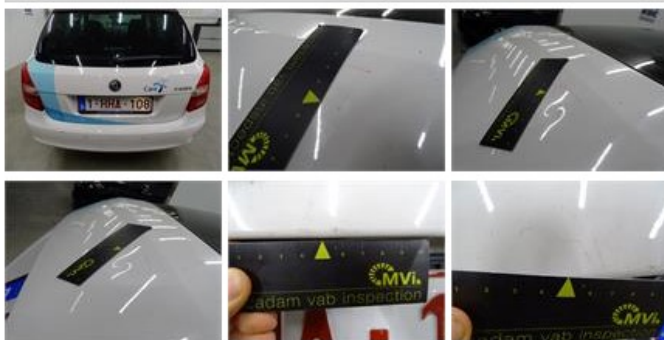
Tailgate, Dent(s) and scratch(es), LI - Repair and paint (complete) 241,34

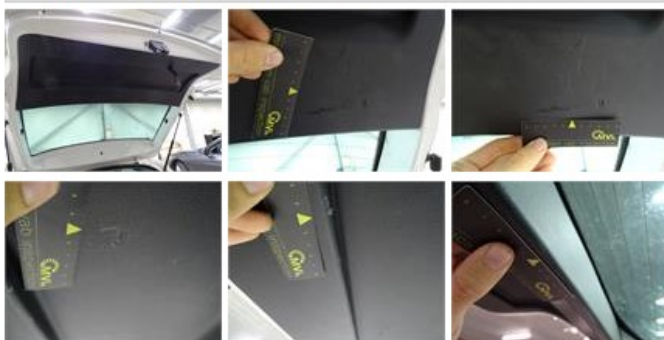
Trunk lid covering R, Scratch(es), Smart repair 110,64

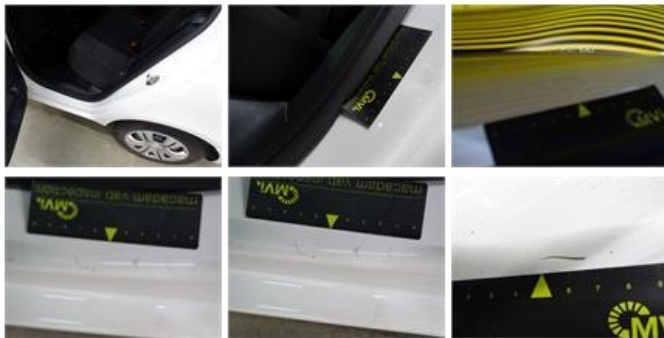
Rocker panel inner R L, Dent(s), LI - Repair and paint (complete) 115,56

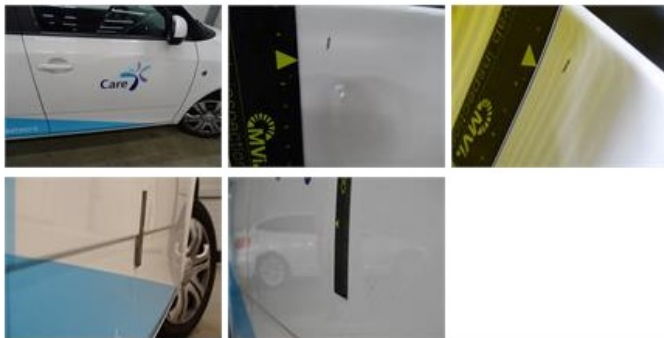
Door F R, Dent(s) and scratch(es), LI - Repair and paint (complete) 254,68

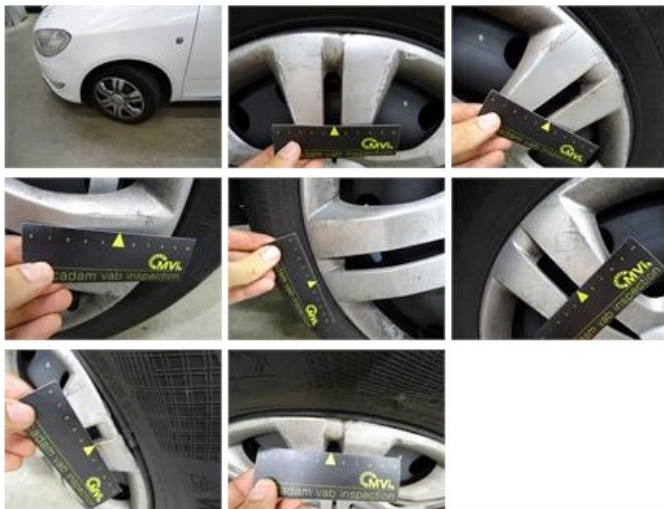
Wheel cover F L, Scratch(es), E - Replace 24,00

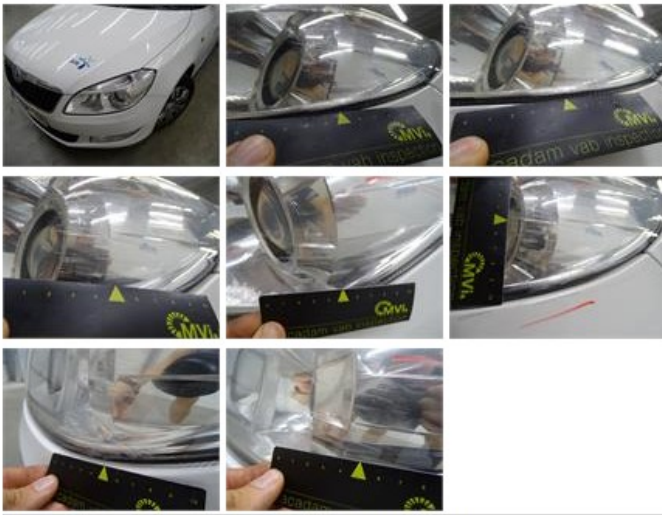
Headlight L, Scratch(es), E - Replace 336,00

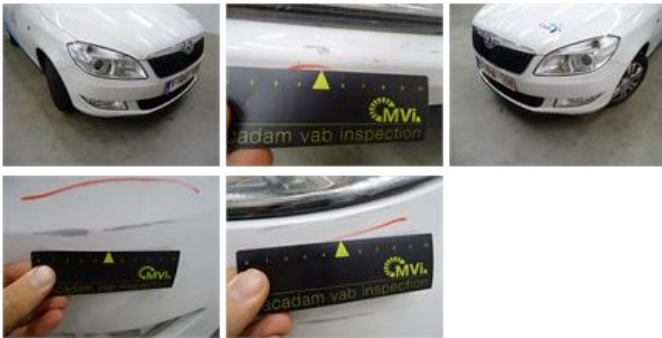
Bumper F, Scratch(es), LI - Repair and paint (complete) 169,44
