VOLVO XC60: 1HHY839

Limited Technical Inspection

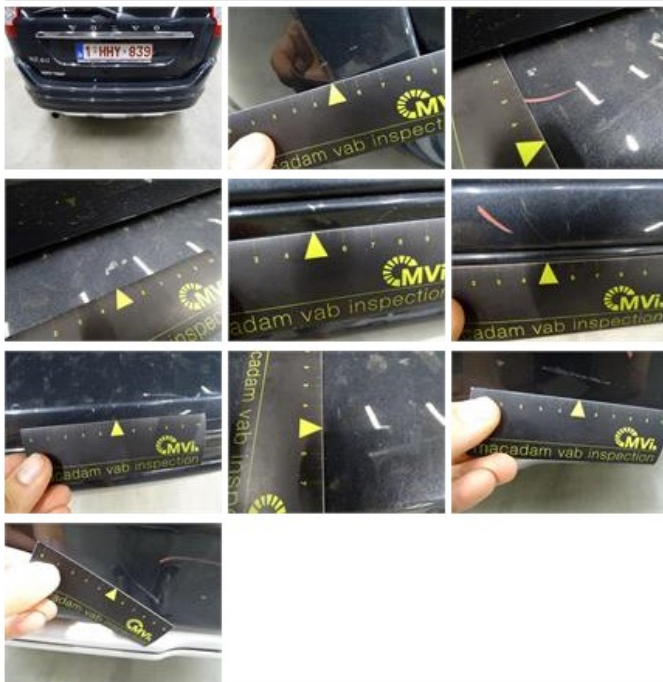
Bumper R, Scratch(es), LI - Repair and paint (complete) 254,16

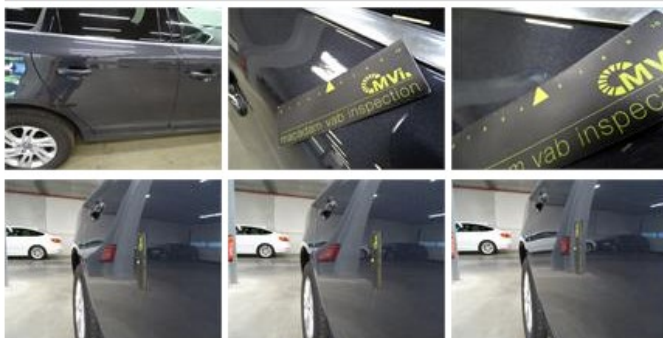
Door R R, Bad repair, Acceptable 0,00

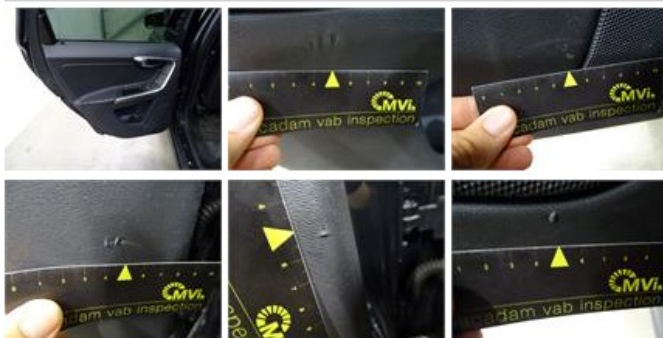
Door panel R L, Tear, E - Replace 132,00

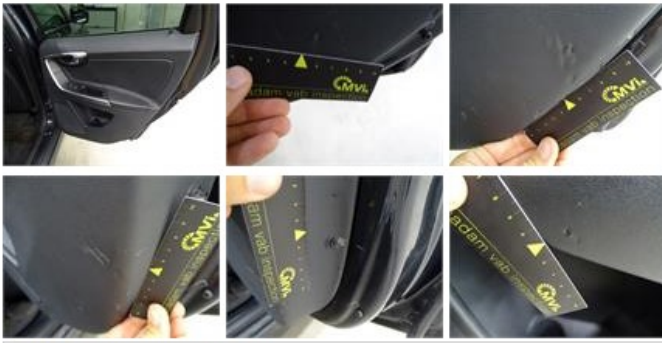
Door panel R R, Tear, E - Replace 132,00

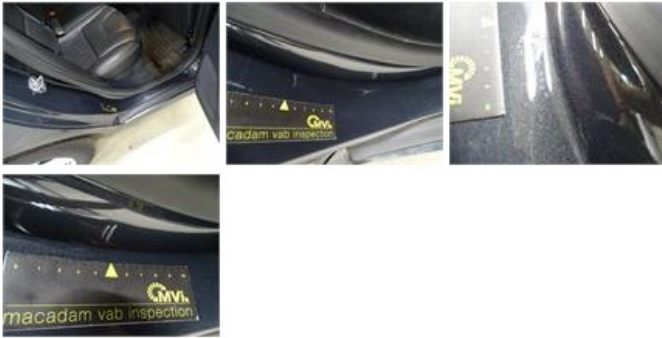
Wing R R, Repaired, Acceptable	0,00
<i>No pictures to display</i>	
Door frame R R, Scratch(es), Acceptable	0,00
<i>No pictures to display</i>	
Wing R L, Scratch(es), Acceptable	0,00
<i>No pictures to display</i>	
Rocker panel inner R R, Dent(s), LI - Repair and paint (complete)	115,56
