VOLVO XC60: 1KFT914

Limited Technical Inspection

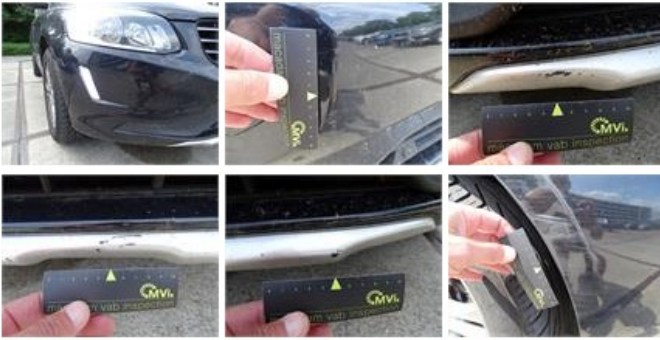
Bumper F, Scratch(es), LI - Repair and paint (complete) 254,16

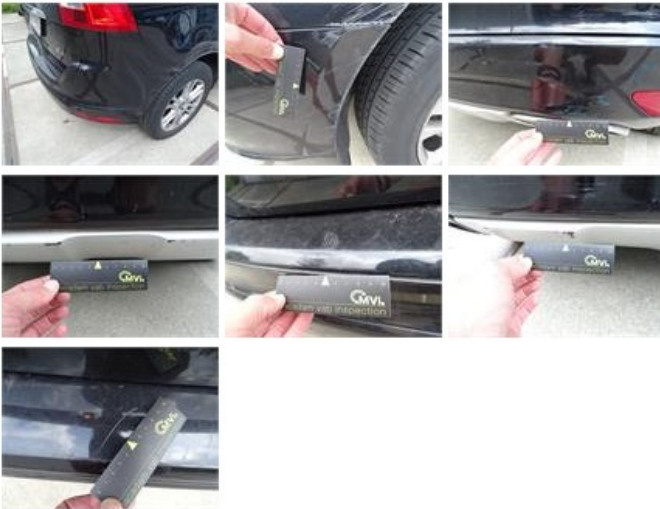
Bumper R, Scratch(es), LI - Repair and paint (complete) 254,16
