VOLVO V40: 1GQV637

Limited Technical Inspection

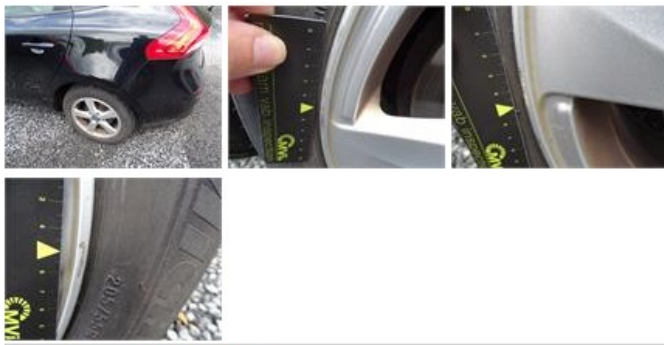
Total cost ex VAT	380,00
Alloy rim R L, Scratch(es), LI - Repair and paint (complete)	95,00
