**VOLVO S60: 1GRP722**

**Limited Technical Inspection**

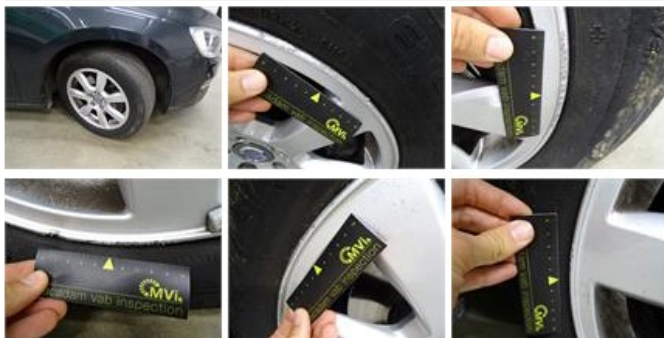
Alloy rim F R, Scratch(es), LI - Repair and paint (complete) 95,00

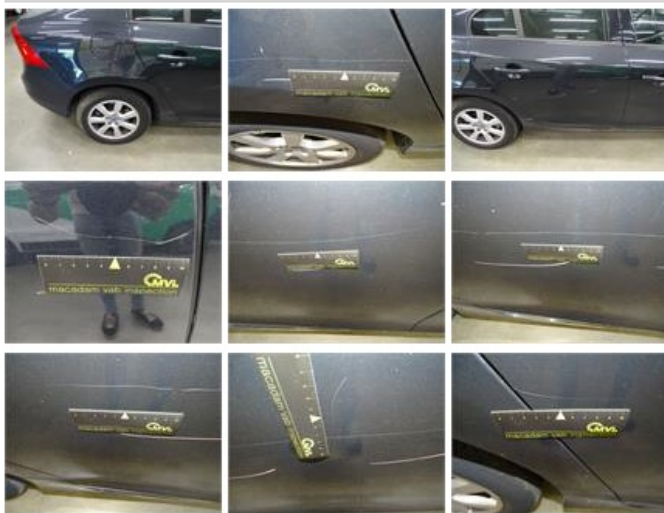
Door R R, Scratch(es), LI - Repair and paint (complete) 318,35

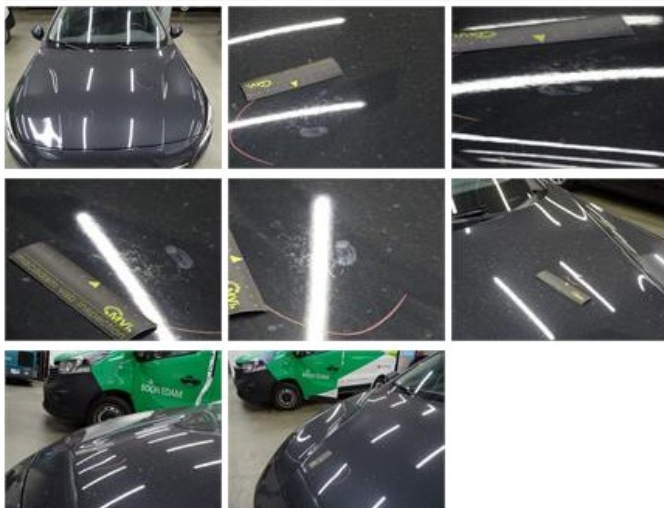
Bonnet, Chemical polution, LI - Repair and paint (complete) 290,08

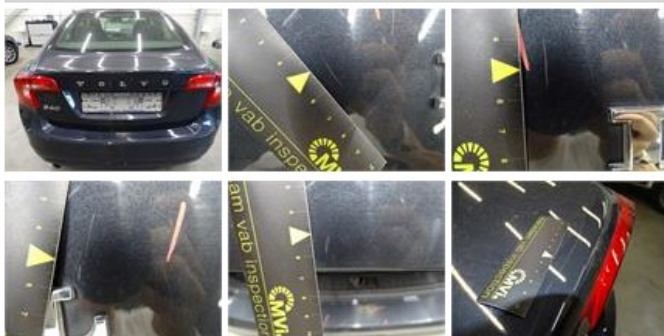
Tailgate, Scratch(es), LI - Repair and paint (complete) 301,68

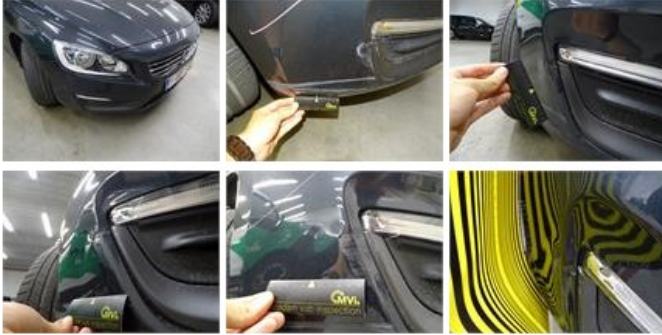
Bumper F, Dent(s) and scratch(es), LI - Repair and paint (complete) 211,80

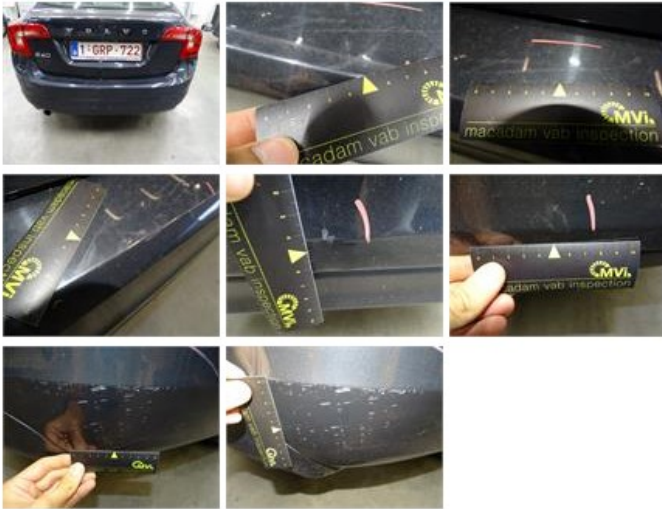
Bumper R, Scratch(es), LI - Repair and paint (complete) 211,80
