**MINI COUNTRYMAN: 1JXZ932**

**Limited Technical Inspection**

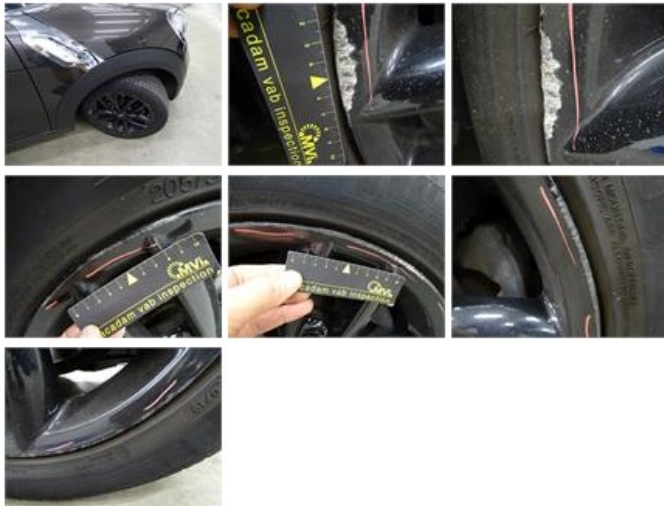
Alloy rim F R, Deformed / Strained, E - Replace

235,20

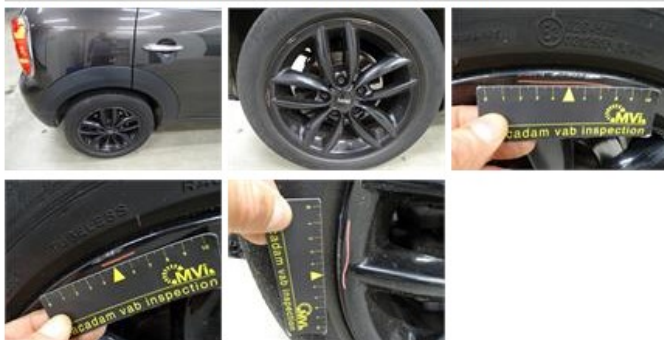
Alloy rim R R, Scratch(es), LI - Repair and paint (complete)

95,00
