LU Volkswagen Golf: KP7868

Limited Technical Inspection

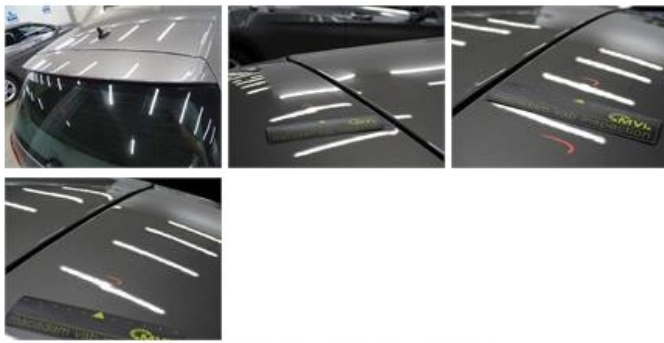
Total cost ex VAT	2204,85
Rear spoiler, Dent(s), LI - Repair and paint (complete)	115,56

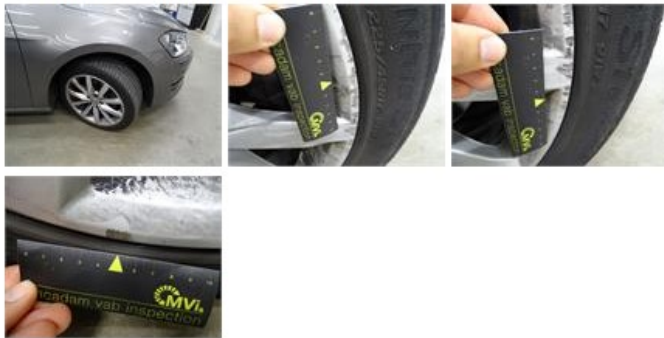
Alloy rim F R, Scratch(es), LI - Repair and paint (complete)

95,00

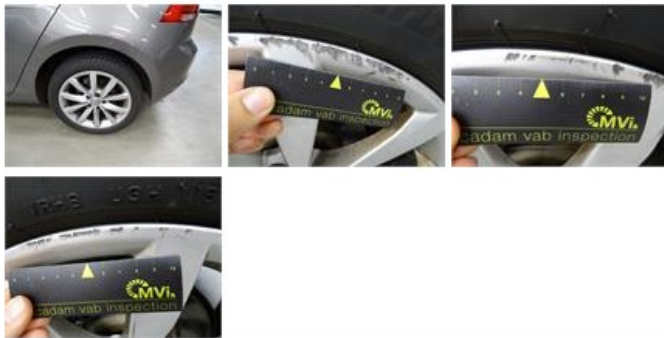
Alloy rim R L, Scratch(es), LI - Repair and paint (complete)

95,00

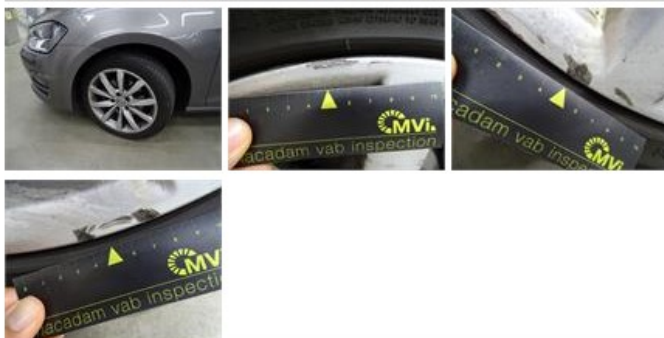
Alloy rim F L, Scratch(es), LI - Repair and paint (complete)

95,00

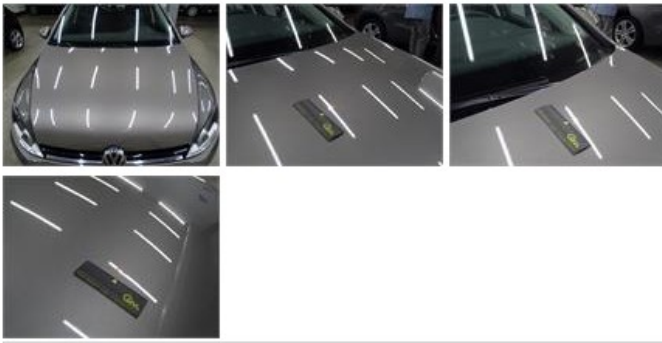
Bonnet, Hail damage, PDR - Hail

175,00

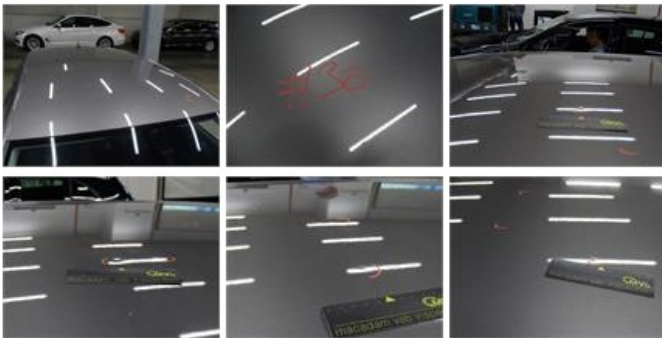
Roof, Hail damage, PDR - Hail 750,00

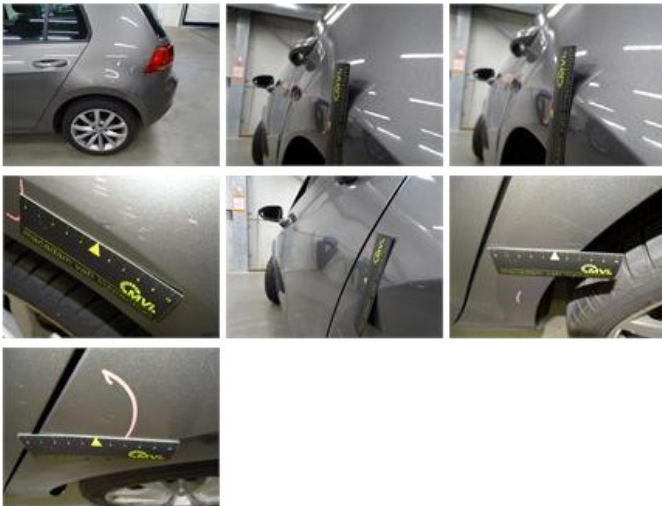
Wing R L, Dent(s) and scratch(es), LI - Repair and paint (complete) 308,20
