BMW 5: 1GWN867

Limited Technical Inspection

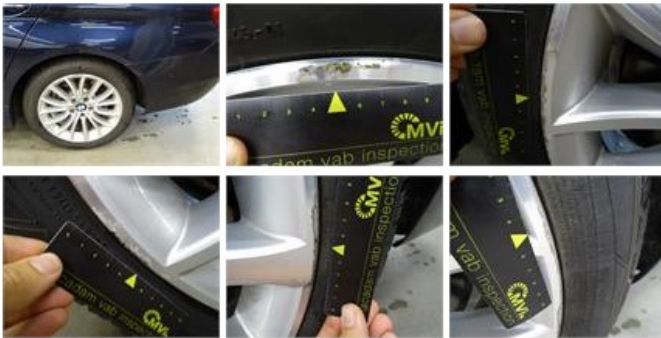
Alloy rim R L polished, Scratch(es), LI - Repair and paint (complete) 95,00

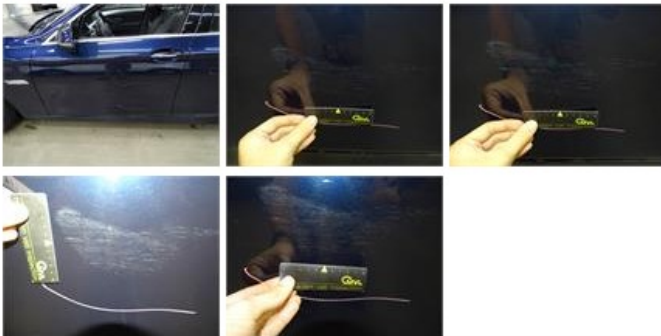
Door F L, Scratch(es), LI - Repair and paint (complete) 382,02

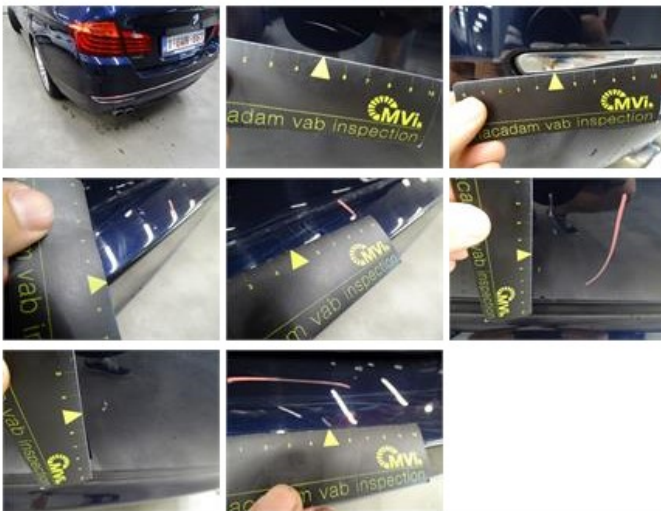
Bumper R, Scratch(es), LI - Repair and paint (complete) 254,16

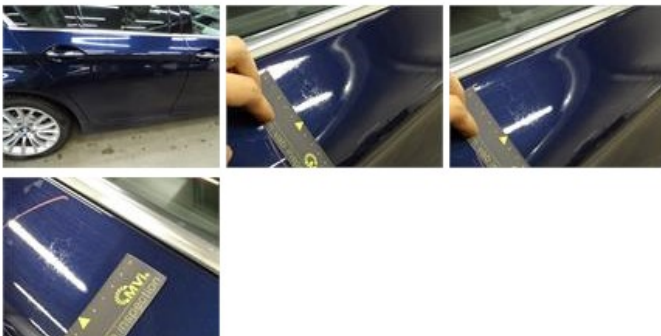
Door R R, Chemical pollution, LI - Repair and paint (complete) 382,02

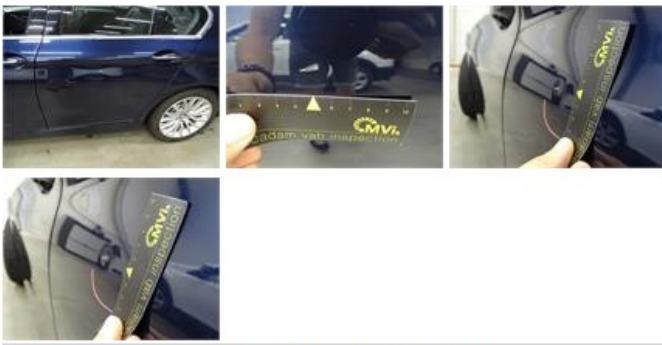
Door R L, Dent(s) and scratch(es), LI - Repair and paint (complete) 382,02

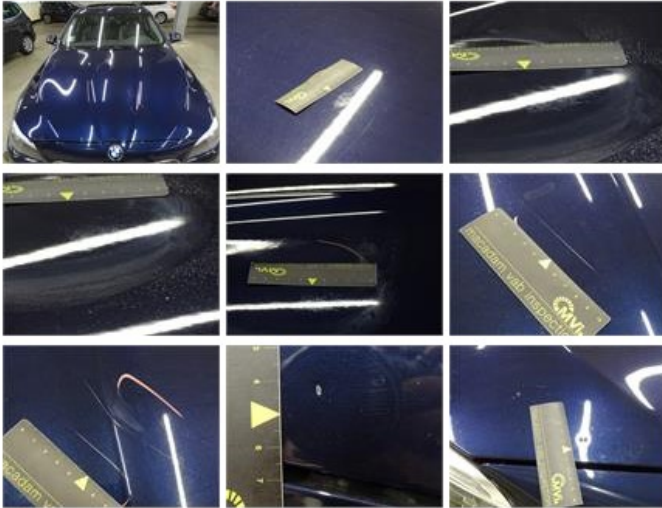
Bonnet, Chemical polution, LI - Repair and paint (complete)

348,09

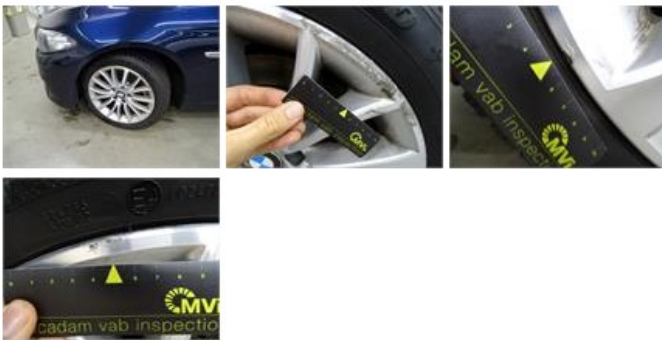
Alloy rim F L polished, Scratch(es), LI - Repair and paint (complete)

95,00

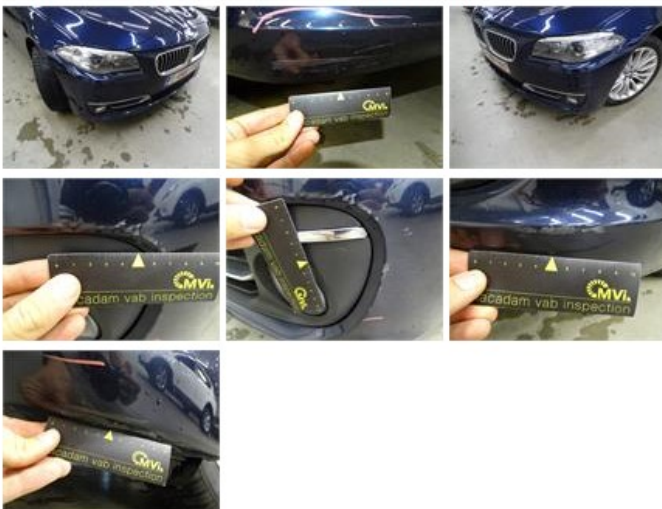
Bumper F, Scratch(es), LI - Repair and paint (complete)

254,16

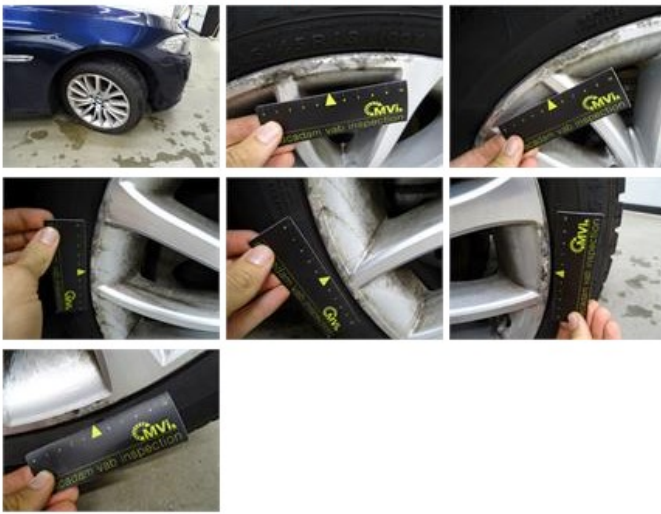
Alloy rim F R polished, Scratch(es), LI - Repair and paint (complete)

95,00
