BMW 2 ACTIVE TOURER: 1LAR348

Limited Technical Inspection

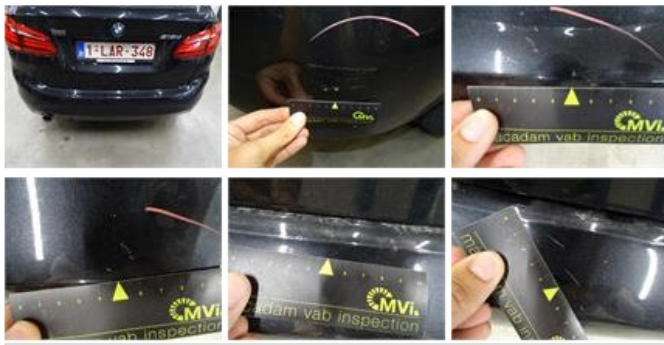
Total cost ex VAT	674,60
Bumper R, Scratch(es), LI - Repair and paint (complete)	211,80

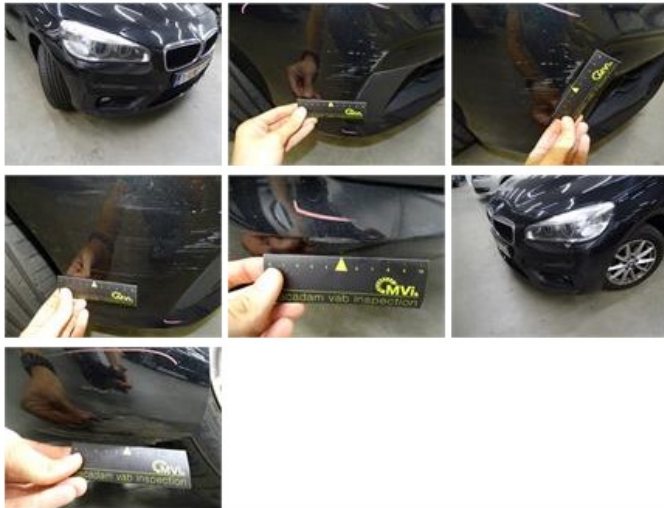
Bumper F, Scratch(es), LI - Repair and paint (complete) 211,80

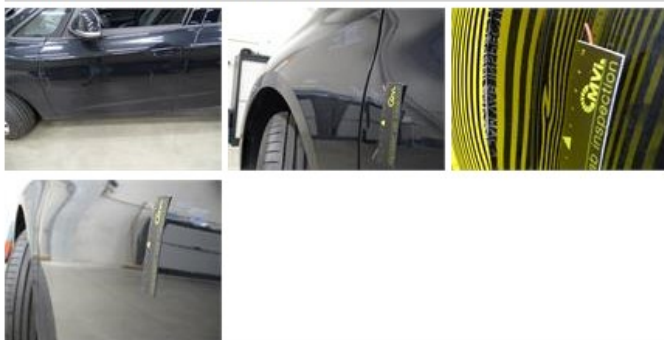
Door F L, Dent(s), PDR - Paintless dent repair 63,00

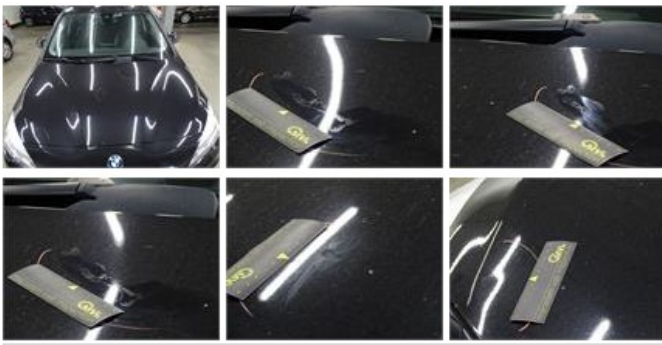
Bonnet, Chemical polution, LI - Repair and paint (complete) 0,00

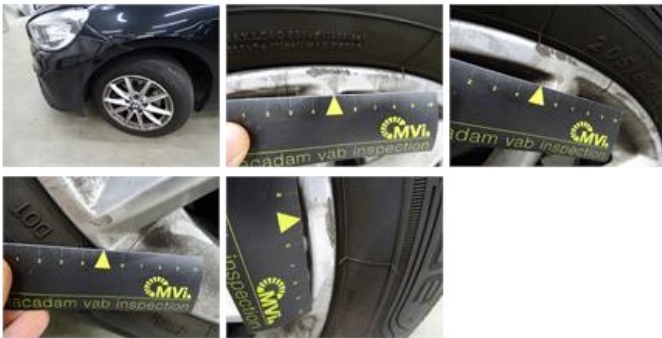
Alloy rim F L, Scratch(es), LI - Repair and paint (complete) 95,00

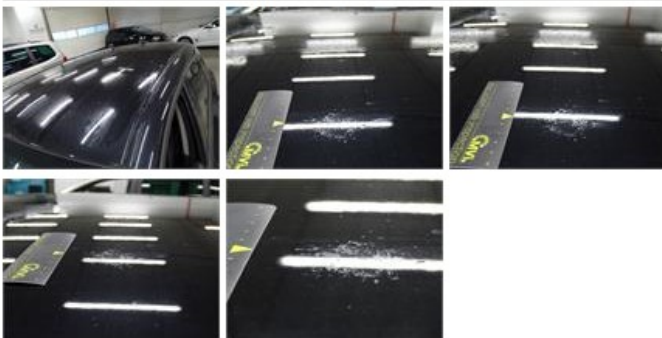
Roof, Chemical polution, LI - Repair and paint (complete) 0,00
