BMW 2 ACTIVE TOURER: 1KSJ232

Limited Technical Inspection

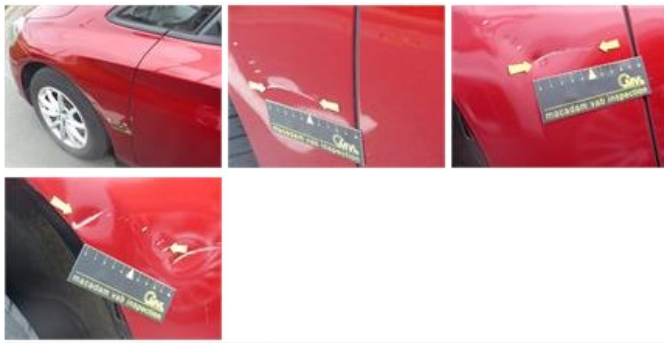
Wing F L, Dent(s) and scratch(es), LI - Repair and paint (complete)	292,18
---	---------------

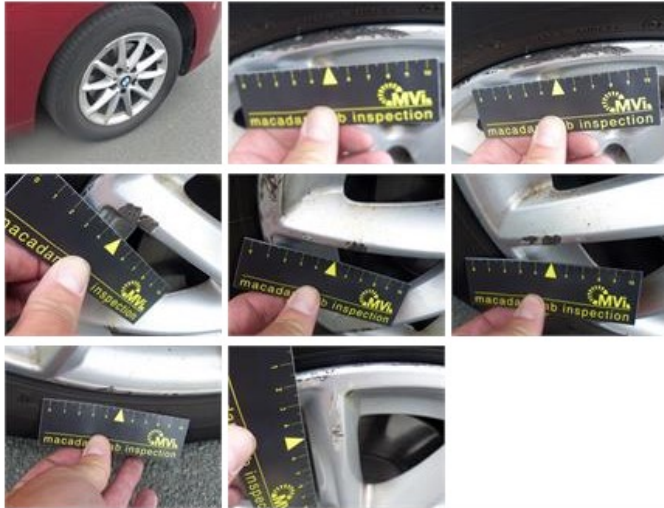
Alloy rim F R, Scratch(es), LI - Repair and paint (complete) 95,00

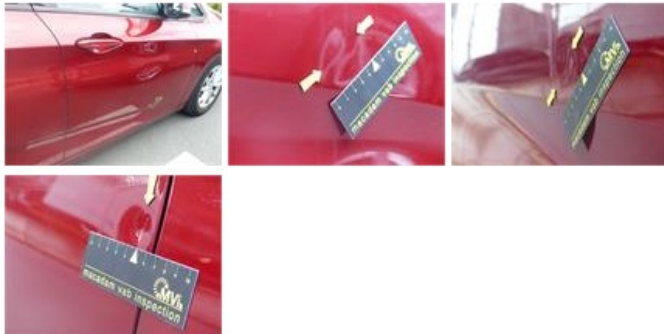
Door F R, Dent(s), PDR - Paintless dent repair 130,80

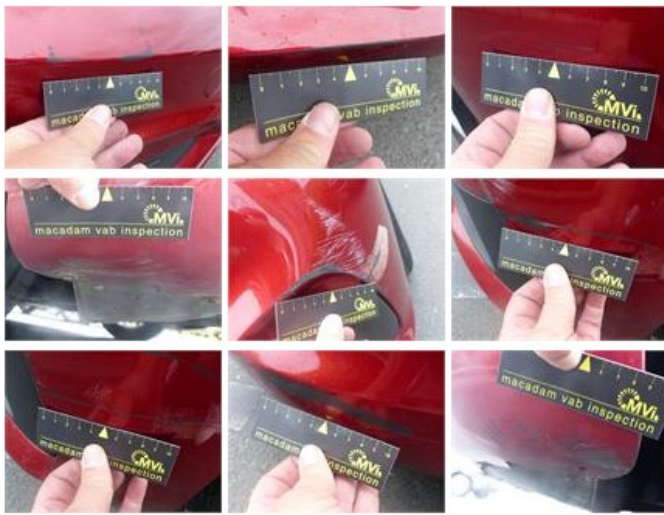
Bumper F, Scratch(es), LI - Repair and paint (complete) 211,80

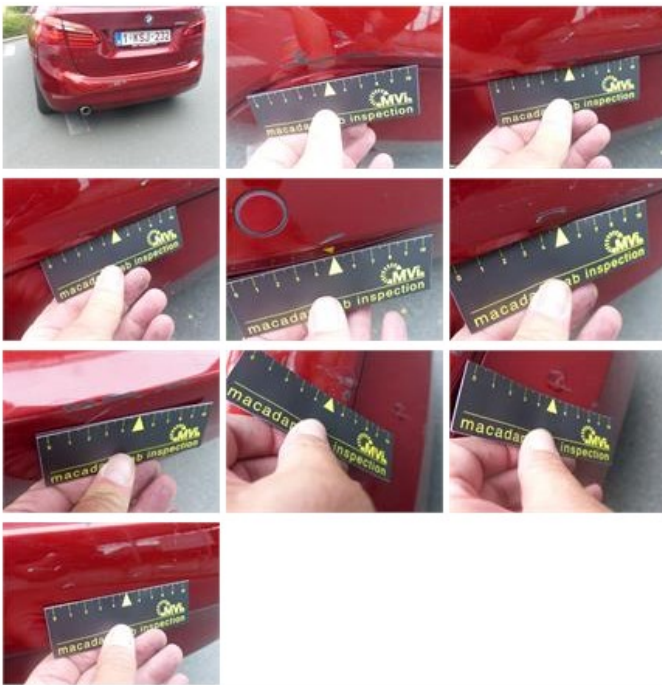
Bumper R, Dent(s) and scratch(es), LI - Repair and paint (complete) 283,80
