**BMW 1: 1KCF574**

**Limited Technical Inspection**

**Degree of wear**

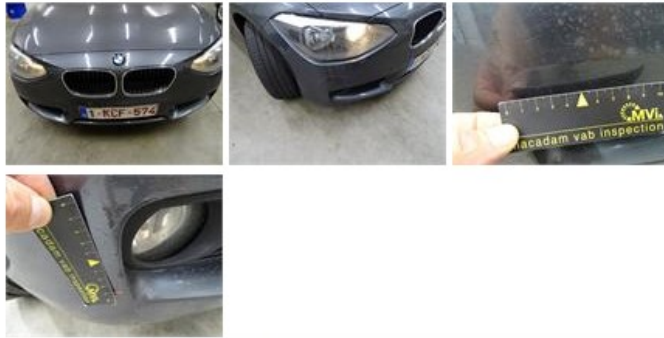
Bumper F, Scratch(es), LI - Repair and paint (complete) 211,80

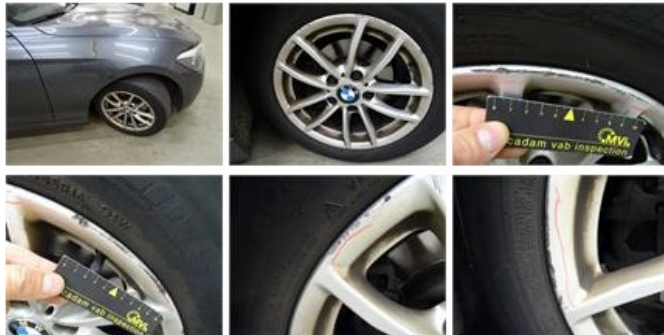
Alloy rim F R, Scratch(es), LI - Repair and paint (complete) 95,00

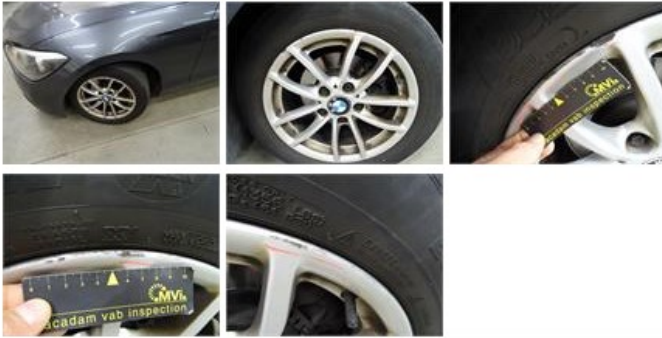
Alloy rim F L, Scratch(es), LI - Repair and paint (complete)

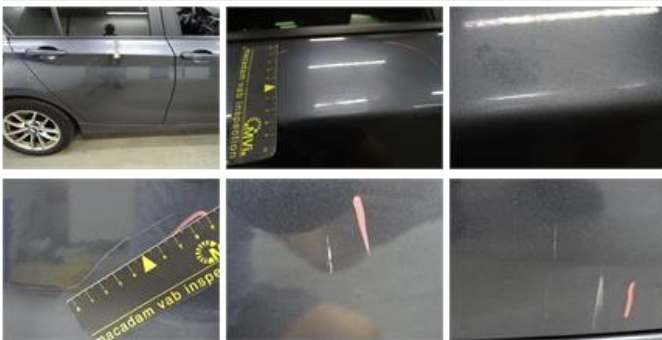
Door R R, Scratch(es), LI - Repair and paint (complete)
