**BMW 2 GRAN TOURER: 1LBL129**

**Limited Technical Inspection**

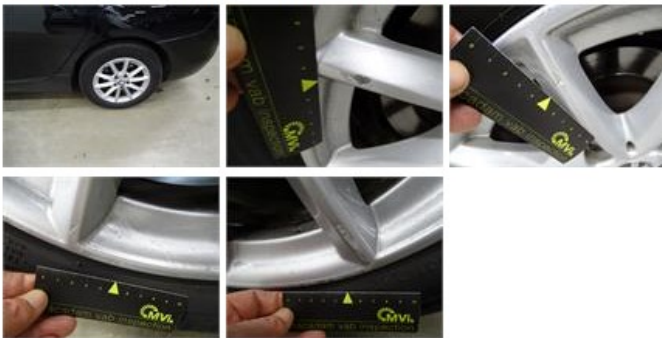
Alloy rim R L, Scratch(es), LI - Repair and paint (complete) 95,00
