BMW 3 TOURING: 1NET780

Limited Technical Inspection

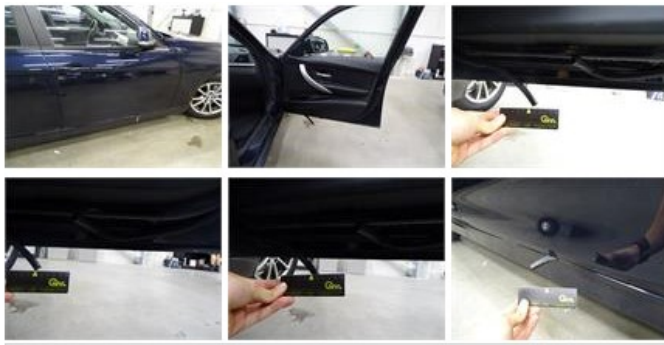
Total cost ex VAT		1074,03
Bonnet, Scratch(es), Acceptable		0,00
<i>No pictures to display</i>		
Door seal F R, Deformed / Strained, E - Replace		54,00

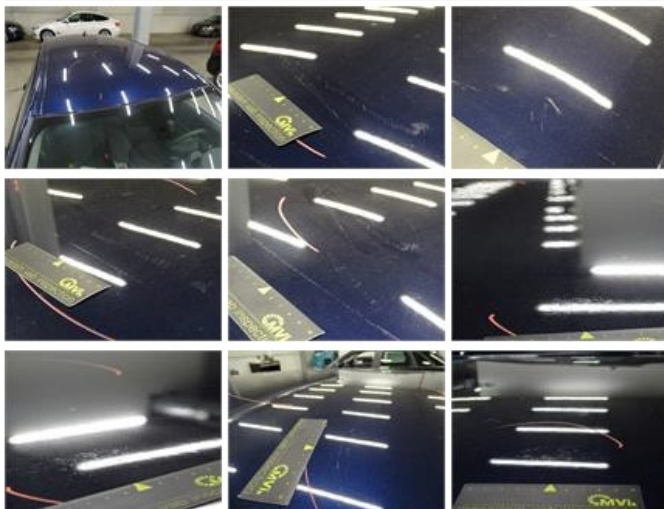
Roof, Scratch(es), LI - Repair and paint (complete) 481,50
