BMW 3: 1HJK342			
Vinnumber:	WBA3D91070J414677	Versionname:	3 BER 316d 116PK
First Registrationdate:	1/08/2014	Fiscalpower:	
Expertise Mileage:	126941	Power Kw:	85
Bodytype:	Berline	Body color:	Grey
Gearbox:	MAN 6 VIT	Paint type:	Metalic
Transmission:	Back	Rims summer:	Aluminium
Fueltype:	Diesel	Oil level:	OK
Battery functioning:	Yes	Parking lot:	3702
Number of doors:	4		
Number of seats:	5		
Number head rests:	5		
Rims summer:	Aluminium		
Category:	Passenger Car		
Oil level:	OK		
Registration Certificate Car (BE):	Yes

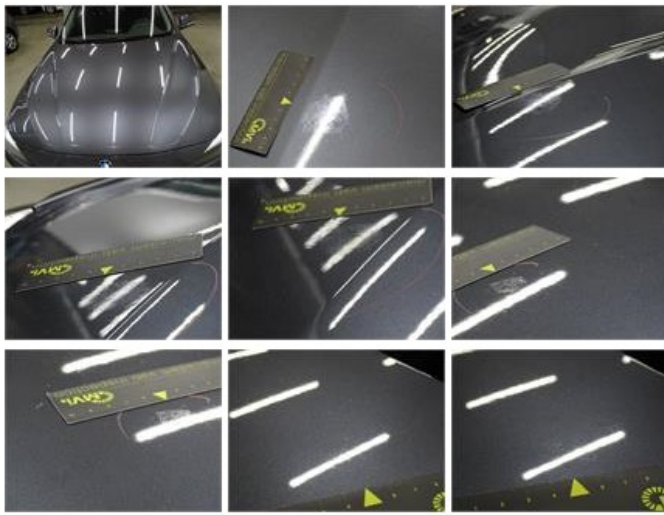
Total cost ex VAT		1144,42
Bonnet, Chemical polution, LI - Repair and paint (complete)		290,08

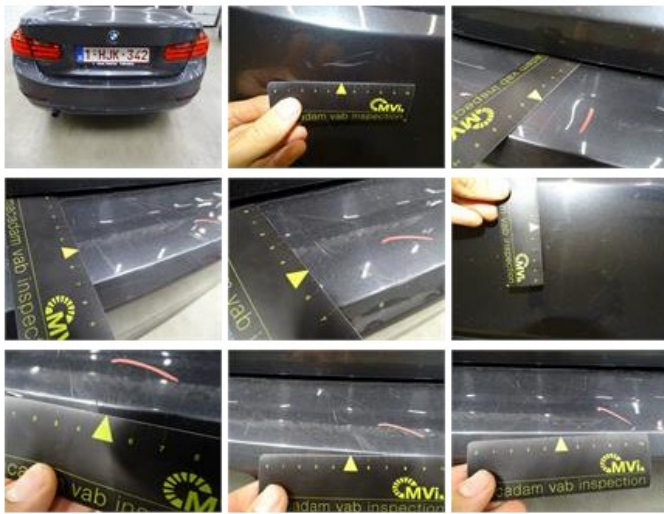
Bumper R, Scratch(es), LI - Repair and paint (complete) 211,80

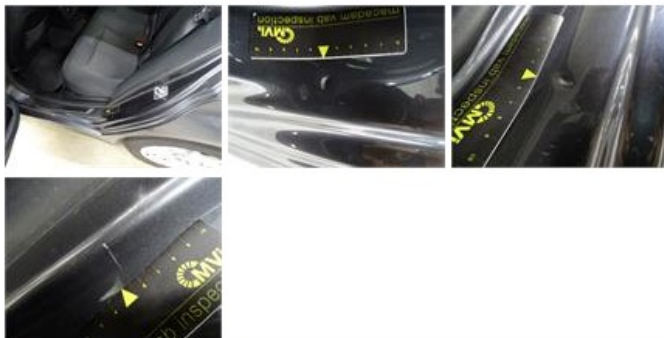
Rocker panel inner R L, Dent(s), LI - Repair and paint (complete) 115,56

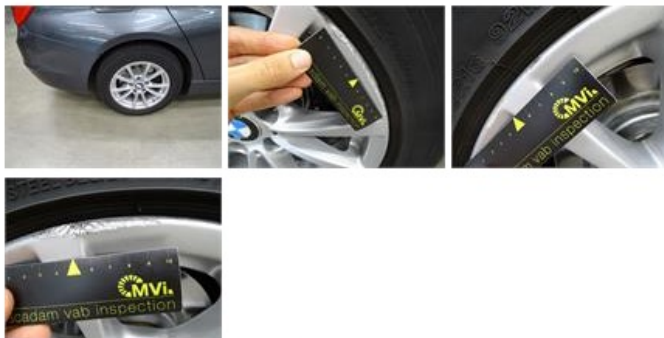
Alloy rim R R, Scratch(es), LI - Repair and paint (complete) 95,00

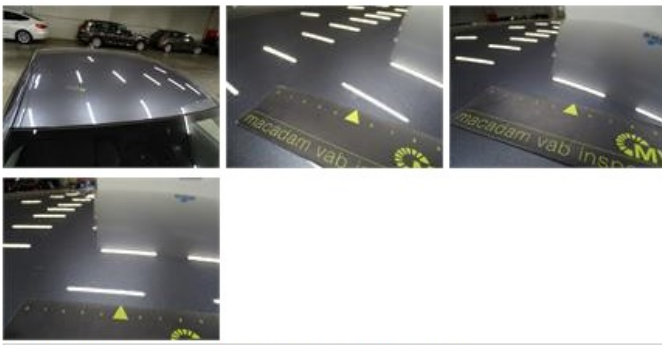
Roof, Bad repair, Acceptable 0,00

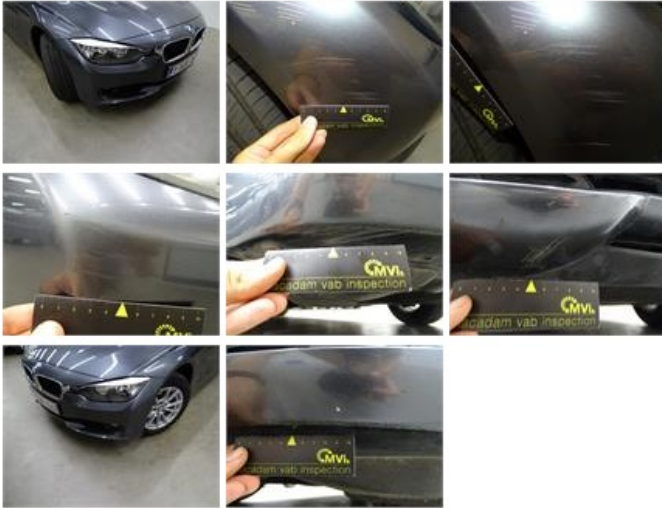
Bumper F, Scratch(es), LI - Repair and paint (complete) 211,80

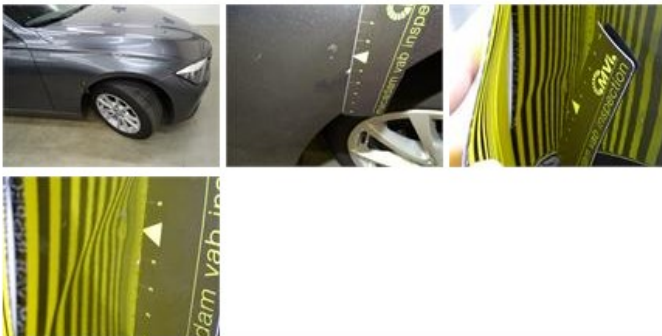
Wing F R, Dent(s) and scratch(es), LI - Repair and paint (complete) 220,18

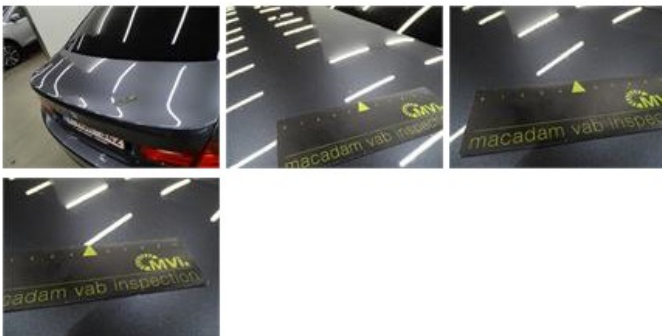
Tailgate, Bad repair, Acceptable 0,00
