PEUGEOT 308 SW: 1LGY179

Limited Technical Inspection

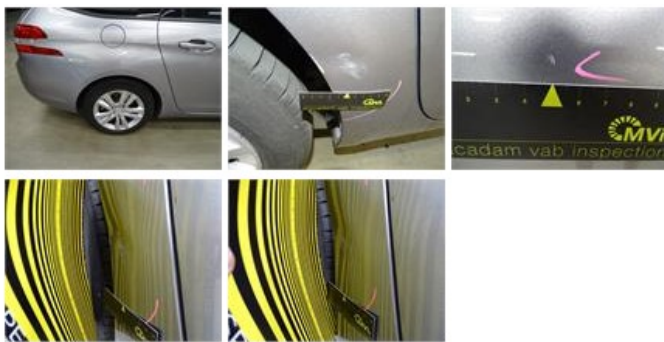
Total cost ex VAT	2219,12
Wing R R, Dent(s) and scratch(es), LI - Repair and paint (complete)	308,20

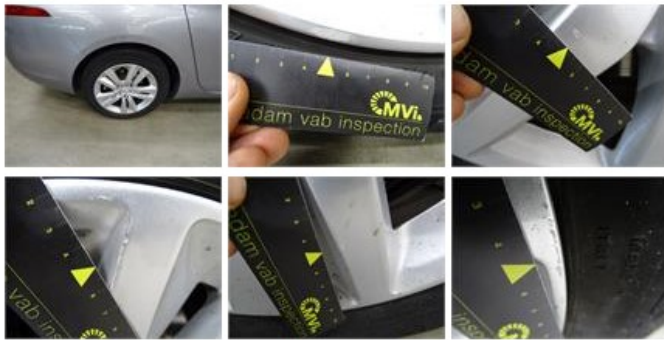
Alloy rim R R, Scratch(es), LI - Repair and paint (complete) 95,00

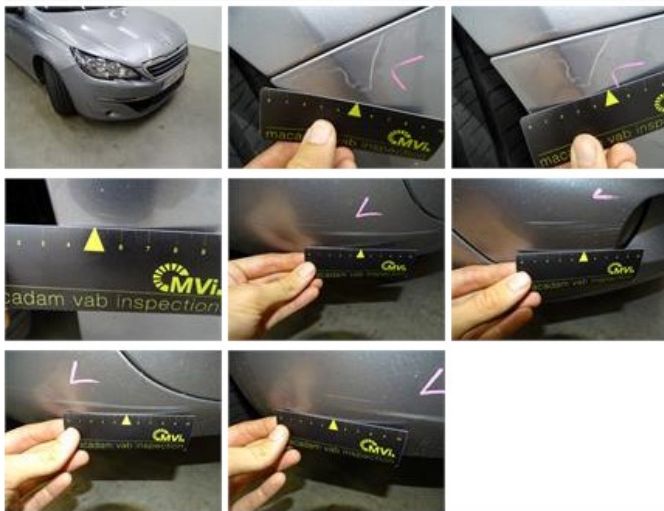
Bumper F, Scratch(es), LI - Repair and paint (complete) 211,80

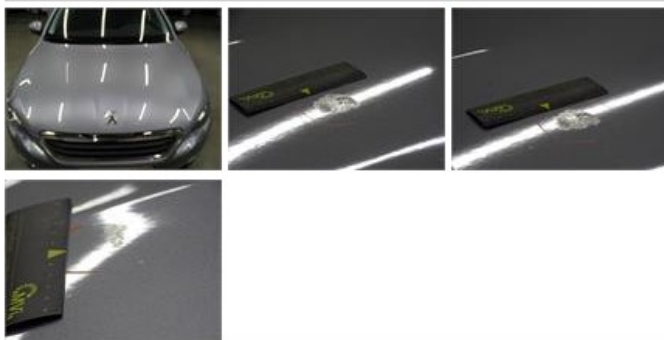
Bonnet, Chemical polution, LI - Repair and paint (complete) 290,08

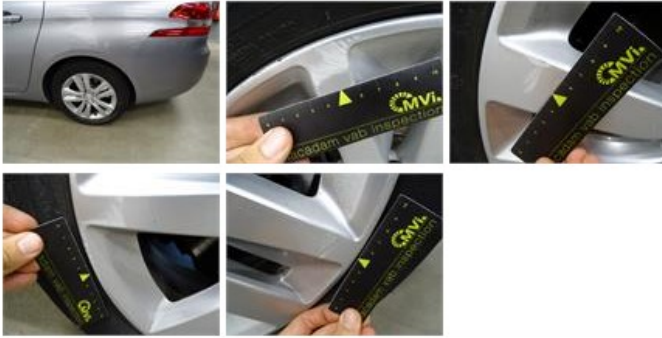
Alloy rim R L, Scratch(es), LI - Repair and paint (complete) 95,00

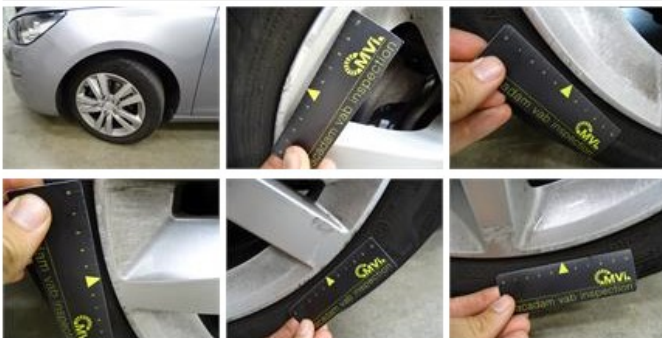
Alloy rim F L, Scratch(es), LI - Repair and paint (complete) 95,00

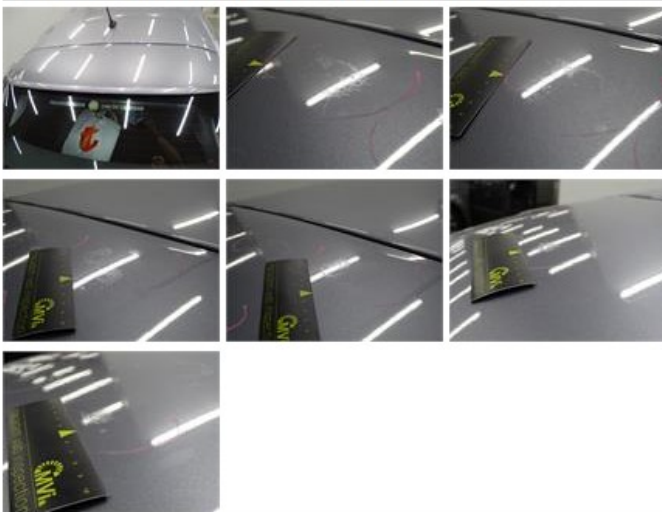
Rear spoiler, Chemical polution, LI - Repair and paint (complete) 115,56

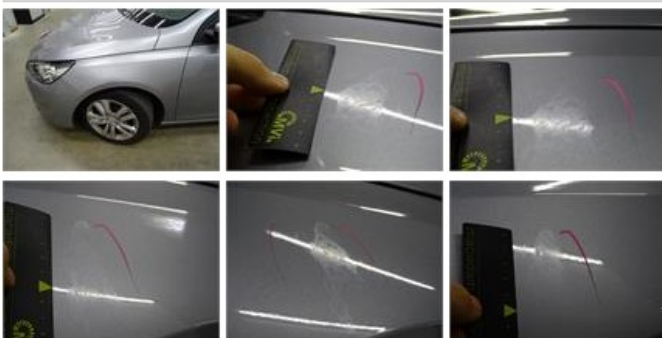
Wing F L, Chemical polution, LI - Repair and paint (complete) 220,18

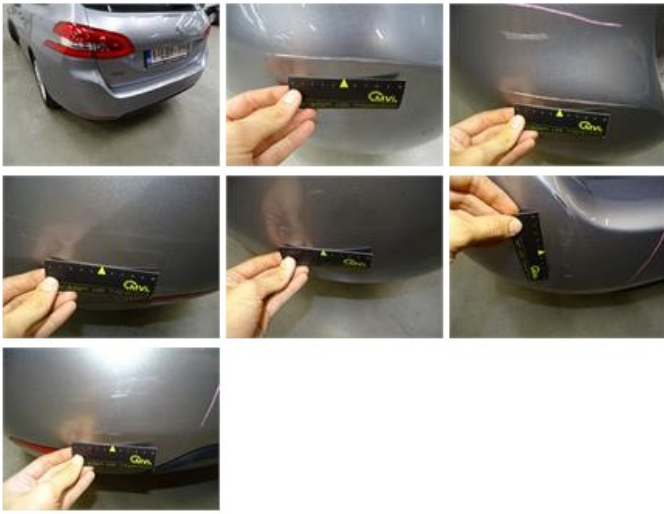
Bumper R, Scratch(es), LI - Repair and paint (complete)

211,80
