CITROEN C4 Picasso: 1GWN828

Limited Technical Inspection

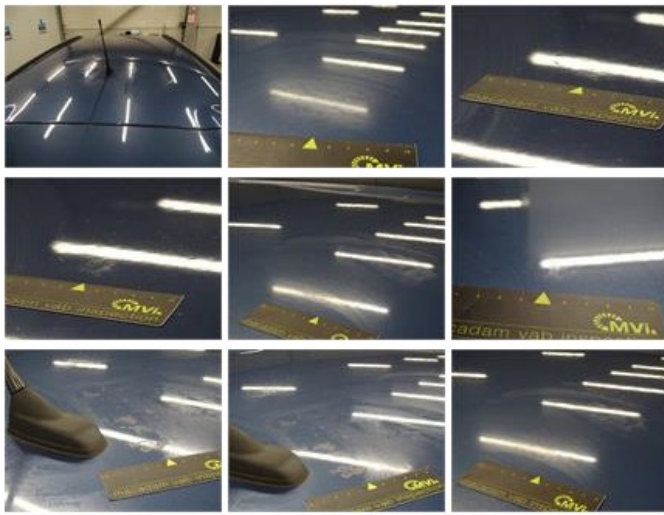
Total cost ex VAT	2929,99
Roof, Chemical polution, LI - Repair and paint (complete)	481,50

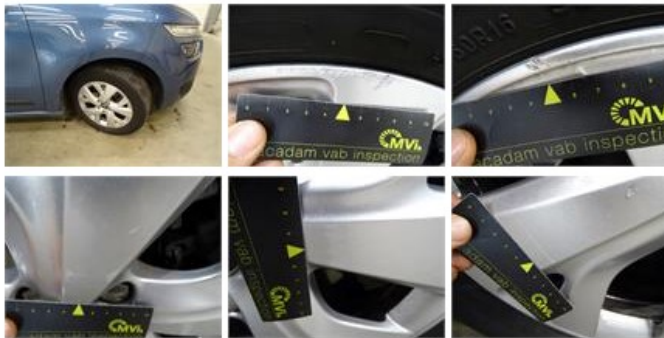
Alloy rim F R, Scratch(es), LI - Repair and paint (complete)

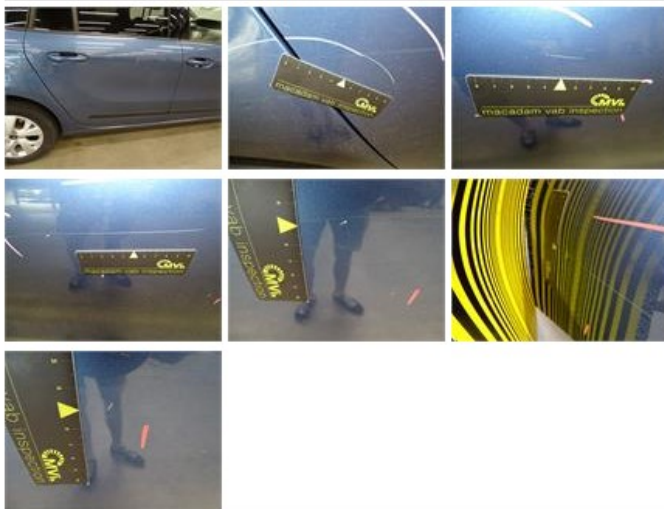
Door R R, Dent(s) and scratch(es), LI - Repair and paint (complete)

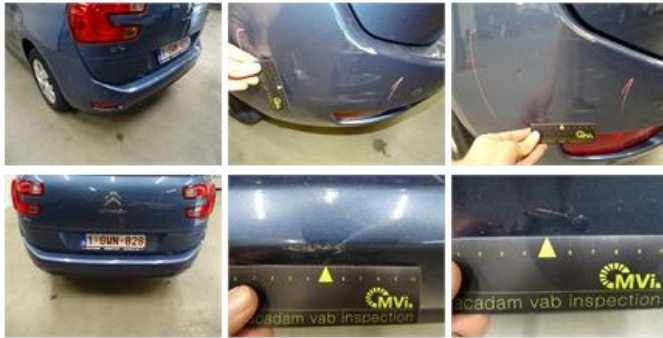
Bumper R, Scratch(es), LI - Repair and paint (complete)

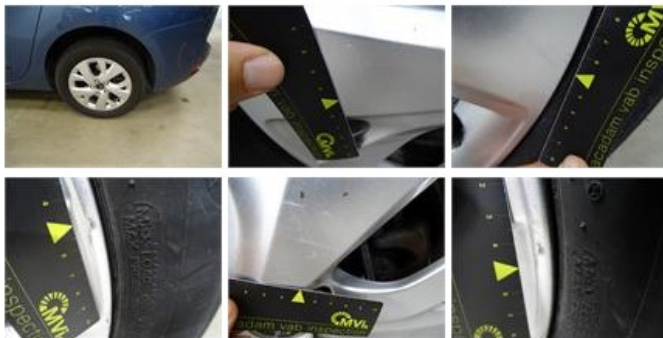
Alloy rim R L, Scratch(es), LI - Repair and paint (complete)

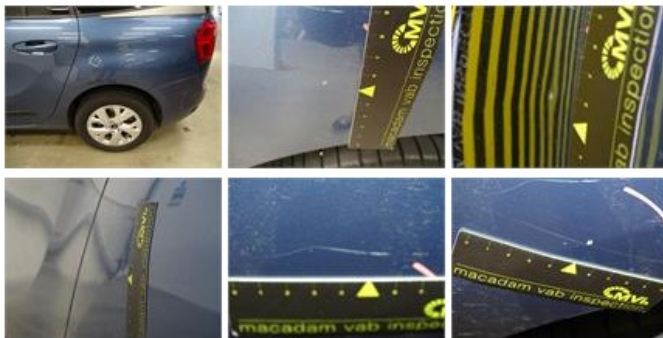
Wing R L, Dent(s) and scratch(es), LI - Repair and paint (complete)

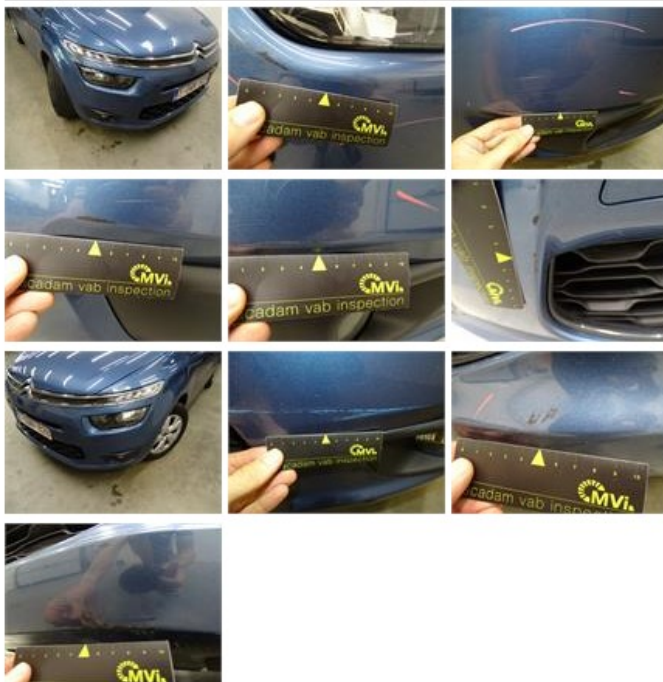
Bumper F, Scratch(es), LI - Repair and paint (complete)

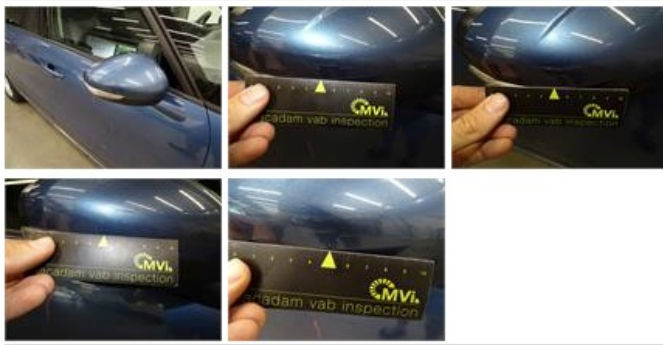
Door F L, Dent(s) and scratch(es), LI - Repair and paint (complete)

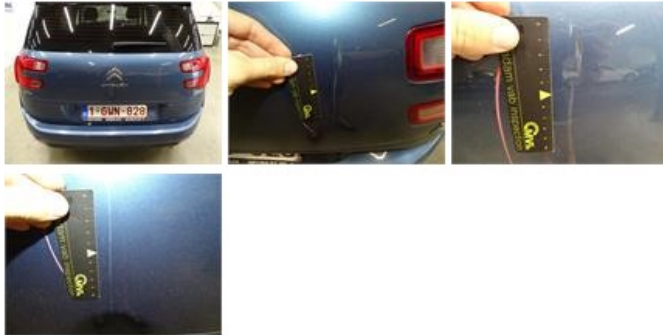
Tailgate, Scratch(es), LI - Repair and paint (complete)

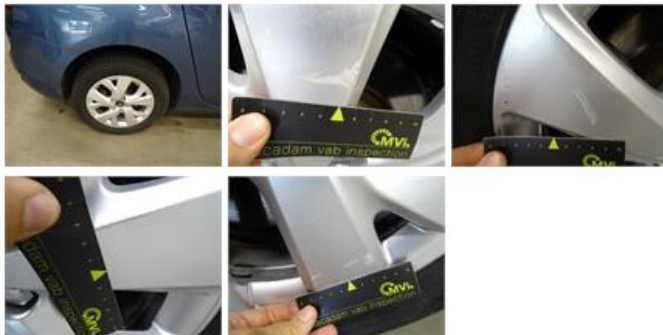
Alloy rim R R, Scratch(es), LI - Repair and paint (complete)

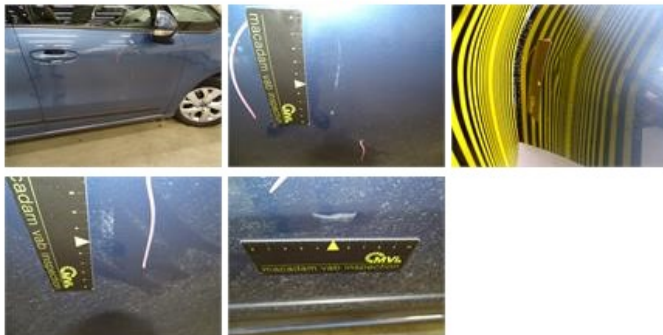
Door F R, Dent(s) and scratch(es), LI - Repair and paint (complete)

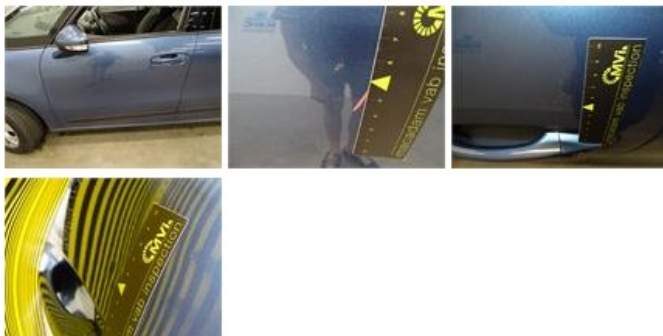
Door F L, Dent(s) and scratch(es), LI - Repair and paint (complete)
