## CITROEN DS5: 1HDT893

## Limited Technical Inspection

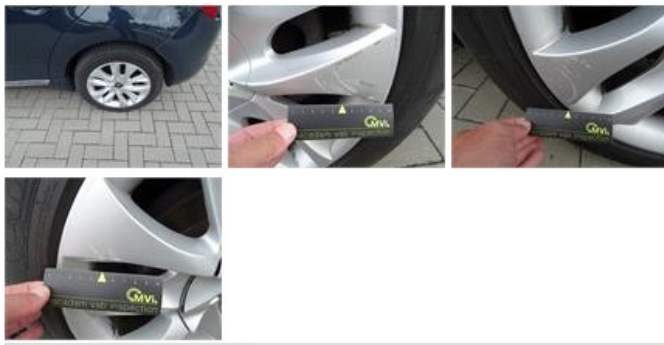
Total cost ex VAT	<b>551,64</b>
Alloy rim R L, Scratch(es), LI - Repair and paint (complete)	<b>95,00</b>
