**MERCEDES C: 1JUY139**

**Limited Technical Inspection**

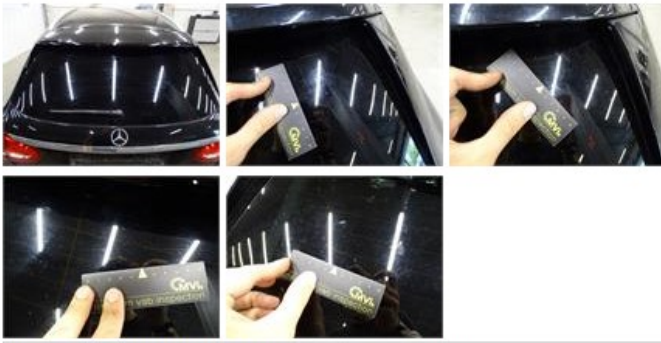
Rear window, Scratch(es), Acceptable 0,00

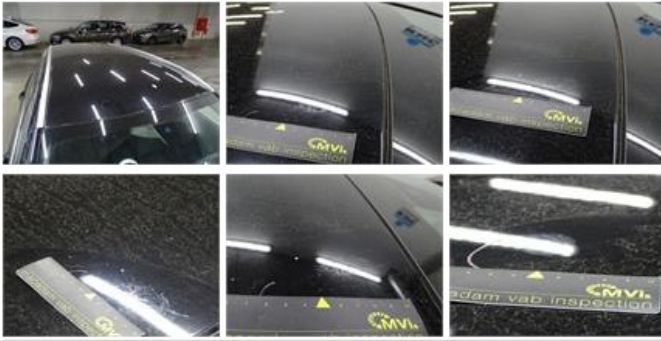
Roof, Chemical pollution, LI - Repair and paint (complete) 481,50

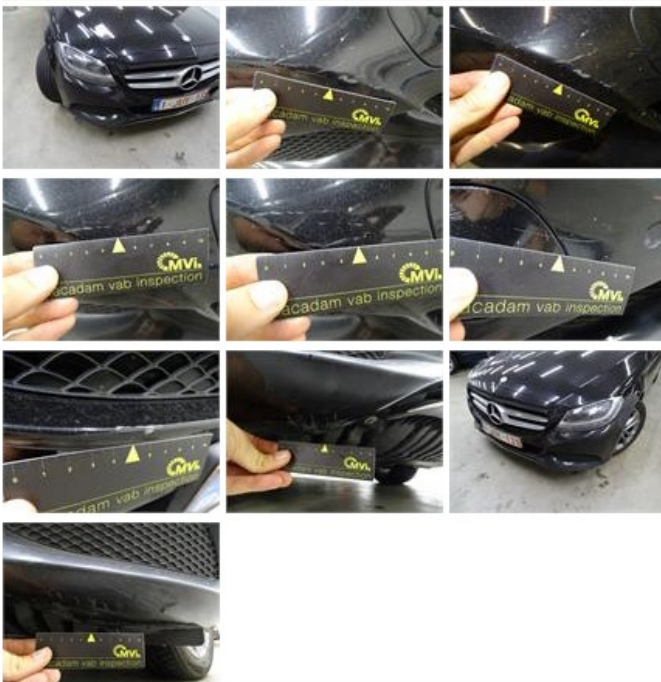
Bumper F, Scratch(es), LI - Repair and paint (complete) 211,80

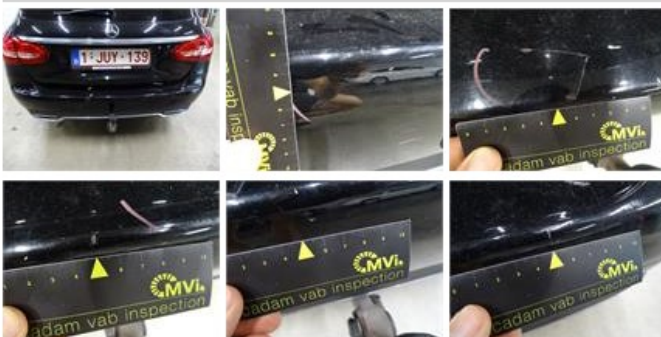
Bumper R, Scratch(es), LI - Repair and paint (complete) 211,80
