VOLKSWAGEN Golf: 1KSU526

Limited Technical Inspection

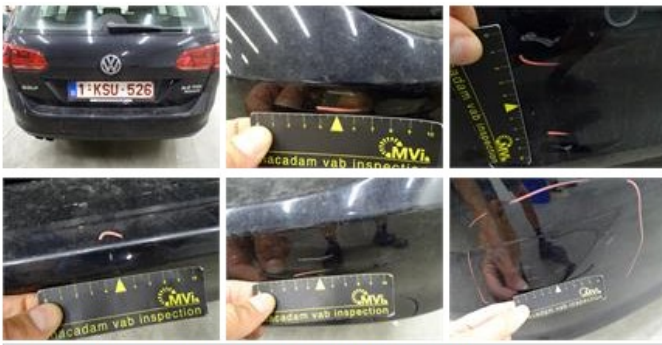
Total cost ex VAT	1915,97
Bumper R, Scratch(es), LI - Repair and paint (complete)	211,80

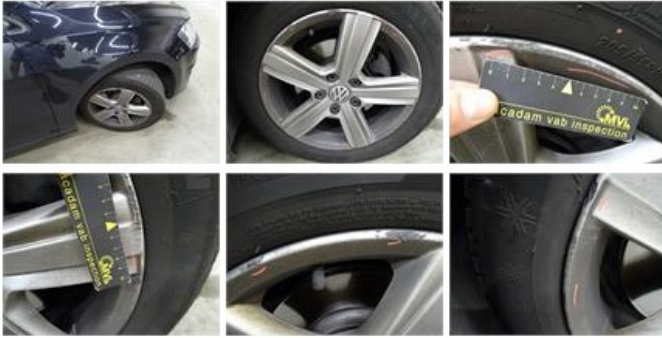
Alloy rim F R, Scratch(es), LI - Repair and paint (complete)

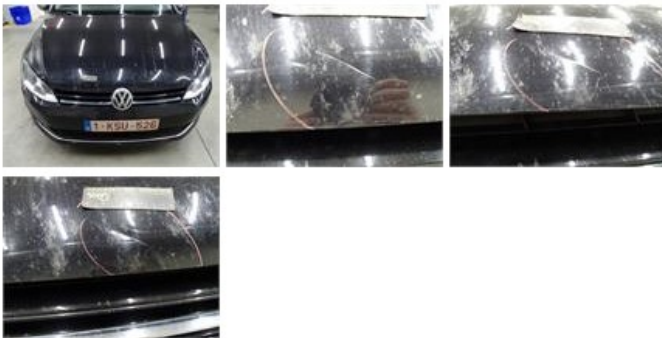
Bonnet, Dent(s) and scratch(es), LI - Repair and paint (complete)

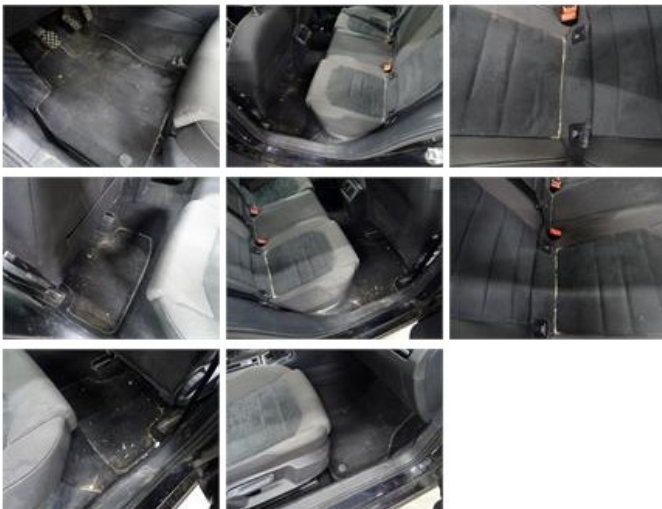
Interior, Dirty, Cleaning

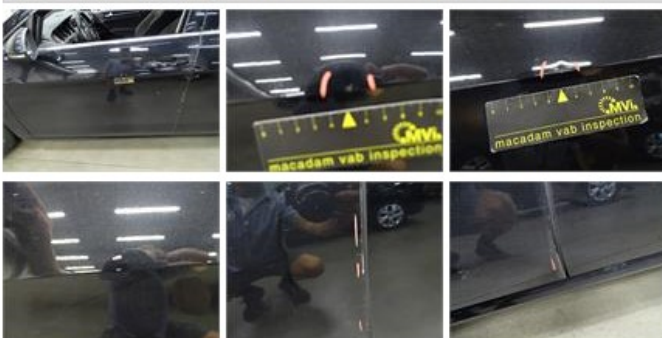
Door F L, Dent(s) and scratch(es), LI - Repair and paint (complete)

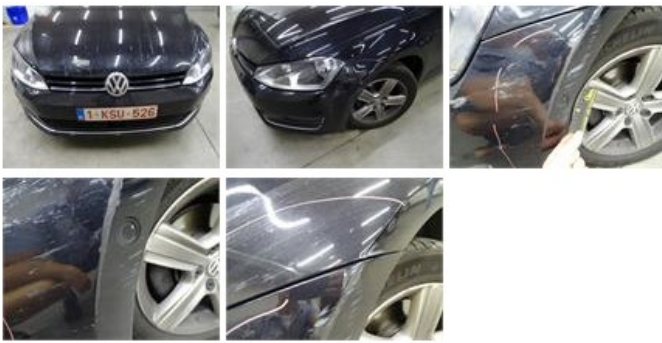
Bumper F, Scratch(es), LI - Repair and paint (complete)

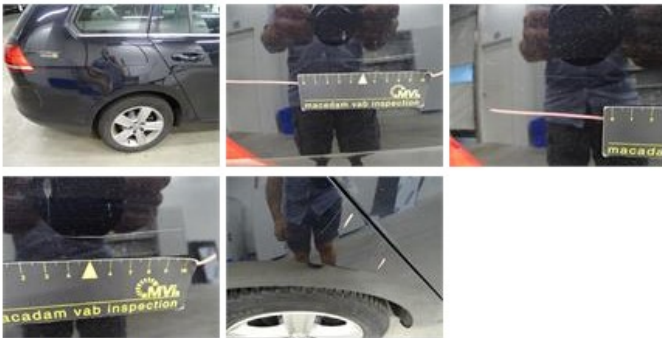
Wing R R, Scratch(es), LI - Repair and paint (complete) 308,20

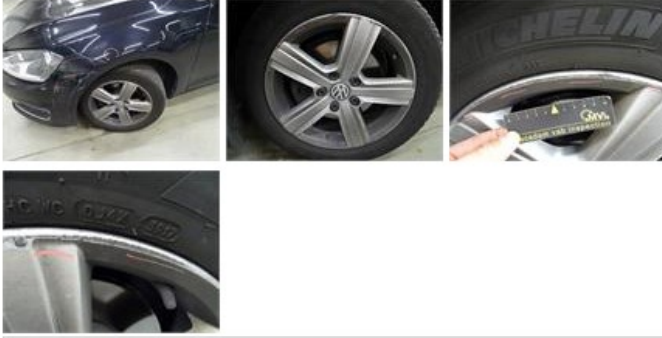
Alloy rim F L, Scratch(es), LI - Repair and paint (complete) 95,00
