**SKODA OCTAVIA COMBI: XS7237**

**Limited Technical Inspection**

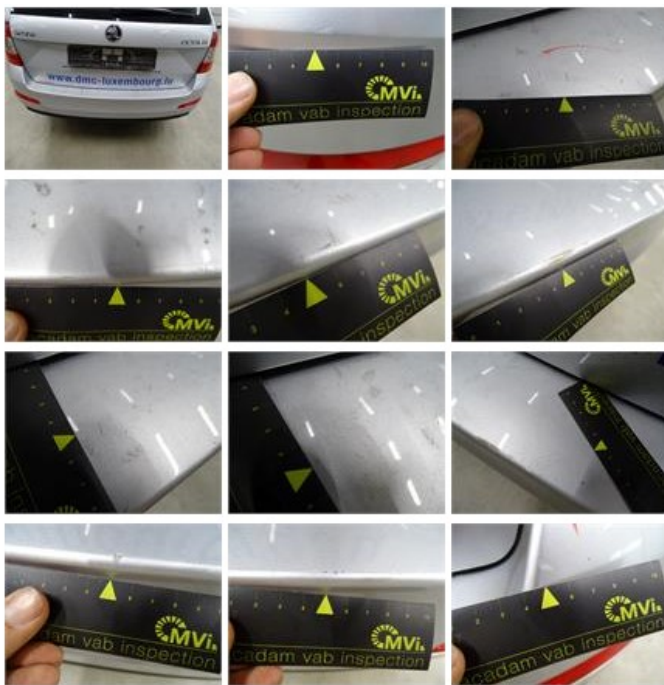
Total cost ex VAT	<b>1672,89</b>
Bumper R, Scratch(es), LI - Repair and paint (complete)	<b>211,80</b>

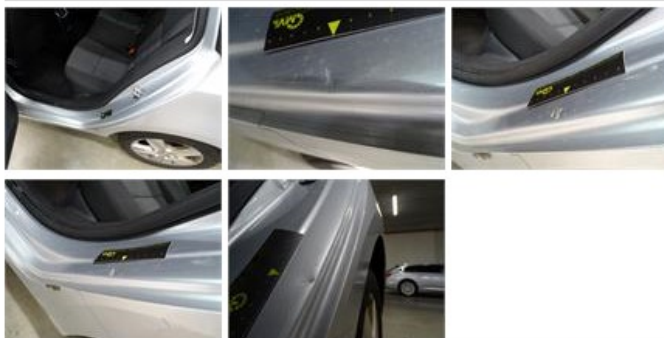
Rocker panel inner R L, Dent(s), LI - Repair and paint (complete)

115,56

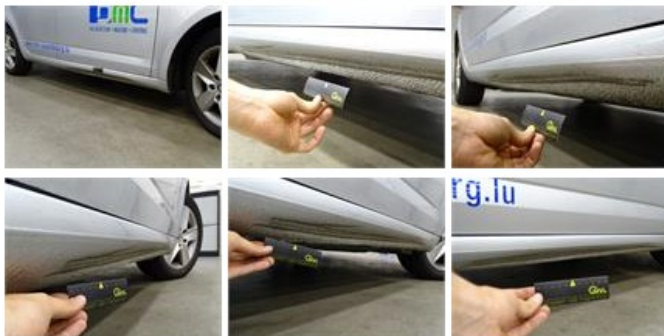
Sill outer R, Dent(s) and scratch(es), LI - Repair and paint (complete)

358,50

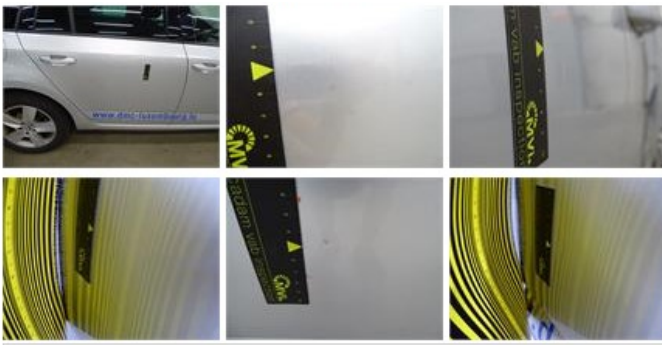
Door R R, Dent(s) and scratch(es), LI - Repair and paint (complete)

318,35

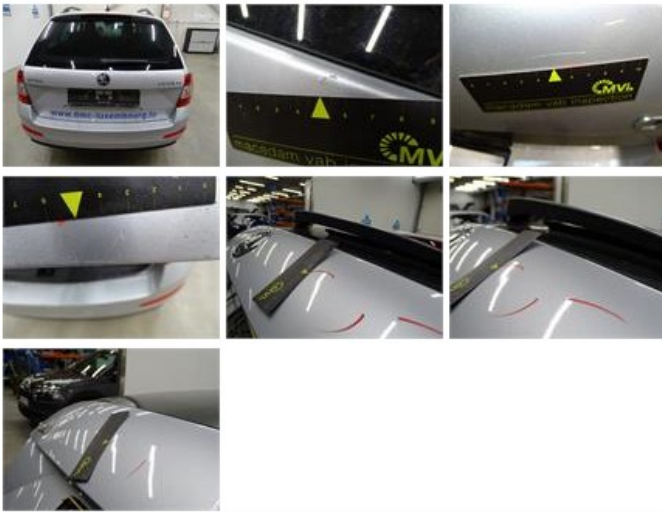
Tailgate, Dent(s) and scratch(es), LI - Repair and paint (complete) 301,68
