VOLKSWAGEN Golf: 1GXQ768

Limited Technical Inspection

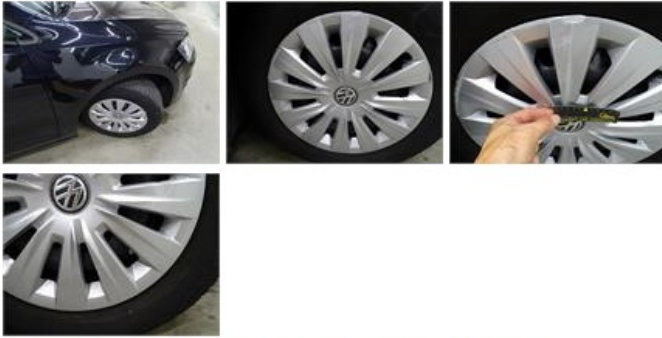
Rearview mirror housing R, Scratch(es), 67 - Polish	0,00
<i>No pictures to display</i>	
Bonnet, Chemical polution, 67 - Polish	0,00
<i>No pictures to display</i>	
Door F R, Chemical polution, 67 - Polish	0,00
<i>No pictures to display</i>	
Bonnet, Scratch(es), Acceptable	0,00
<i>No pictures to display</i>	
Wheel cover F R, Scratch(es), E - Replace	30,00

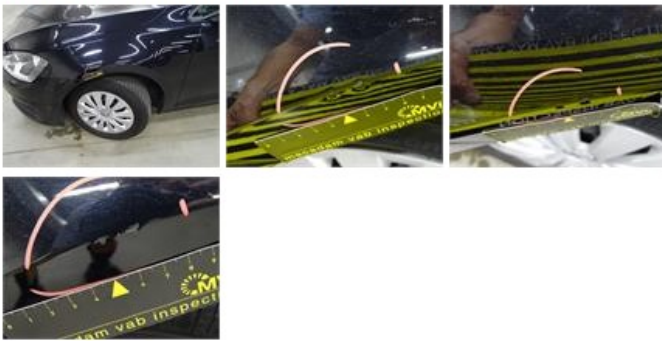
Wing F L, Dent(s) and scratch(es), LI - Repair and paint (complete)	220,18
---	--------

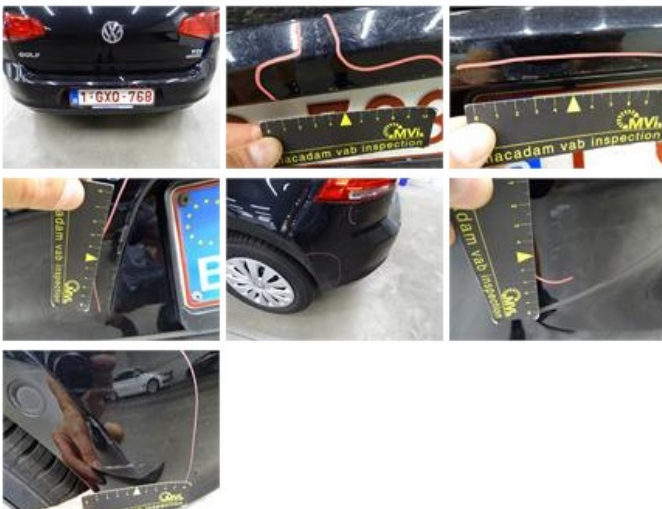
Bumper R, Scratch(es), LI - Repair and paint (complete)	211,80
---	--------
