RENAULT Captur: 1HAG029

Limited Technical Inspection

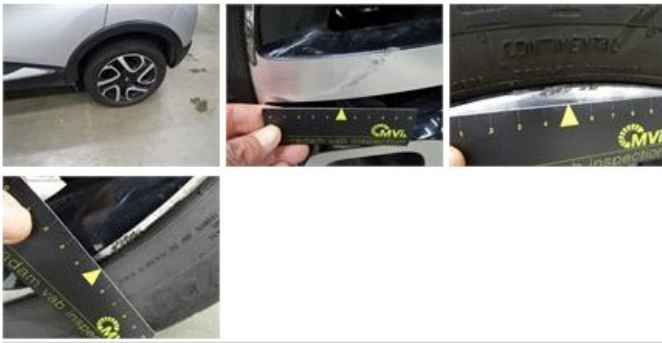
Alloy rim R L polished, Scratch(es), LI - Repair and paint (complete)	95,00
---	-------

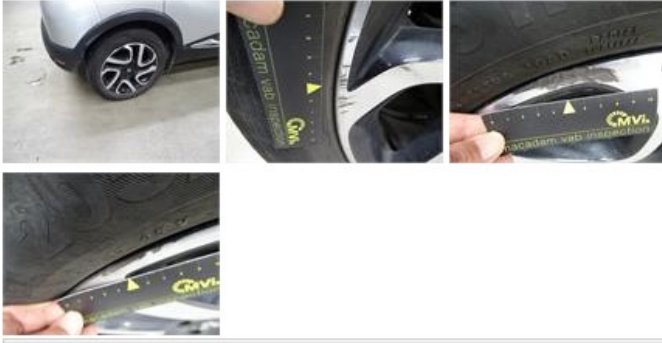
Alloy rim R R polished, Scratch(es), LI - Repair and paint (complete) 95,00
