SKODA Octavia: 1GPI397

Limited Technical Inspection

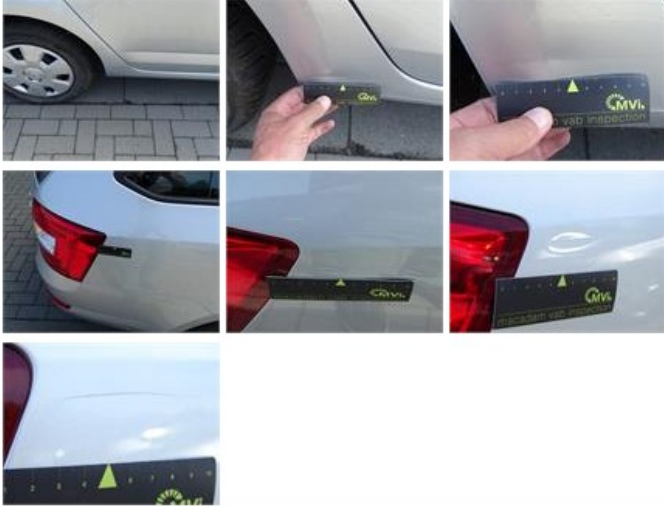
Wing R R, Dent(s) and scratch(es), LI - Repair and paint (complete) 308,20

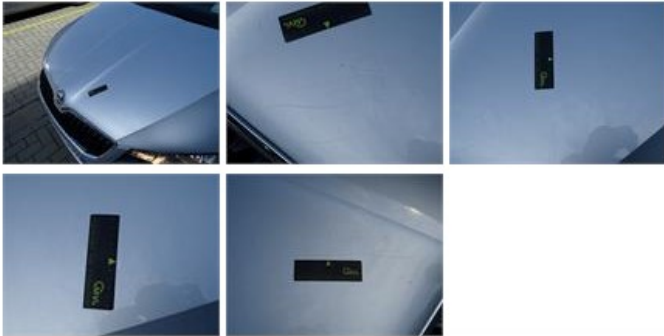
Bonnet, Scratch(es), 67 - Polish 0,00
